Design Stage Conceptual Site Model Wyckoff Eagle Harbor Superfund Site

Battelle Sediments Conference

Jeff Gentry, Jacobs Helen Bottcher, U.S. Environmental Protection Agency Ken Scheffler, Jacobs Scott McKinley, Jacobs Dave Finney, Jacobs February 2019

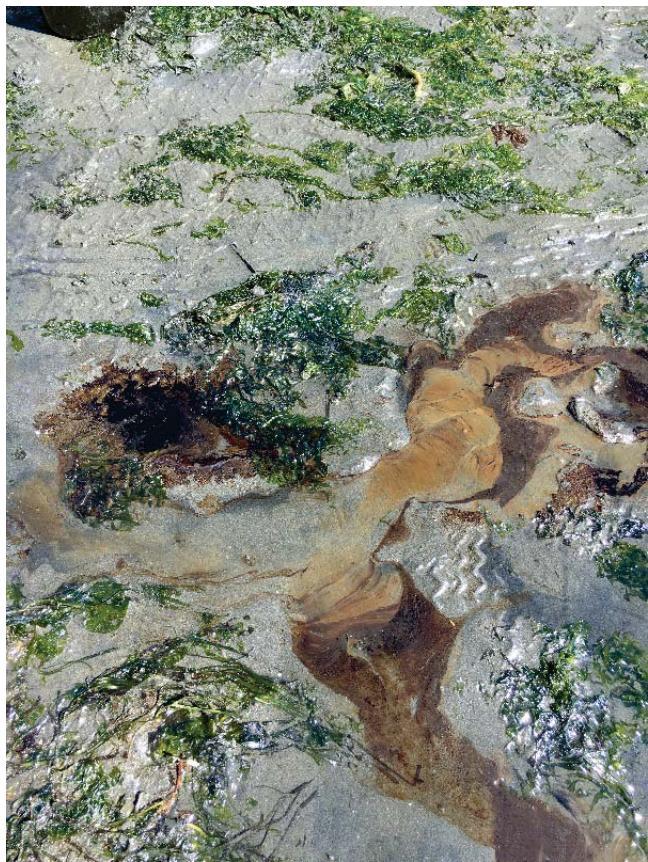
- 1986 Video shows low vegetation and high NAPL discharge
- Currently, eel grass and clams present
- However, at low tides, NAPL surface discharge still occurs in select areas

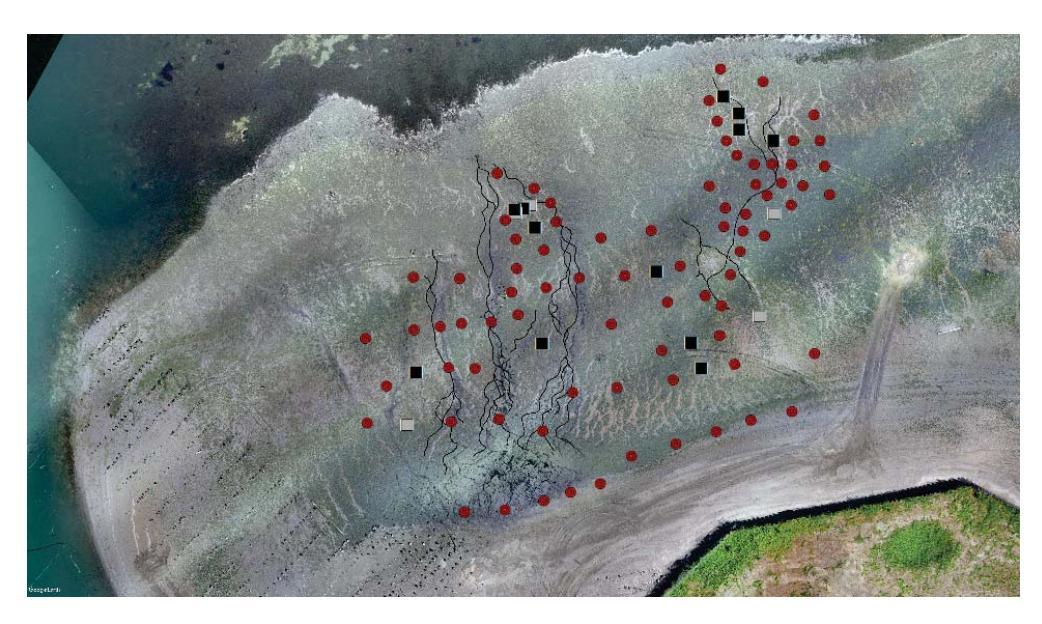
- NAPL blebs and sheen in shallow sediment followed tidal drainage
- Surface blebs observed 235 feet from sheet pile wall
- Detailed imagery allowed surface NAPL impacts to be identified
- August event planned for shallow test pits focused along tidal drainage

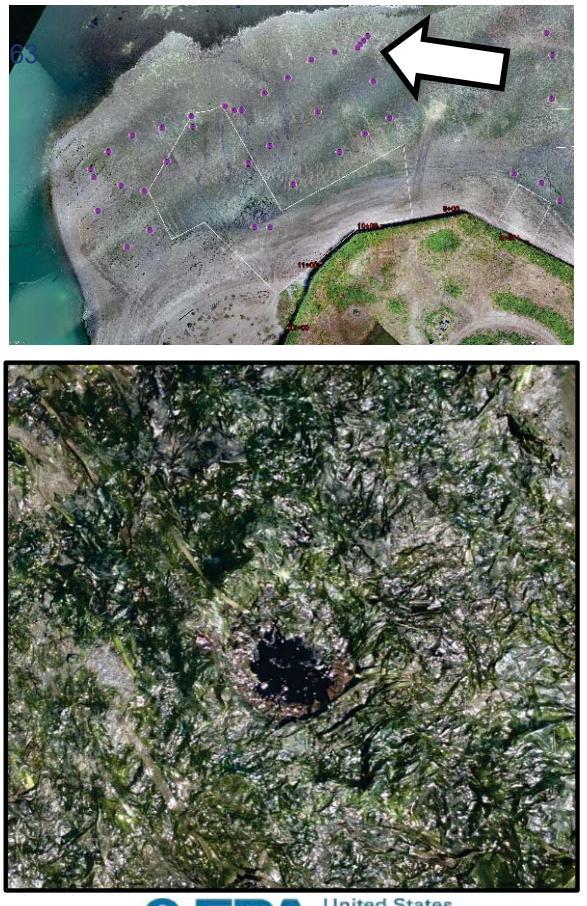
- High TarGOST response up to 6 feet deep
 - 250 feet from wall
- Two step-out borings, same general response
- NAPL observed in borehole

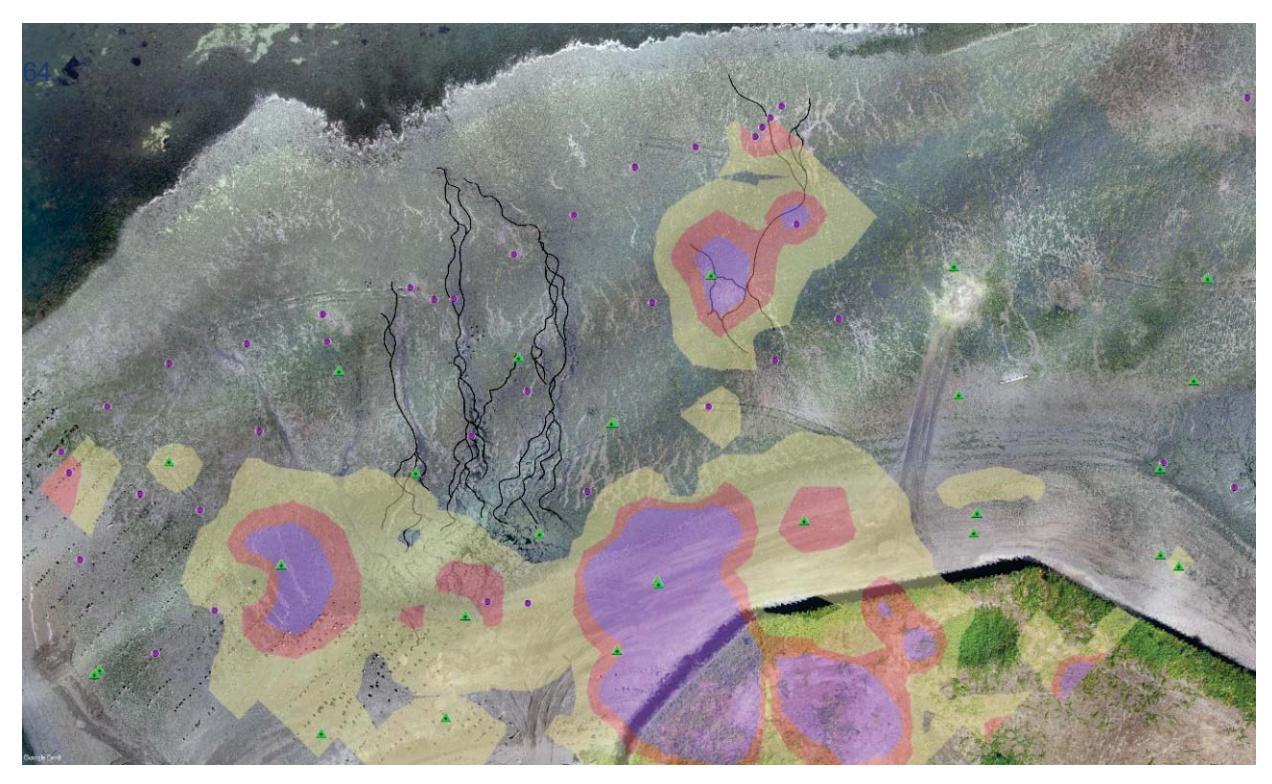
- High TarGOST response up to 6 feet deep
 - 250 feet from wall
- Two step-out borings, same general response
- NAPL observed in borehole
- TarGOST interpolation also follows tidal drainage

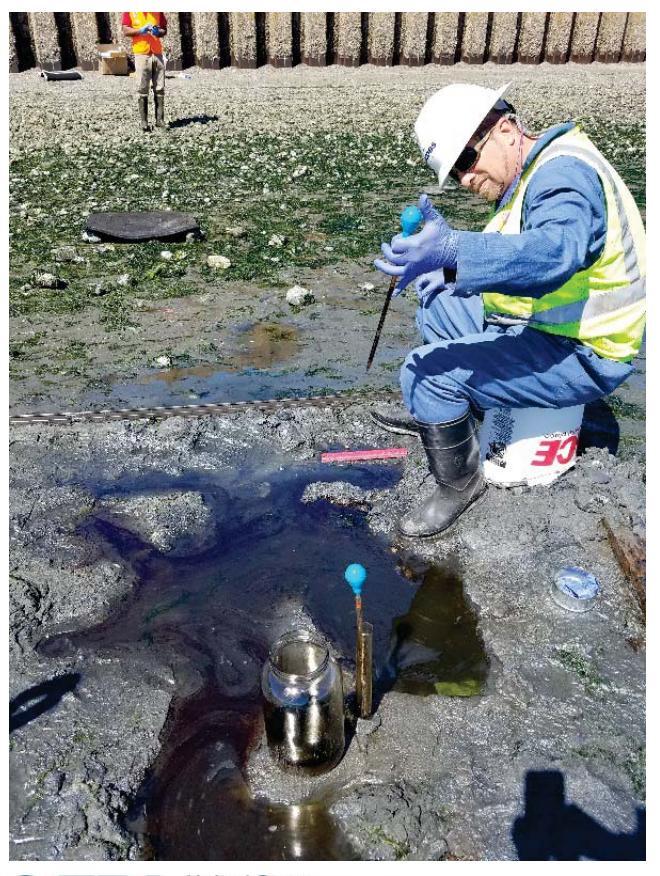
- 200 mL of NAPL (or 196 grams) was collected over one tide cycle
 - 0.97 specific gravity LNAPL!
 - Total collection area ~100 ft² (9.2 m²)
 - majority of the discharge occurring from an area of 1 ft² (0.092 m²)

Assumed	Volumetric	Mass
Seep Area	Discharge	Discharge
	(mL/m²)	(g/m²)
1 ft ²	2,150	2,110
(0.092 m ²)		
100 ft ²	21.5	21.1
(9.2 m ²)

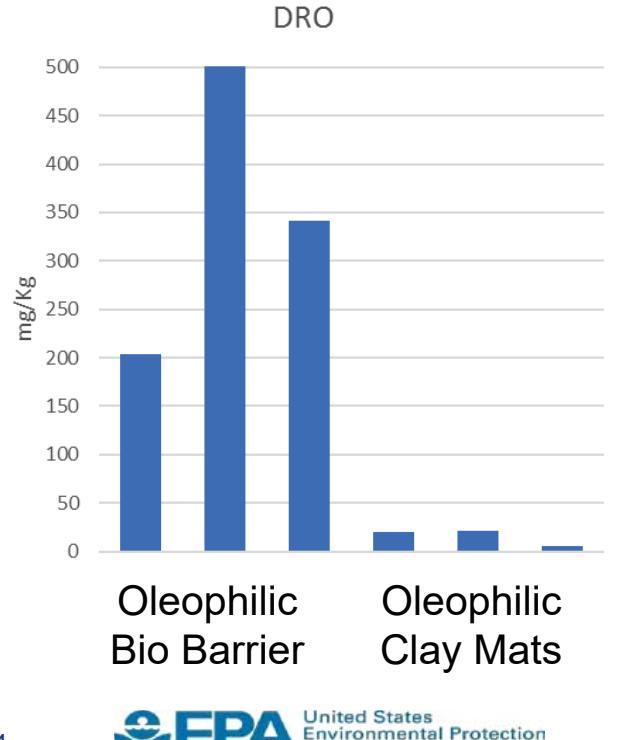
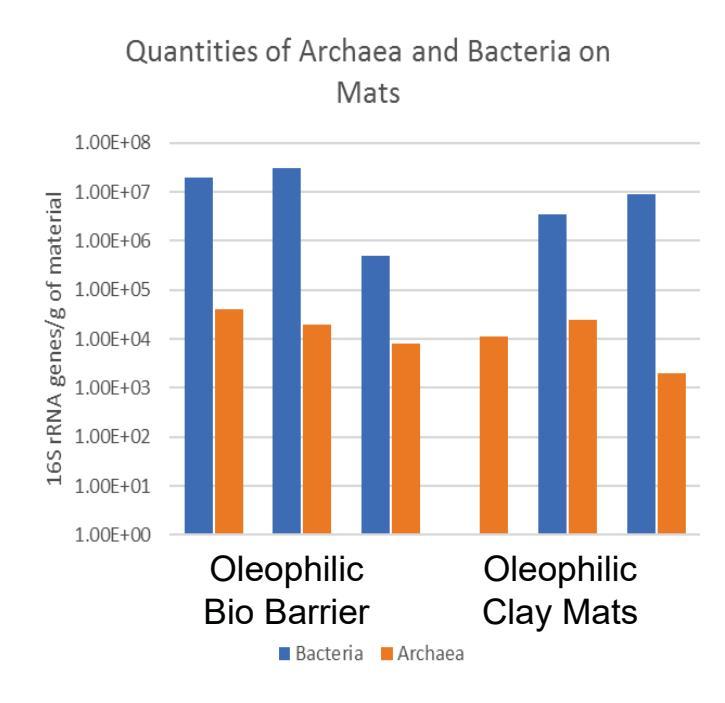
Absorptive Media Tests

- North Shoal samples had inconclusive data
- DRO loading on OBB was higher than the oleophilic clay mat
- Both mats colonized by bacterial in 60 days
 - 1x10⁷ count considered high by CSU researchers

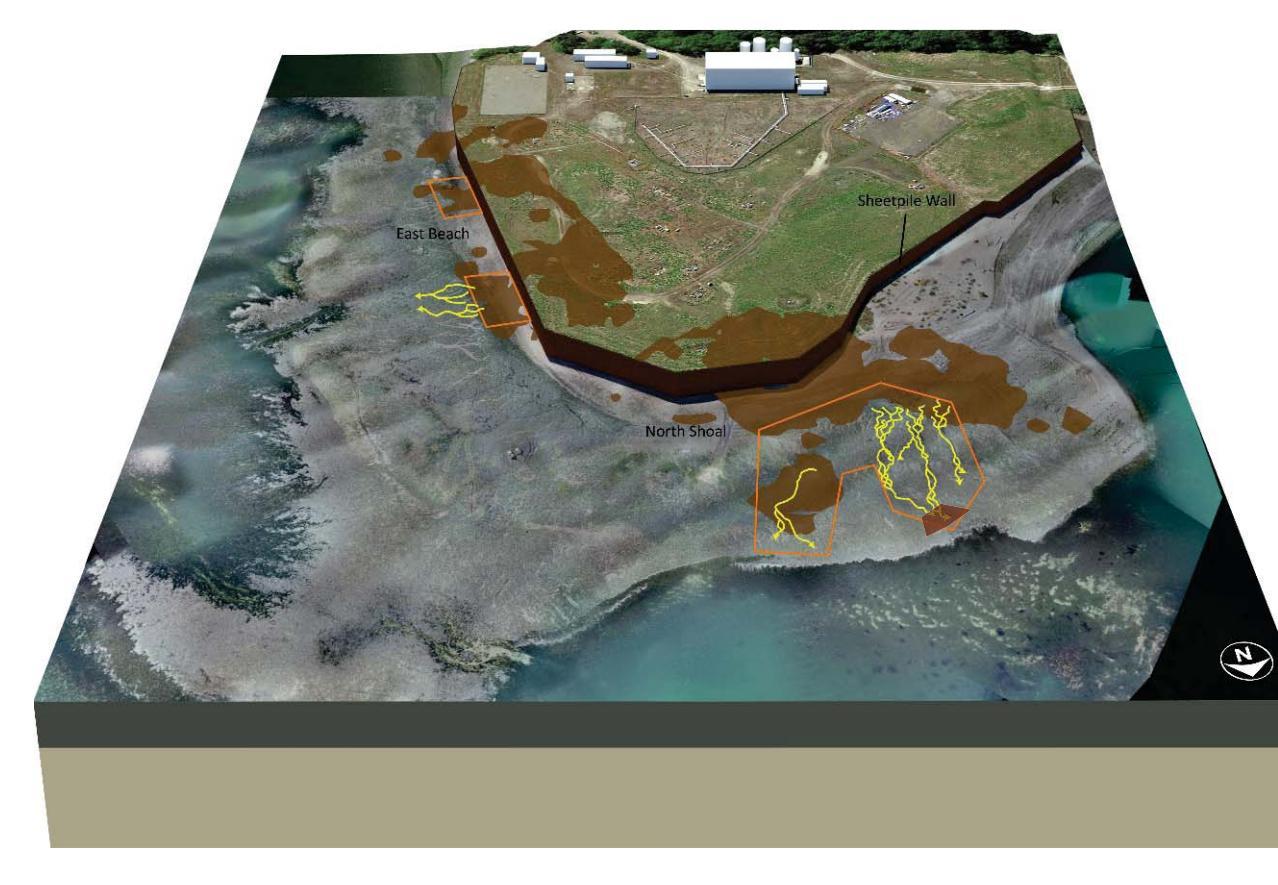
Surface NAPL Flow Informed Design Stage CSM

- NAPL surface discharge and transport explains the lateral NAPL distribution the site
- Tidal drainages are also accumulation areas for NAPL resulting in deeper NAPL impacts

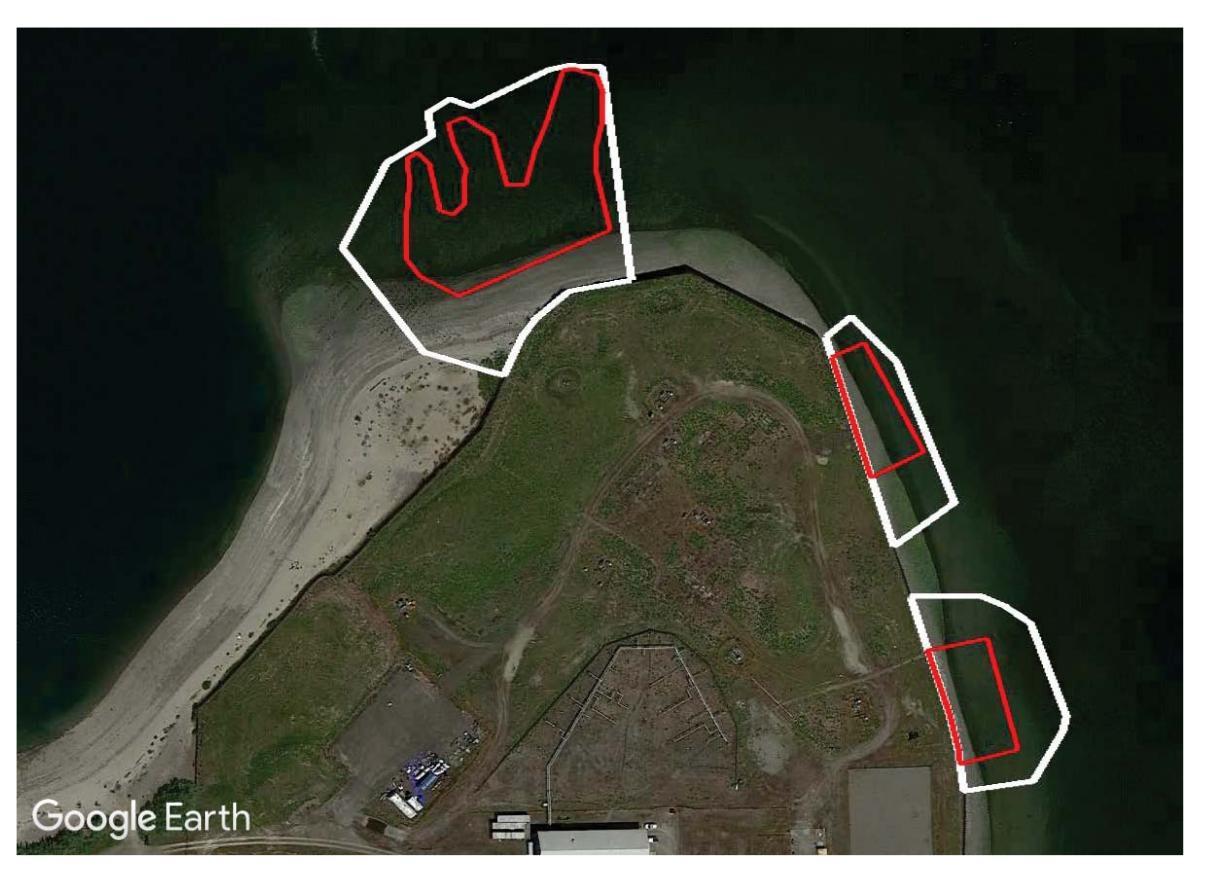
Revised Remedial Target Areas

- High NAPL discharge areas identified (1.3 acres)
 - Discharge too high for passive cap types
 - Improved source control and/or mass removal needed
- Total remedial target area identified (4.4 acres)
 - Low discharge or sheen areas, more cap types possible
