# Evaluation of Effects of Remediation and Background Indoor Sources on Indoor Air in a Commercial Facility

Nadine Weinberg, Eric Hoffman, and Jeff Campbell

April 2018

## Conference on Remediation of Chlorinated and Recalcitrant Compounds

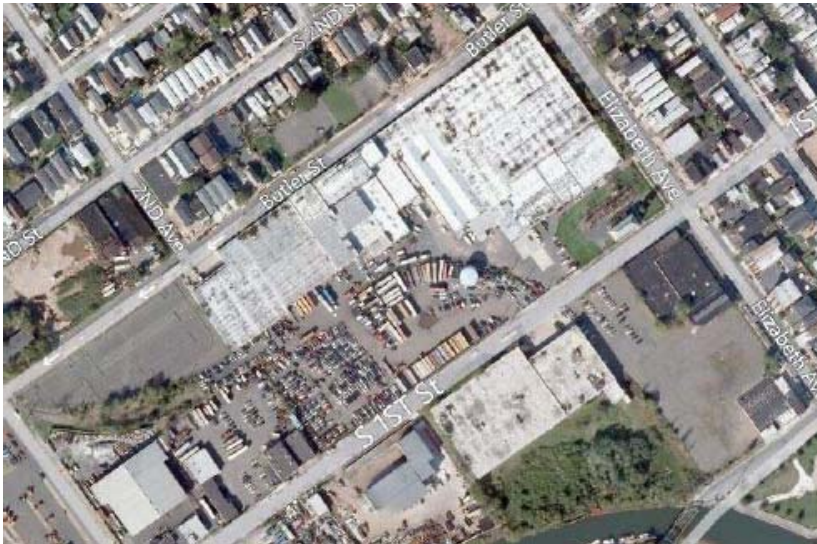
- Building 100 years old
- Historically used for manufacture of electrical components
- Degreasing operations, cadmium & zinc plating
- Located in an urban industrial area
- Listed under state program & investigated since 1995
- Dual Phase Extraction (DPE): 2002 to 2004
- Vapor intrusion investigations started in 2003
- Building currently occupied by various commercial & industrial occupants

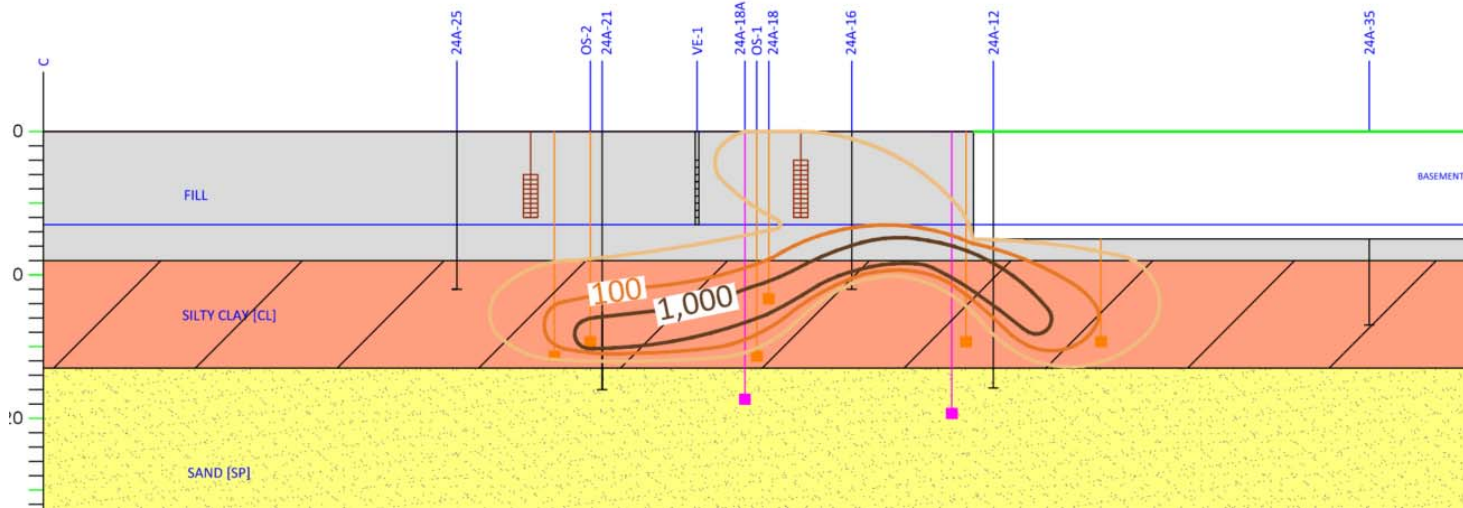
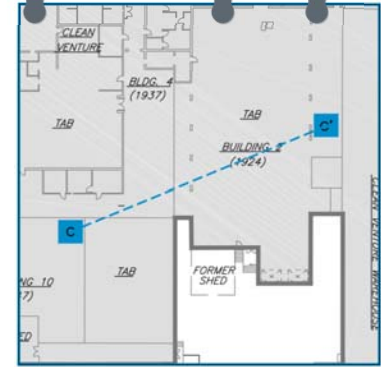
# Site Hydrogeology

- CROSS SECTION
- VAPOR BARRIER
- GROUNDWATER
- FILL
- SILTY CLAY
- SAND
- SOIL BORING
- SILT OZONE INJECTION WELL
- SAND OZONE INJECTION WELL
- SOIL VAPOR EXTRACTION
- TCE ISO-CONTOUR - NON-RESIDENTIAL BELOW GROUNDWATER 20mg/kg & SSIGW ABOVE GROUNDWATER TABLE
- TCE ISO-CONTOUR - 100 mg/kg
- TCE ISO-CONTOUR - 1,000 mg/kg

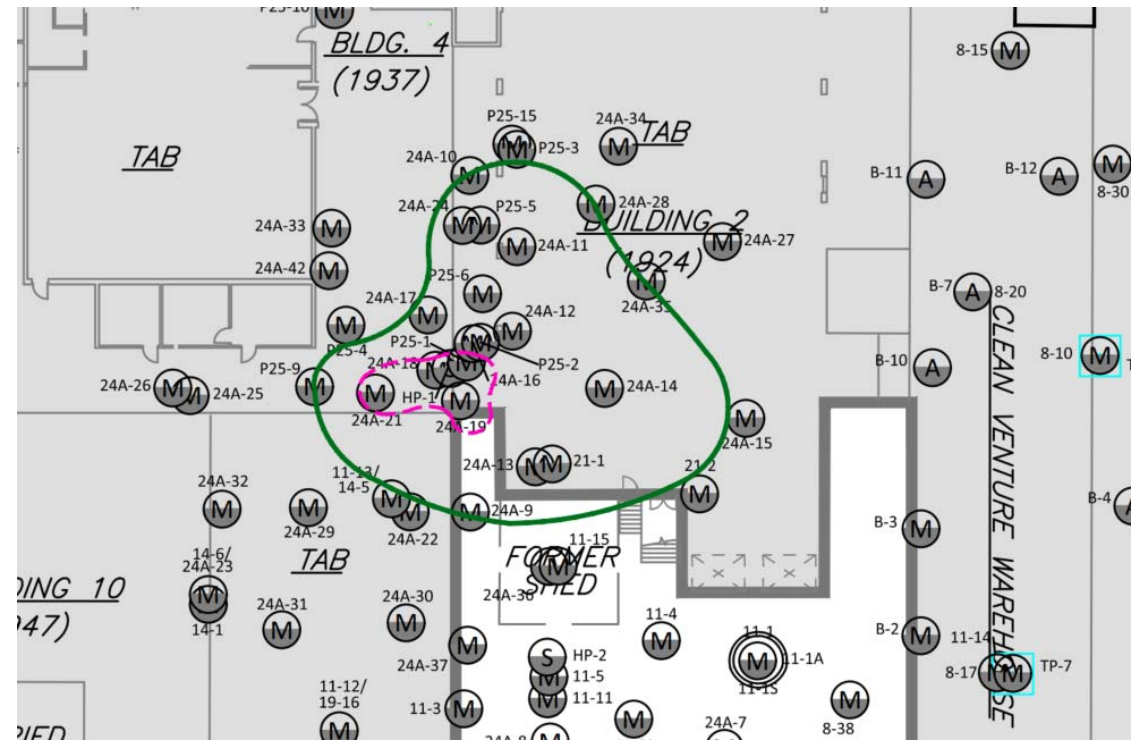
# TCE AOC

- Soil contamination TCE
  - Maximum concentrations 5,200 mg/kg
  - DNAPL present
- Groundwater contamination TCE
  - Shallow aquifer - 3,800 ug/L
  - Sand aquifer - 8,000 ug/L
  - Bedrock aquifer 300 ug/L

TCE - > 20 mg/kg

INFERRED DNAPL  
SOURCE AREA BOUNDARY

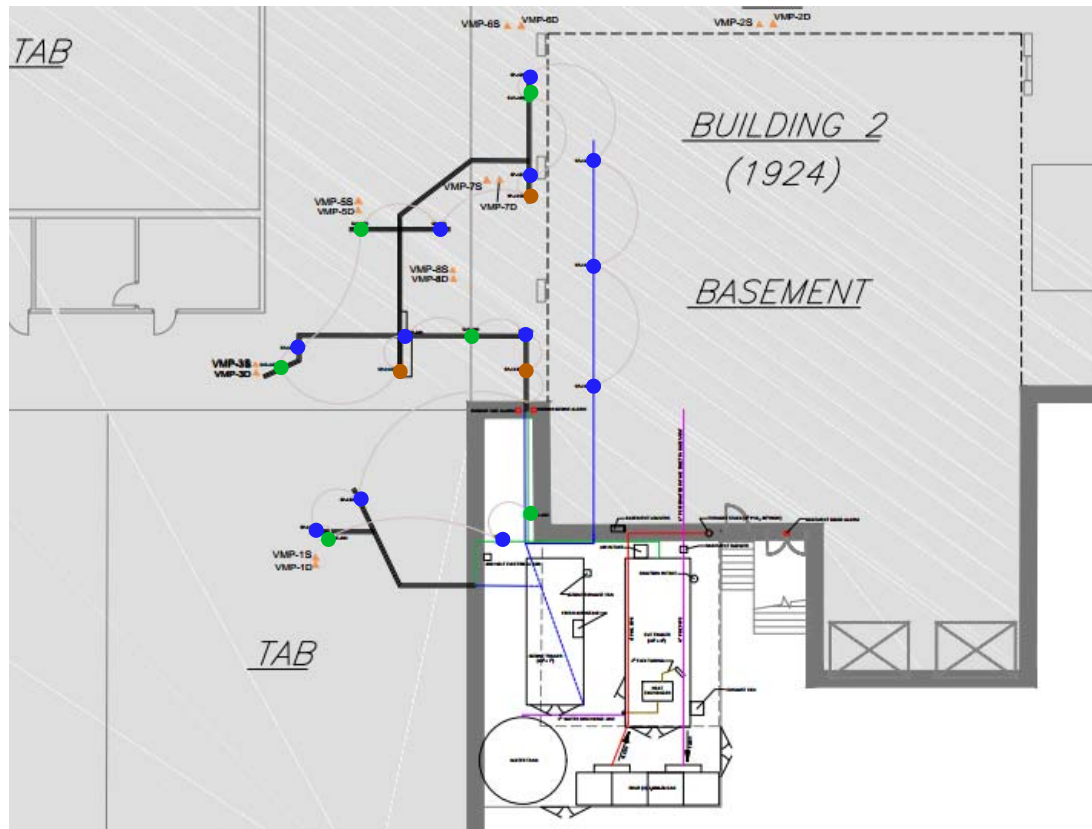
# TCE Remediation Layout

-   SPARGE POINT
-   DEEP SPARGE POINT
-   SVE POINT

1. WELLS SHOWN IN THE BASEMENT ARE LOCATED IN THE BASEMENT FLOOR AND DO NOT EXTEND TO THE FIRST FLOOR.
2. SVE LINES SHOWN WITHIN THE TRAILER COMPOUND ARE LOCATED IN PLANE ALONG THE SOUTHWEST & NORTHEAST WALLS.
3. SPARGE POINT LINES ARE LOCATED ON THE FLOOR OF THE COMPOUND AND RUN UNDER AND UP INTO THE OZONE TRAILER.

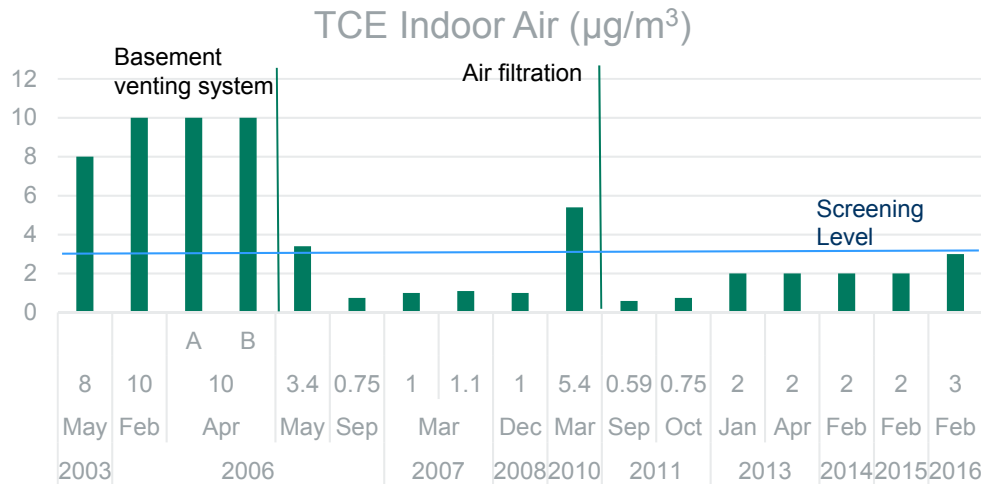
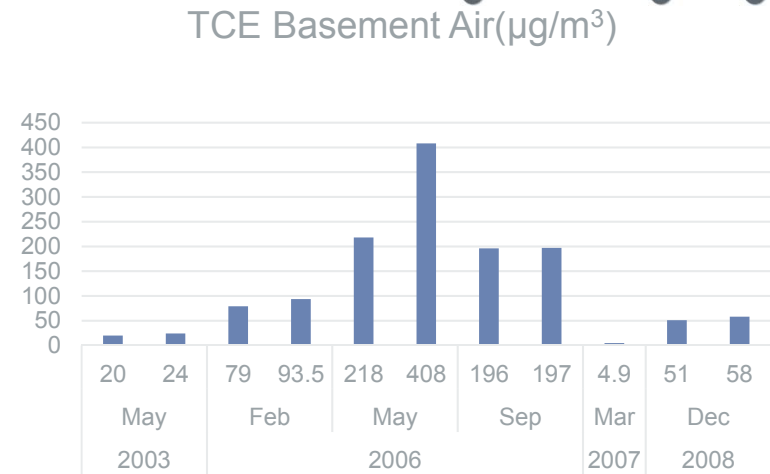
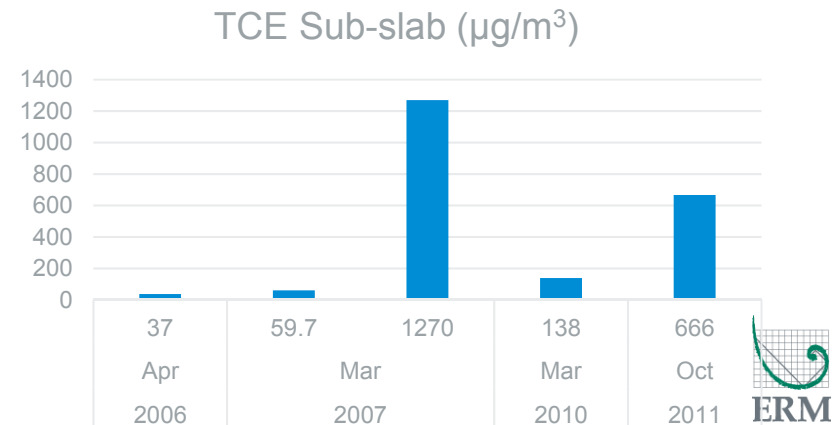
# Evaluation of the VI Pathway

- Vapor barrier between basement and first floor
- Basement fresh air exchange system
- Three 1,900 CFM carbon air filter units

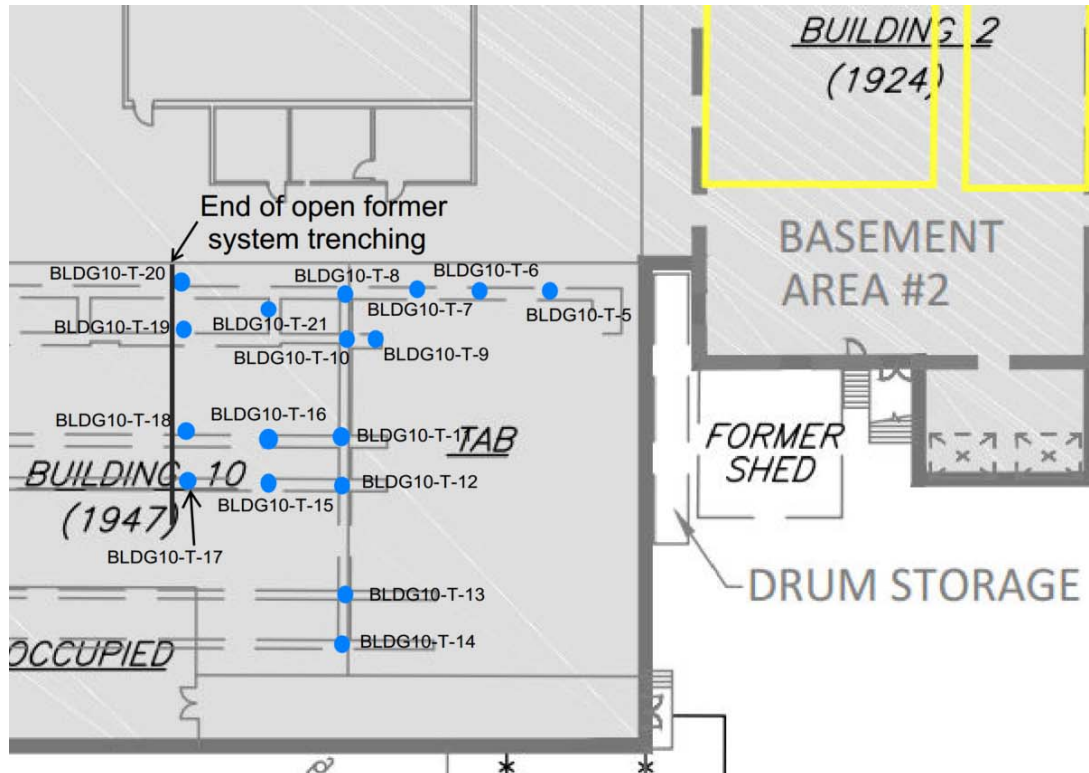
# Frog Trench Investigation

Vapor Sample Identifier	ppbRAE reading	1,2-Dichloroethene (cis)	Trichloroethene
<b>Former System Trenching</b>			
BLDG10-T-5	632	1650	325
BLDG10-T-6	590	1256	217
BLDG10-T-7	569	1146	165
BLDG10-T-8	740	839	233
BLDG10-T-9	169	1150	12.8
BLDG10-T-10	463	547	121
BLDG10-T-11	410	724	8.02
BLDG10-T-12	579	1312	99.8
BLDG10-T-13	213	1666	11.6
BLDG10-T-14	269	1855	59.1
BLDG10-T-15	415	1646	68.7
BLDG10-T-16	483	1095	246
BLDG10-T-17	362	1524	67.8
BLDG10-T-18	320	1229	166
BLDG10-T-19	539	433	219
BLDG10-T-20	660	484	317
BLDG10-T-21	623	551	173

1,2-DCE and TCE results in  $\mu\text{g}/\text{m}^3$

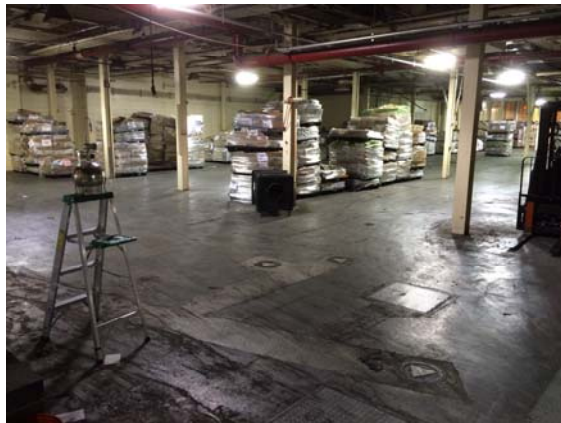
**View of Building 10 Inventory**

Vapor Sample Identifier	ppbRAE reading (ppb)	1,2-Dichloroethene (cis)	Trichloroethene
<b>Inventory</b>			
INVENTORY-1	2,645	1,773	ND
INVENTORY-2	1,654	2,029	ND
INVENTORY-3	2,829	626	21,091
INVENTORY-4	1,065	1,871	2,097
INVENTORY-5	1,774	2,064	3,509
INVENTORY-6	3,416	2,155	10,349
INVENTORY-7	NA	1,308	276
INVENTORY-8	2,876	1,505	748
INVENTORY-9	3,005	2,131	233
INVENTORY-10	2,265	13,835	934
INVENTORY-11	2,792	261,512	1,954
INVENTORY-12	3,269	263,130	3,074
INVENTORY-13	2,505	98,976	653
INVENTORY-14	3,510	277,900	1,088
INVENTORY-15	3,327	86,651	955
INVENTORY-16	2,466	22,556	398

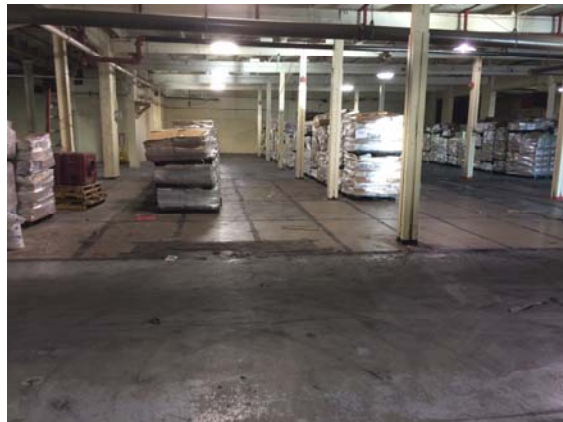
**View of Building 4 Inventory**
