Sediment Cap Design and Placement: Site 19, Former Derecktor Shipyard Marine Sediment (Operable Unit 5), Newport, RI

Tenth International Conference on the Remediation and Management of
Contaminated Sediments

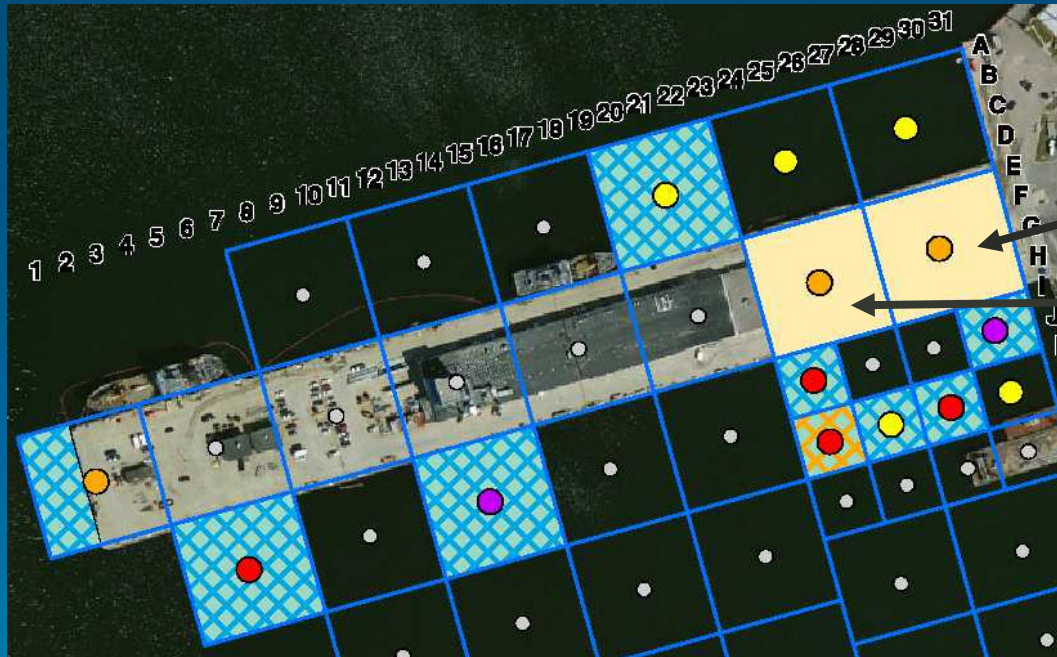
Contaminant	Cell 25	Cell 29	ROD Cleanup Levels
Benzo(a)pyrene ($\mu\text{g}/\text{kg}$)	2,200	1,600	539 (ingestion of shellfish)
Heavy molecular weight PAHs	26,800	17,300	13,903 (toxic to aquatic organisms)
Lead (mg/kg)	212	98	168 (toxic to aquatic organisms)

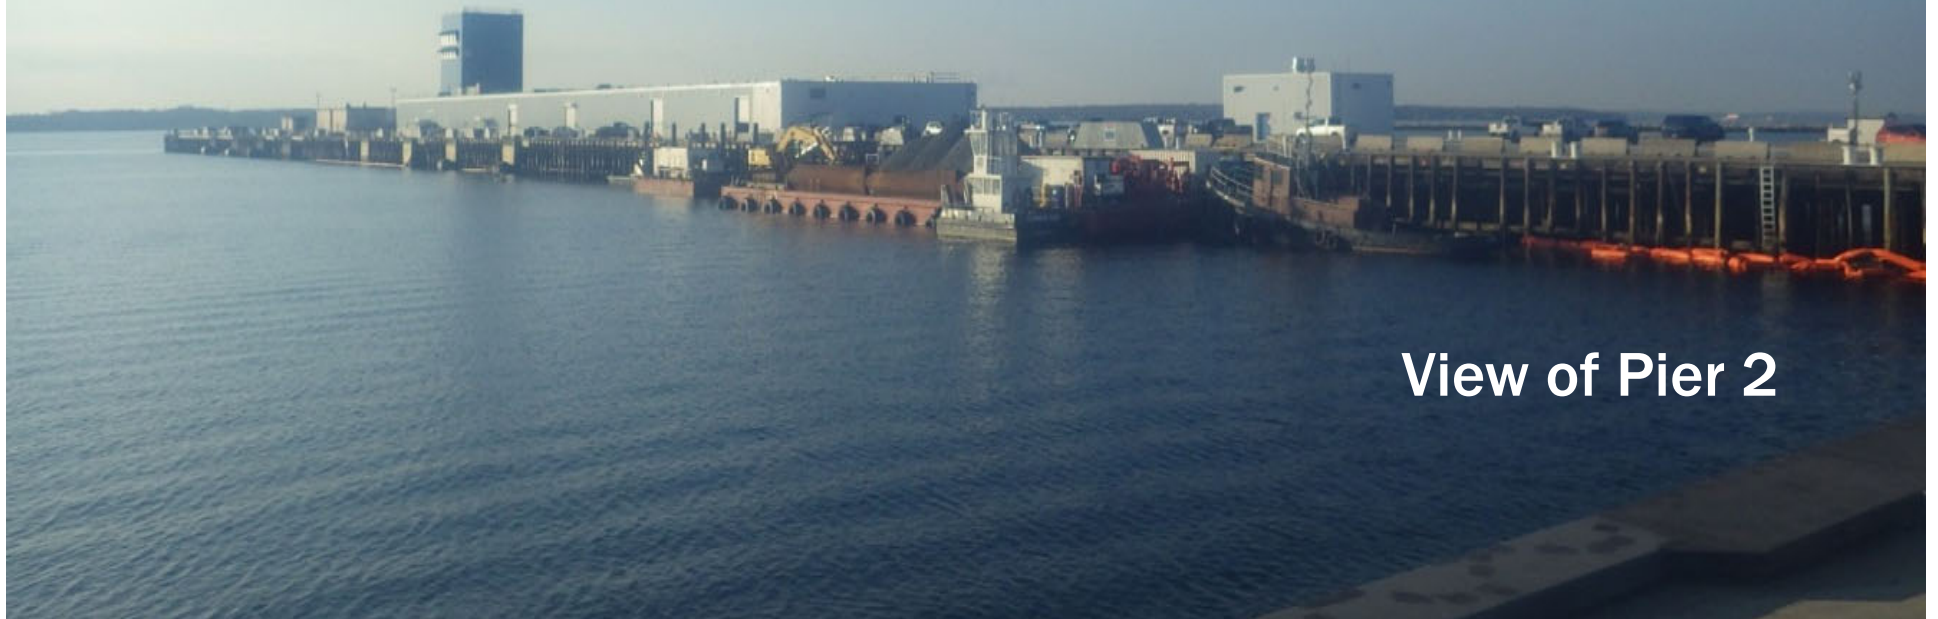
- **Constructed in 1950s (1,600 x 200 ft wide) with three functional berths**
- **Concrete decking with concrete pilings (10 ft spacing)**
- **30+ feet of water with 3 to 4 ft of clearance below pier at high tide**

View of Pier 2

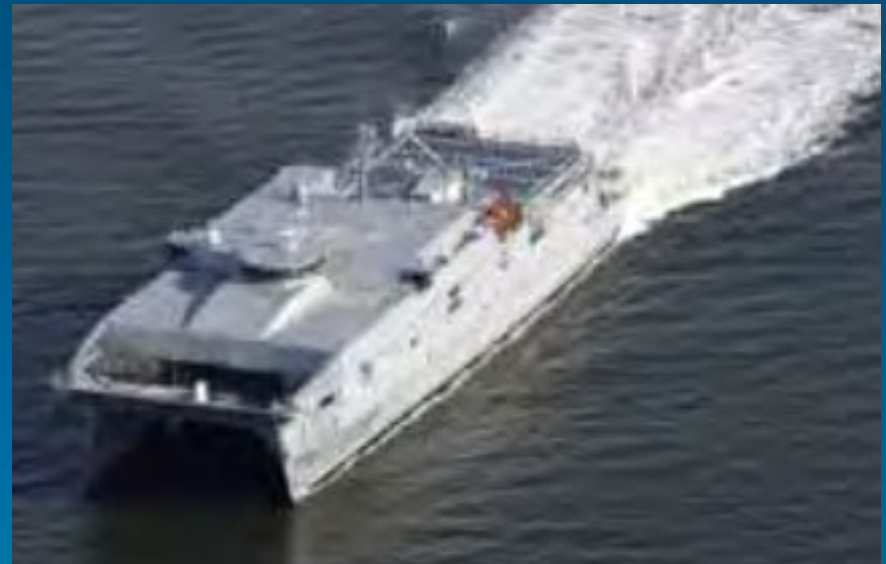
USS Carson City

- Cap required to withstand erosion from currents, 100-year storm, and ship movements (e.g., thrusters)
- Modeling indicated aggregate size of 38 mm met scour concerns for currents, 100-year storm, and all types of ships except Expeditionary Fast Transport (EFT) vessels like the USS Carson City.
- EFT vessels require aggregate size was 85 mm. Selected use of 38 mm aggregate since EFT vessels not likely docked in slips adjacent to cap location

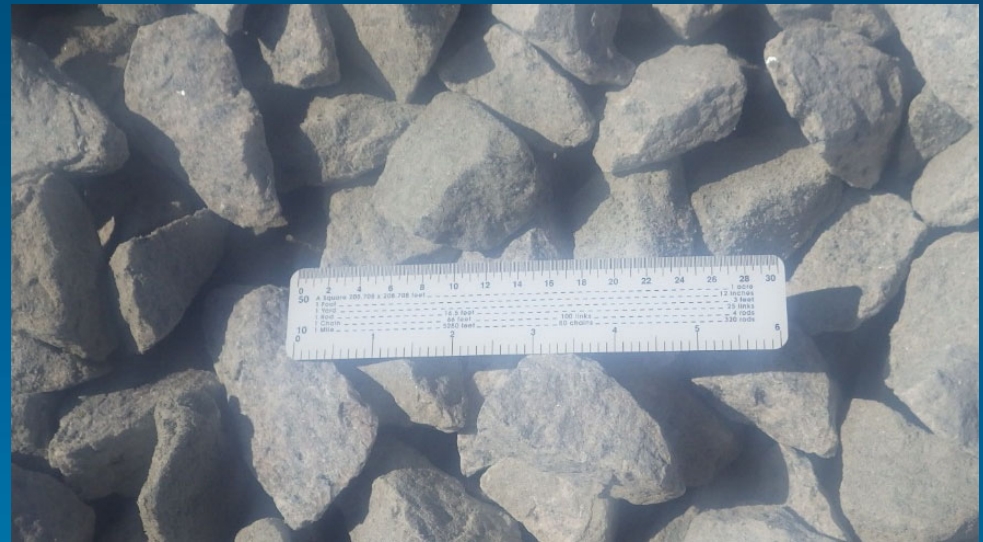
- Once material size was selected, project team needed a source that was regular in size
- Material had to be screened at source to ensure average size in thickness in two dimensions meets requirements. If not, equipment to deploy material would clog.

Cap material measurement

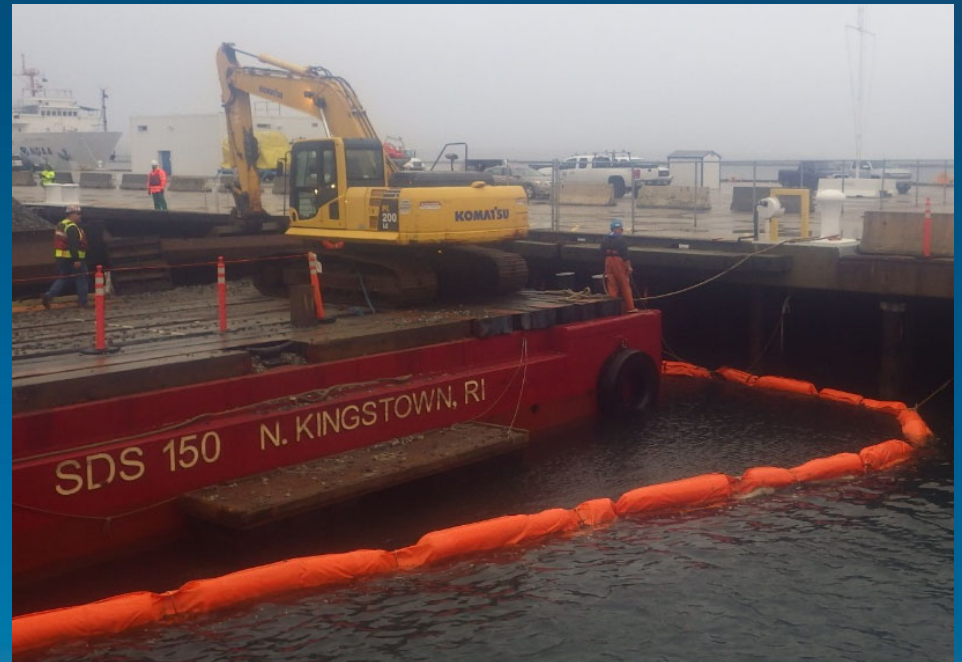
- Turbidity curtain enclosed project area
- Did not extend to sediment surface to account for tidal range and prevent it from contacting/disturbing sediment
- Flotation devices, weights, anchors, and reefing lines
- Routinely inspected, and repaired immediately

Capping material barge within turbidity curtain

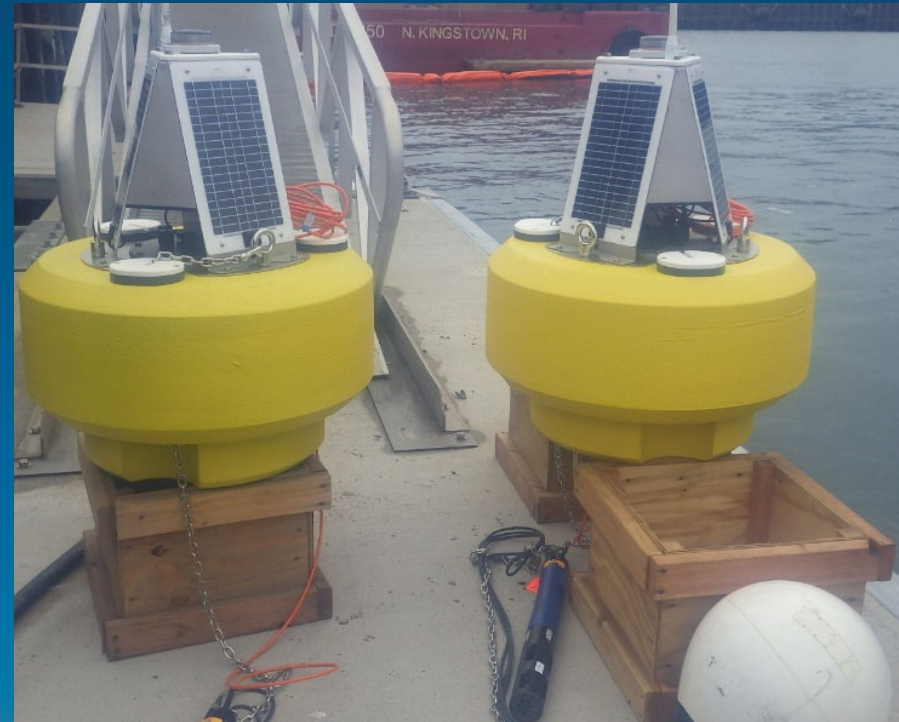
- Negotiated action level requiring stop work (background plus 10 NTUs) with EPA
- Placed buoy-mounted turbidity monitors outside of curtained work area
- Used telemetry system to send real-time data to laptop/cell phone so adjustments could be made immediately

Buoy-mounted turbidity monitors

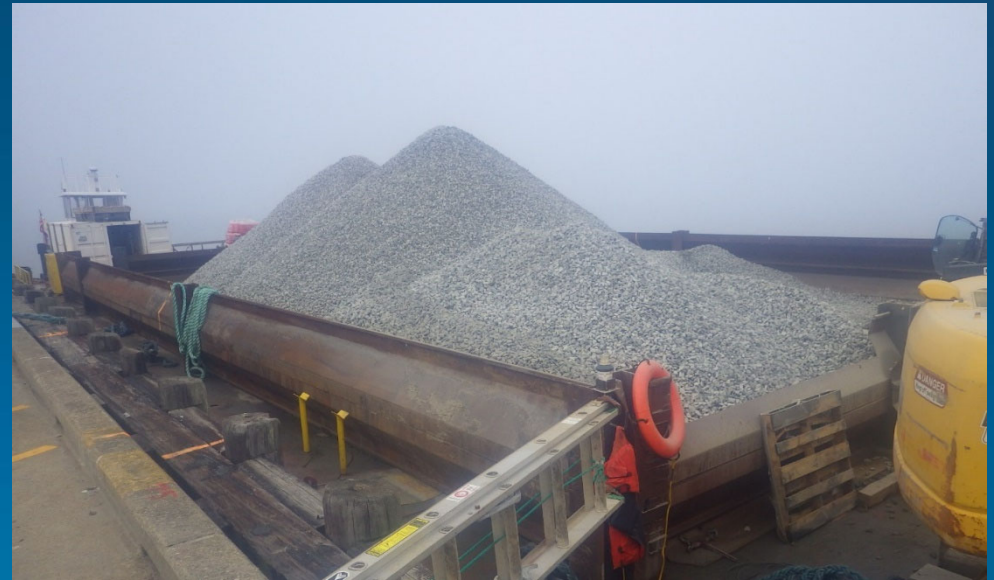
- Conducted a pre-cap bathymetric survey
- Installed cap material using diver-assisted hoses
- Installed berms along outside edge of area to be capped
- Capped material placed starting at berm and working inward in two lifts (6-in. followed by 18-in.)

Cap material stockpile on barge

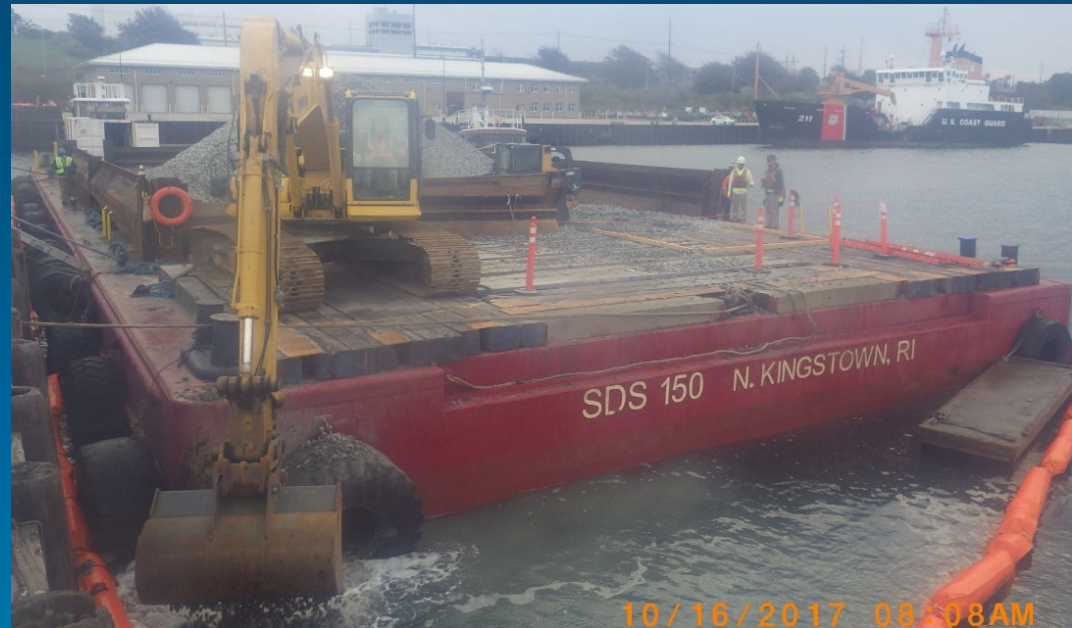
Cap material being placed with an excavator to construct the northern berm adjacent to Pier 2
