Unique Aspects of Capping and Long-Term Monitoring at River Raisin, Michigan

February 12, 2019

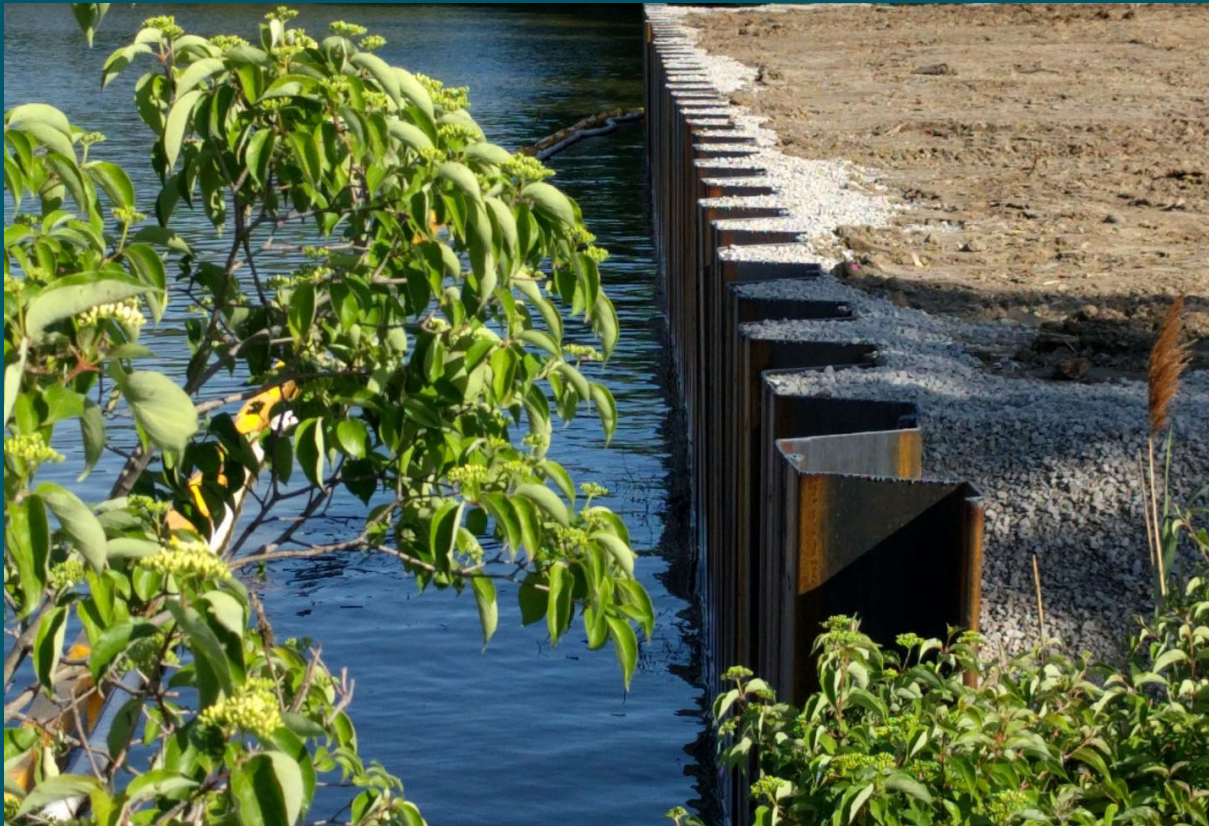
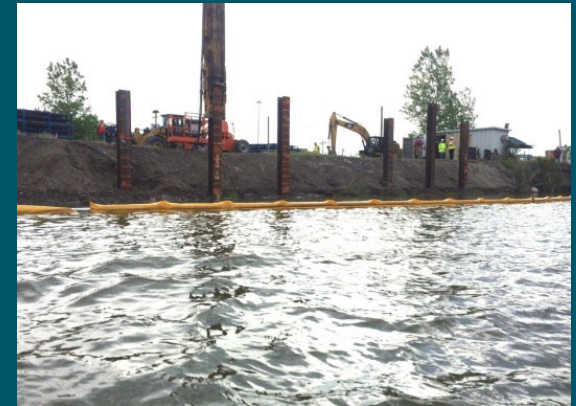
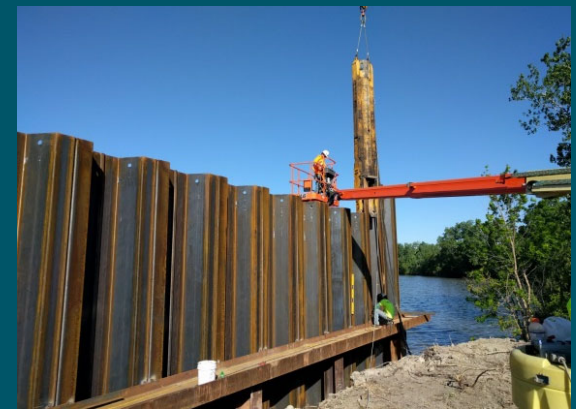
Construction – Sheetpile Installation

2016 Sheetpile Installation

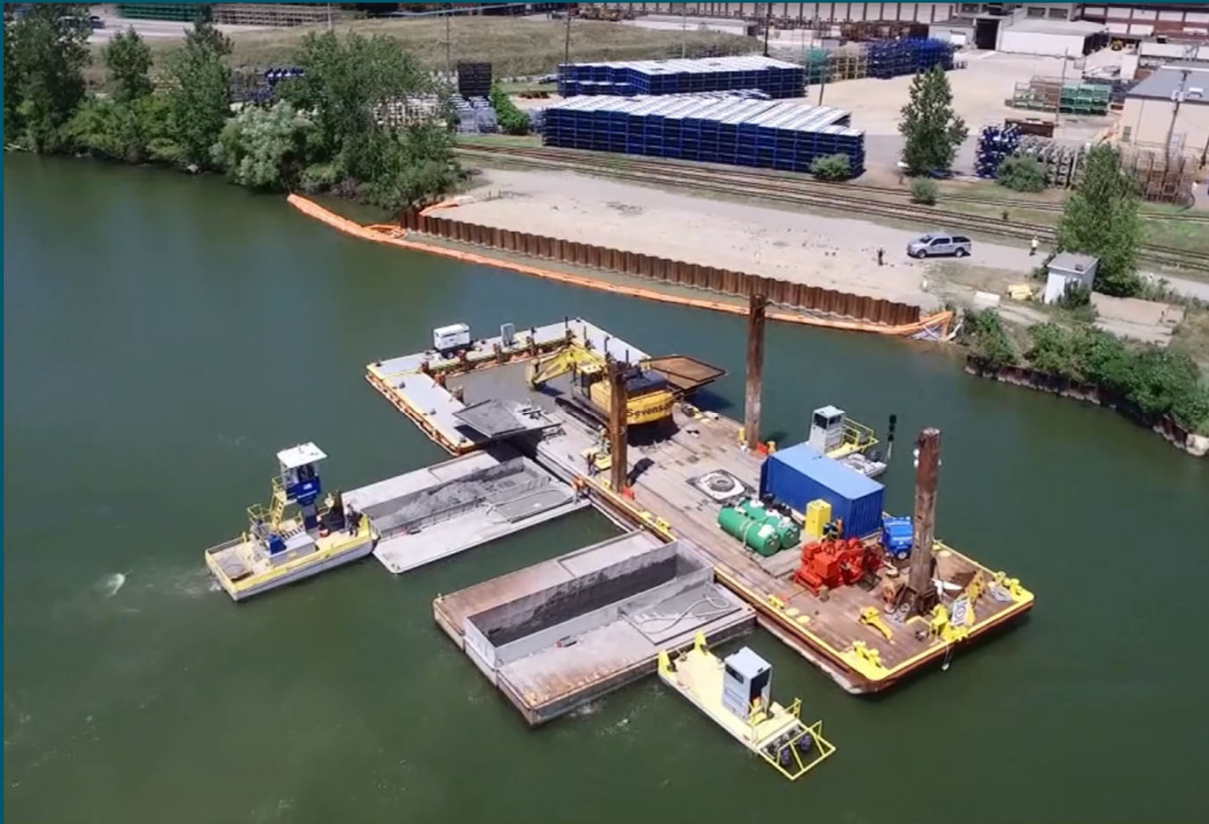
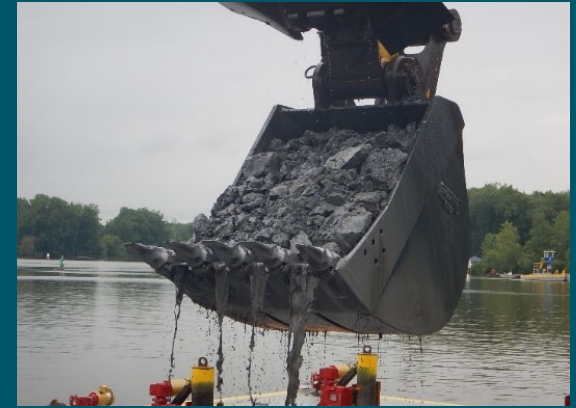
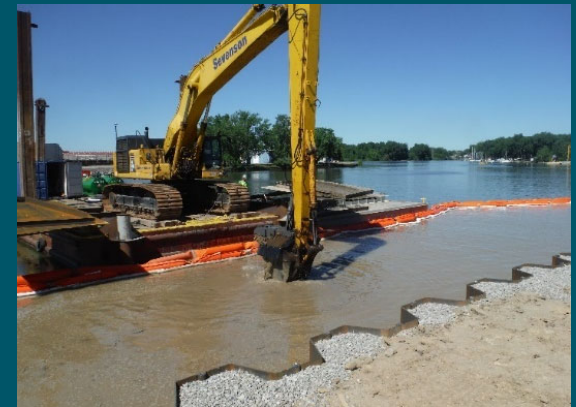
Construction – Dredging

2016 Sediment Remediation at River Raisin¹

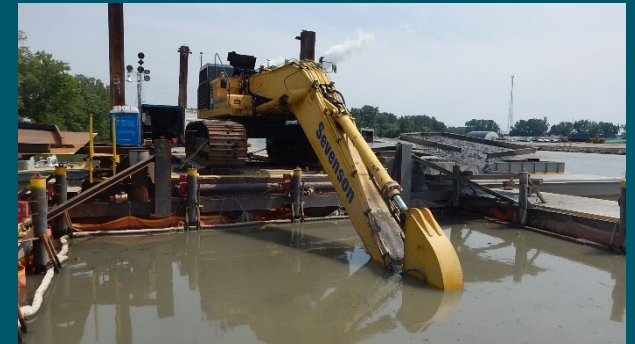
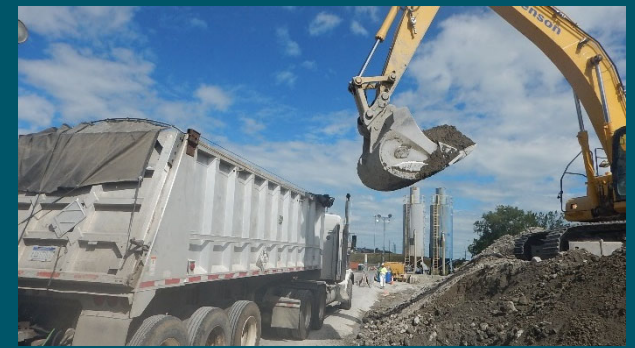
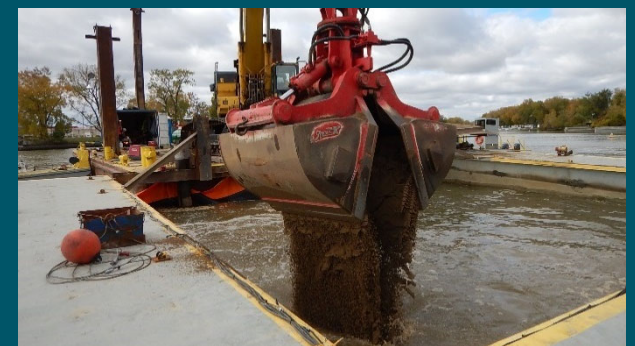
- Removed 29,465 cy (ave 330 cy/day)
- Calciment® and Type II Portland cement (6% ave) for stabilization
- 62,293 tons (1,353 truckloads) stabilized sediment hauled off site as TSCA waste
- Capping completed in 2-week Port shutdown window
 - Sand and organoclay blended onshore (hoppers with augers, conveyors)
 - Sand leveling and sand/organoclay placed inside moonpool
 - Filter gravel and armor stone placed without moonpool

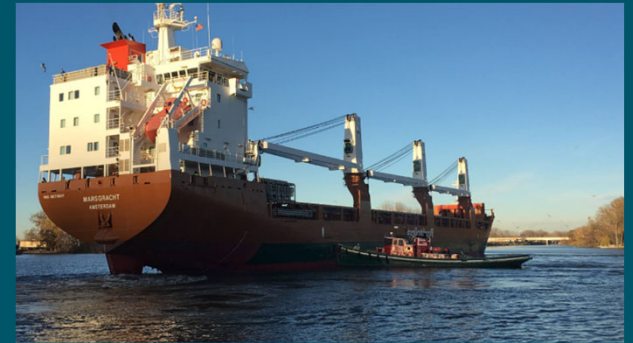
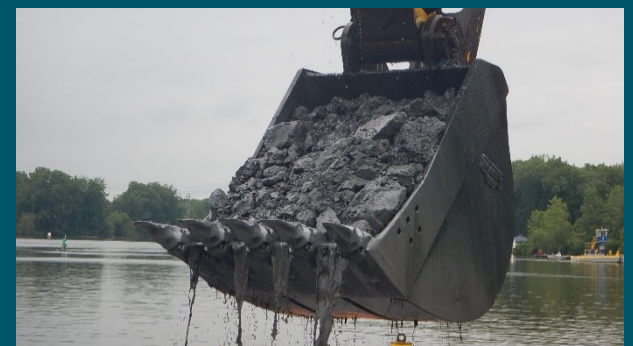
- Very stiff glacial till
- Depth of NAPL/PCBs
- Vessel traffic scheduling and coordination
- Landfill material acceptance
- Procurement and contracting
- Two-week cap schedule

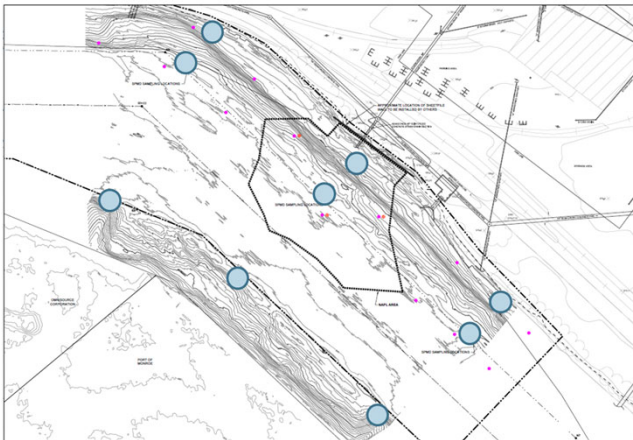
SPMD Sampling

- LDPE sleeve filled with triolein (oil)
- Deployed several weeks, to obtain time-integrated sample – represent surface water
- Nine locations – some disturbed

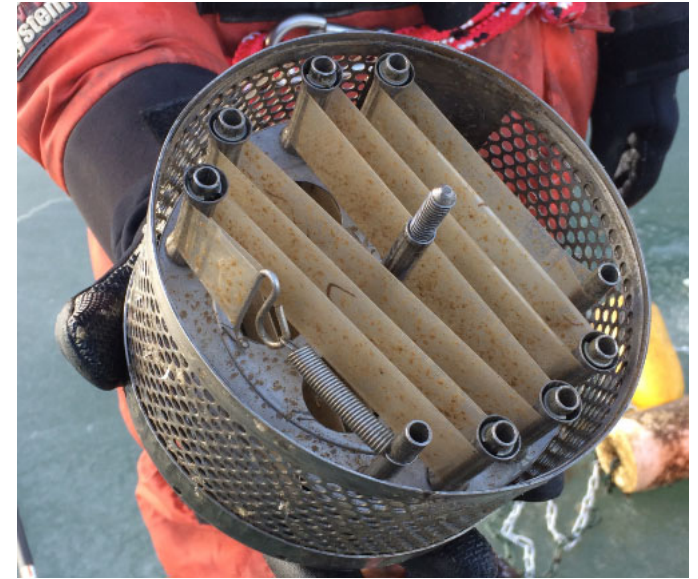
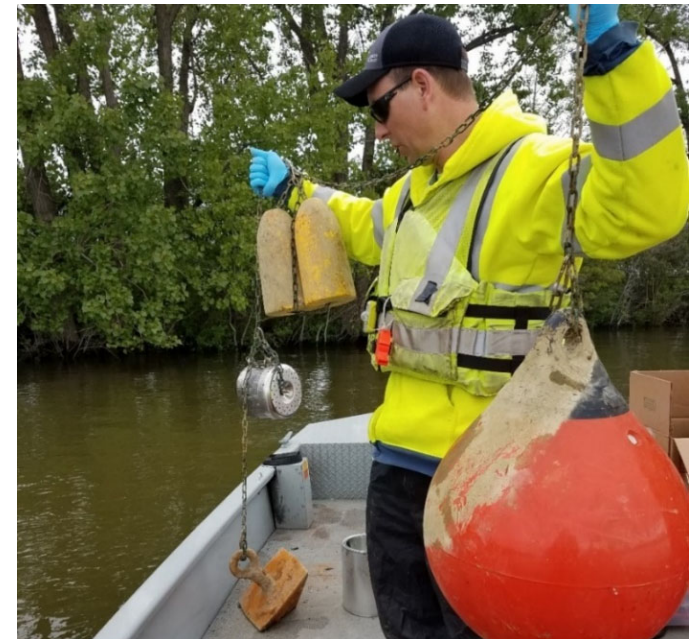
- Redeployment over time allows for relative comparison of PCB levels
- PCBs detected in SPMDs, higher downstream of NAPL Area

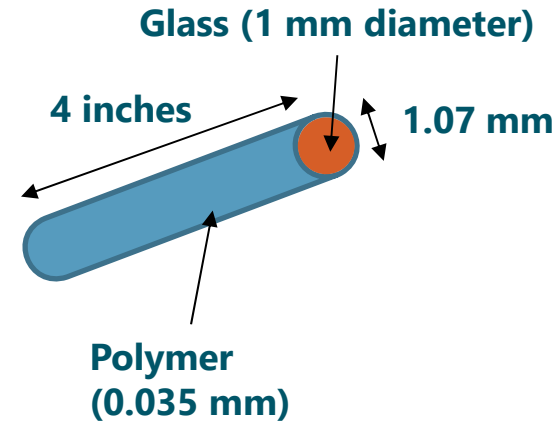
Entire push-point sampler

- Polymer coating absorbs PCBs
- Extended deployment
- Three monitoring ports
 - Sample porewater above organoclay
- PCBs detected in SPME
 - Similar concentrations to SPMD-calculated surface water

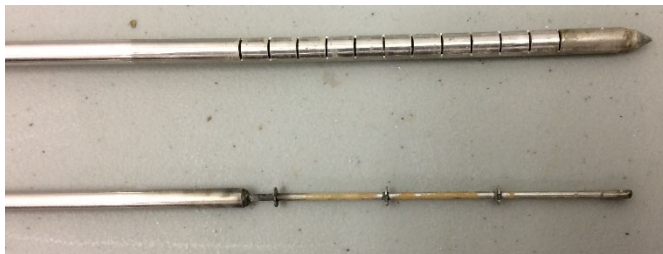
Sampler tip

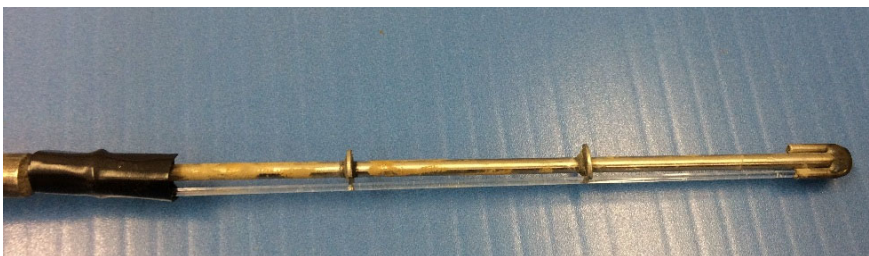
Sampler tip with one fiber
