POST-REMEDIATION MONITORING OF THE BUFFALO RIVER

Kristin Searcy Bell, Victor Magar, Steve Bagnull, Mark Reemts, Mary Sorensen, Katrina Leigh, Hilda Fadaei, Mary Beth Giancarlo, and Richard Galloway

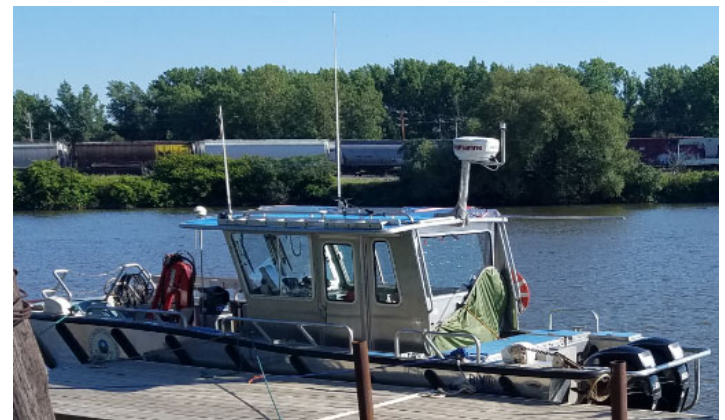
- Year 2 (2017) surface sediment chemistry
 - 260 discrete samples for total PAHs
 - 12 composite samples for PCBs, lead, mercury
 - 40 total organic carbon samples
 - 40 grain size samples
- Sediment chemistry results are compared to Buffalo River remedial goals

Chemical	Buffalo River Remedial Goals
Total PAHs	1 toxicity unit (16 mg/kg)
Lead	90 mg/kg SWAC
Mercury	0.44 mg/kg SWAC
Total PCBs	0.20 mg/kg SWAC

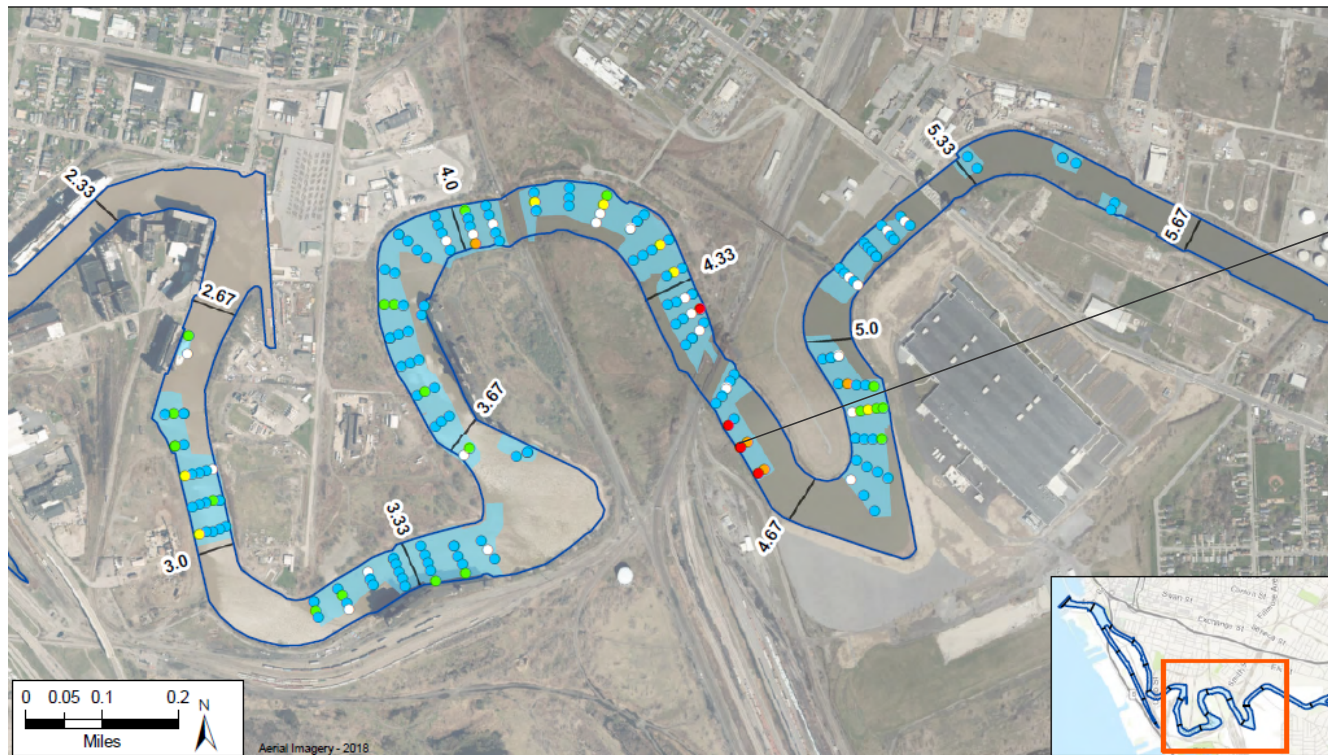
TOTAL PAH CONCENTRATIONS

PAH(mg/kg)

- < 16 (<1×RG)
- 16-32 (1-2×RG)
- 32-80 (2-5×RG)
- 80-160 (5-10×RG)
- >160 (>10×RG)
- Abandoned Sample Location
- GLLA Dredge Footprint
- Buffalo River Area of Concern

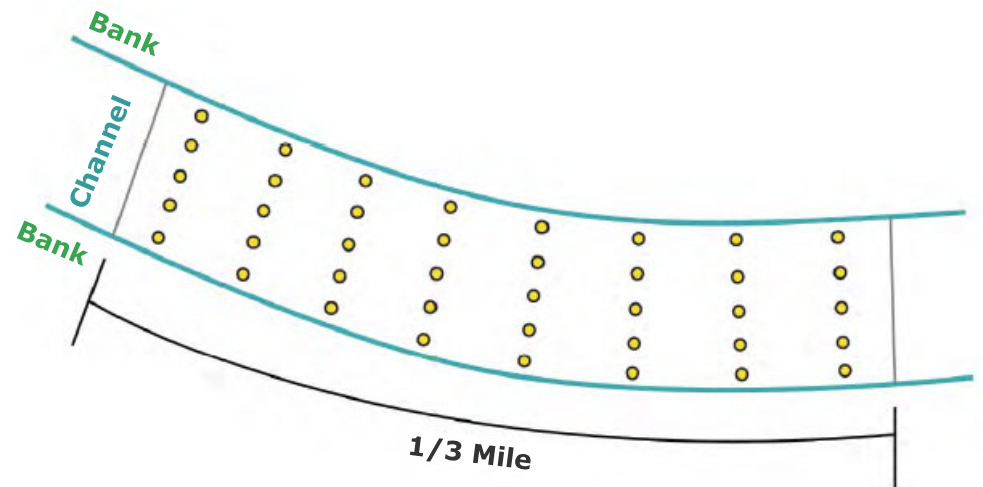
COMPOSITE SAMPLE APPROACH

- Each composite sample analyzed for:
 - Lead
 - Mercury
 - Total PCBs
- Composite samples were collected from 11 areas
- Composite areas = 1/3 mile segments of the river, bank to bank
- 40 samples targeted per composite
 - 8x5 grid

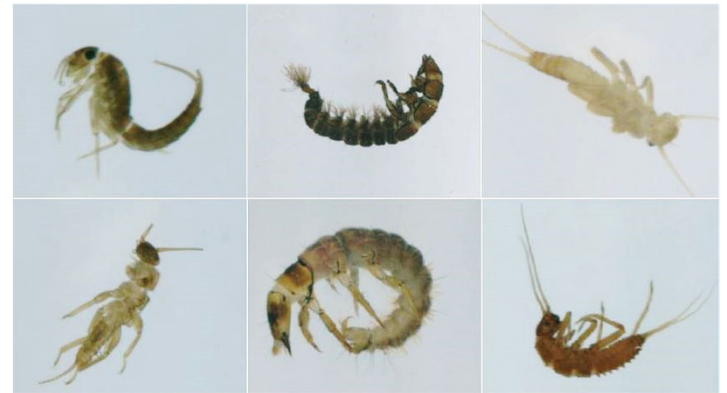
- Both NYSDEC and USEPA approaches show Buffalo River benthic community conditions are comparable to reference areas
- Slight to moderate impairment for both sediment grab samples and Hester-Dendy samples
 - Severe impairment for grab samples (NYSDEC approach)
- Over time (baseline to 2017)
 - No specific trajectory observed (improved, declined, no change)
 - Overall conditions slightly improved
