**An Innovative and Cost-Effective Approach to DNAPL Removal
from Sediment Deposits in the Tittabawasse River**

Battelle: 2019 Sediments Conference

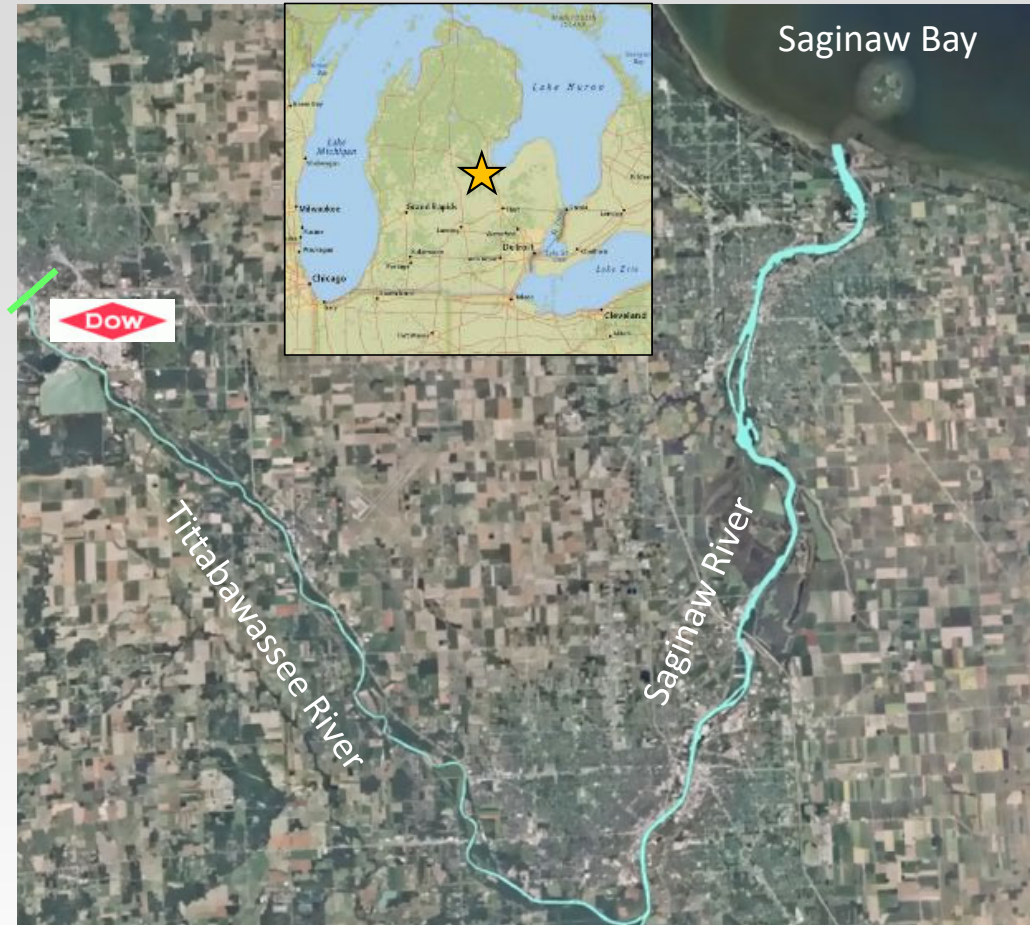
Site Location

- Dow plant located in Midland, MI
- Tittabawassee River
 - From plant to confluence with Saginaw River (24 miles)
- Divided site into 7 manageable units (river segments)
- Presentation focuses on Segment 1 of the Tittabawassee River
 - 3 mile stretch next to the Dow plant

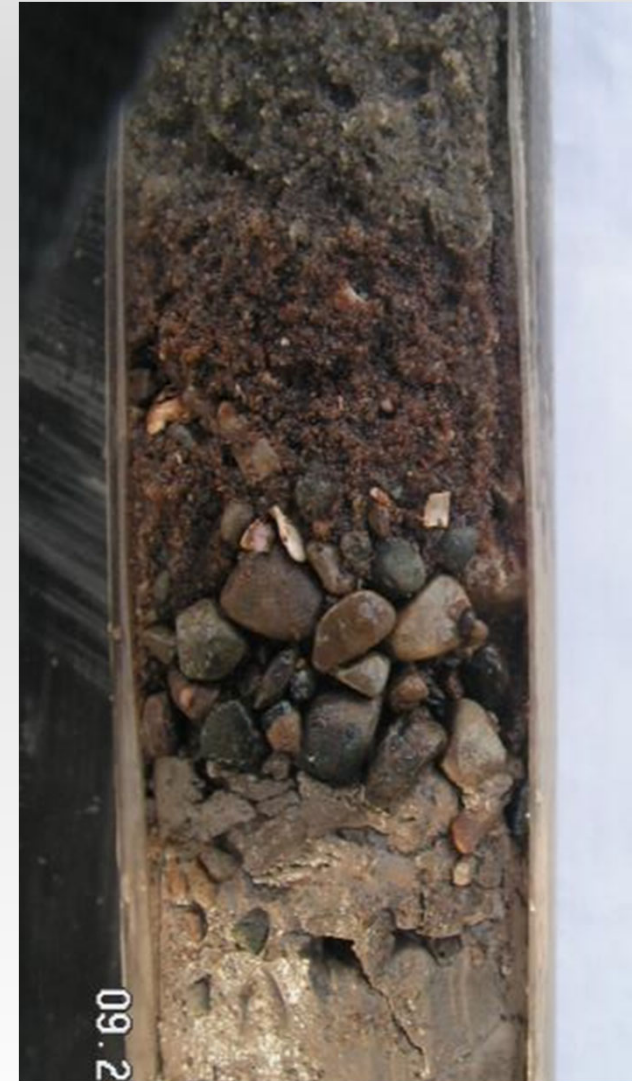
DNAPL Discovery and Identification

- DNAPL was identified in the Tittabawassee River sediments while investigating furan and dioxin impacts
- DNAPL deposits occurred in isolated areas in sandy sediments, overlying a low permeability till
- DNAPL settled in low areas and depressions on till layer
- DNAPL consisted of a mix of chlorinated volatile organic compounds, predominantly chlorobenzenes
- Sediment management areas (SMAs) were established at each of the DNAPL deposit areas

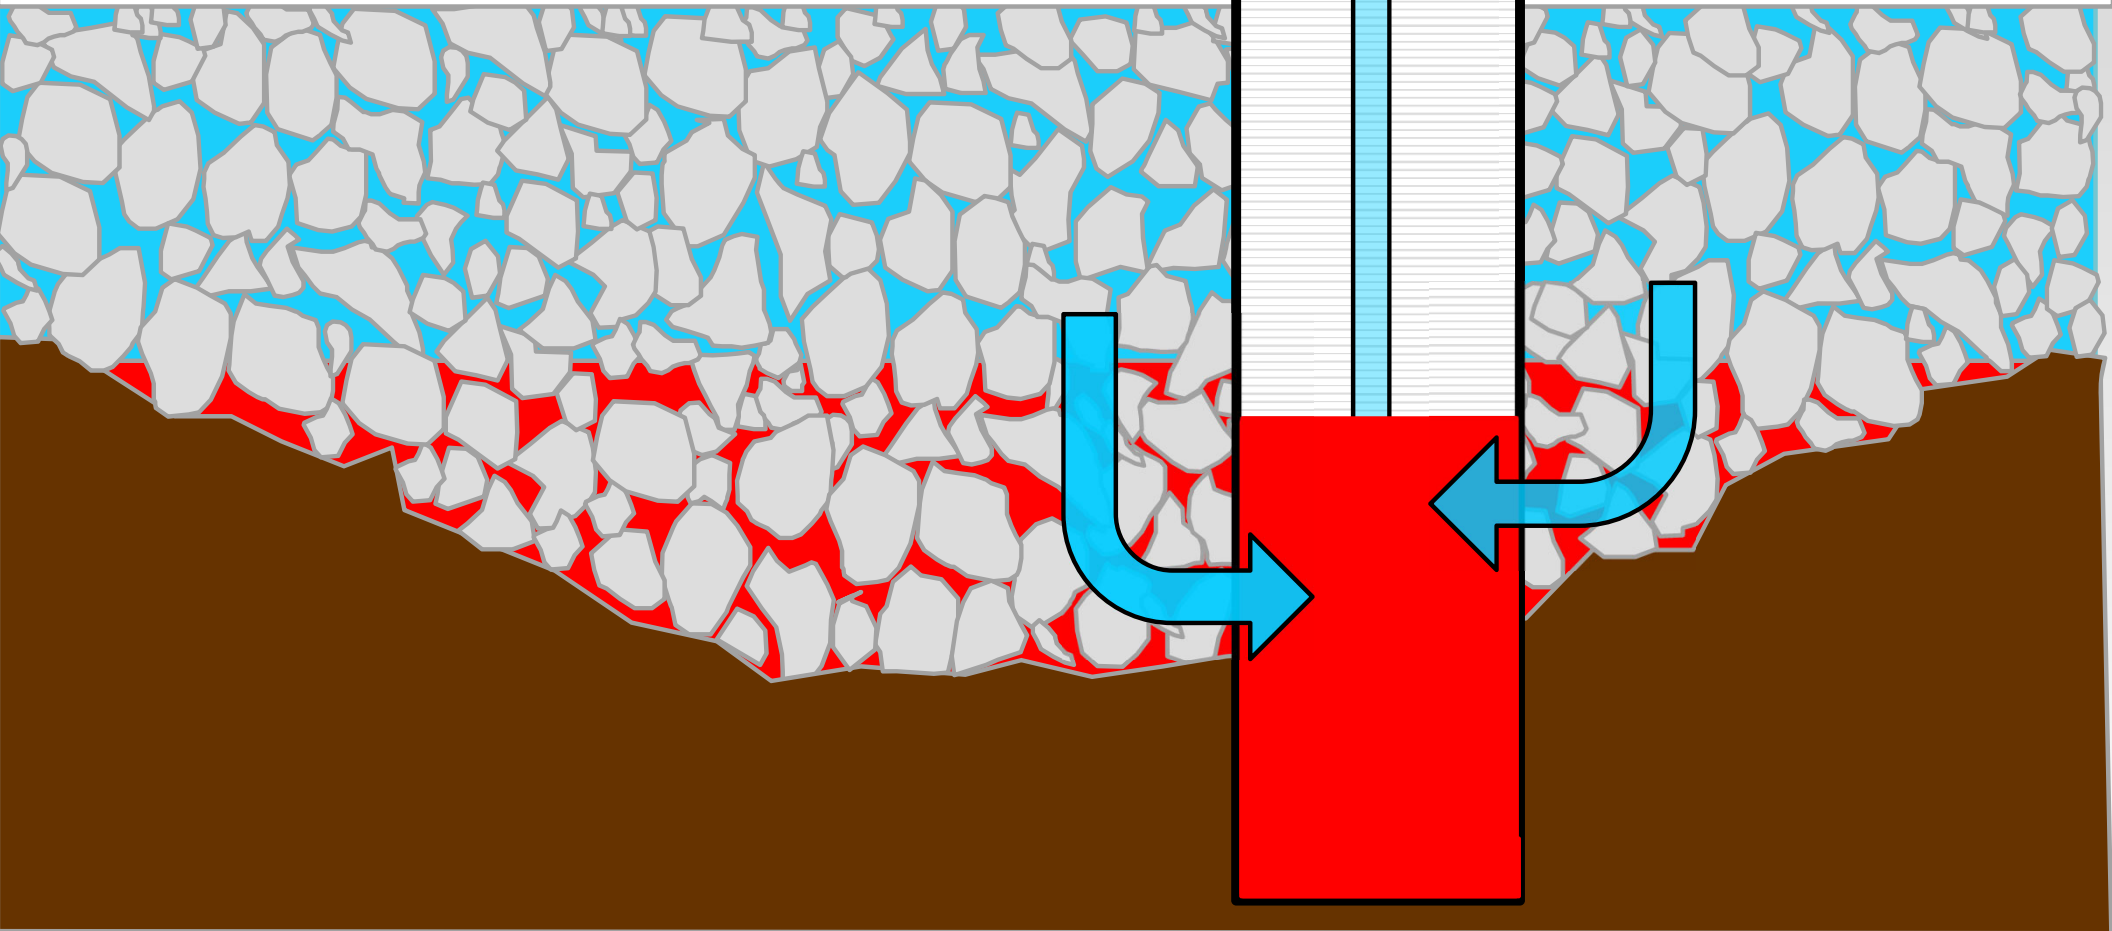
Active Recovery

**ACTIVE
PUMPING**

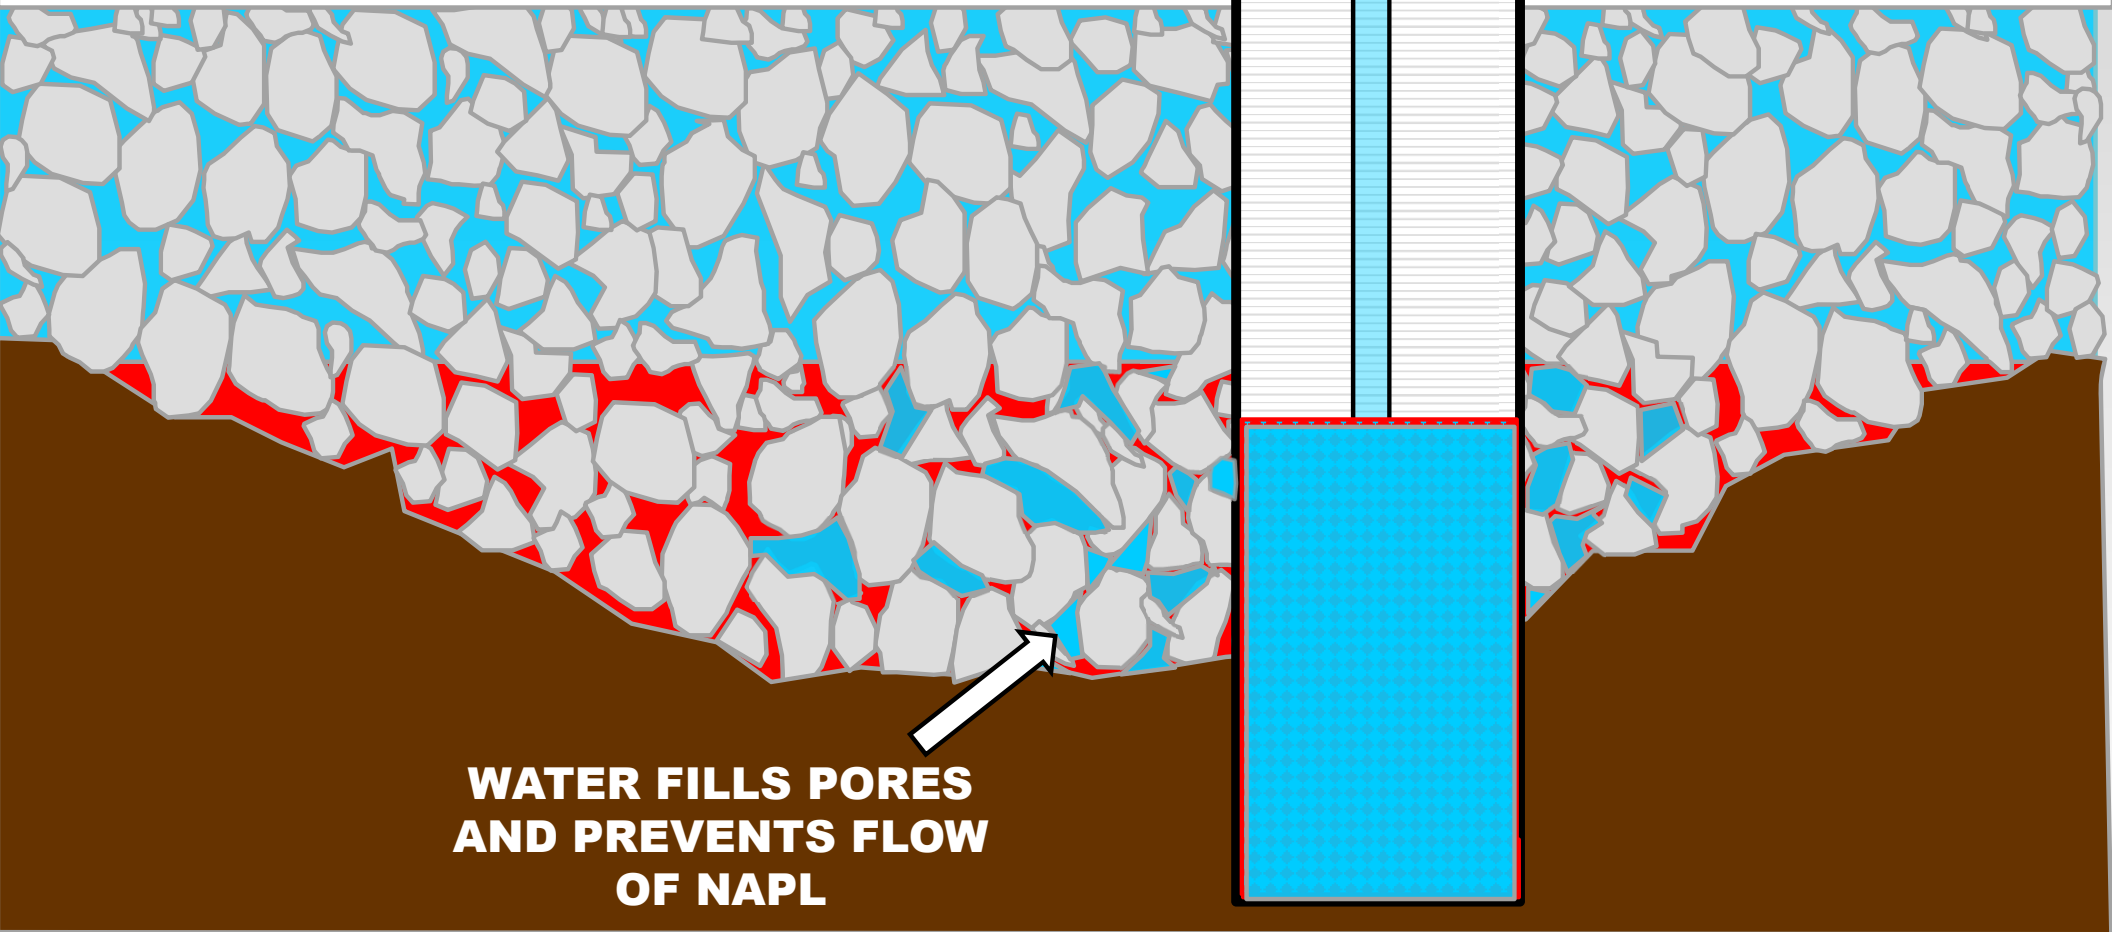
Active Recovery

**Active
Pumping**

**WATER FILLS PORES
AND PREVENTS FLOW
OF NAPL**

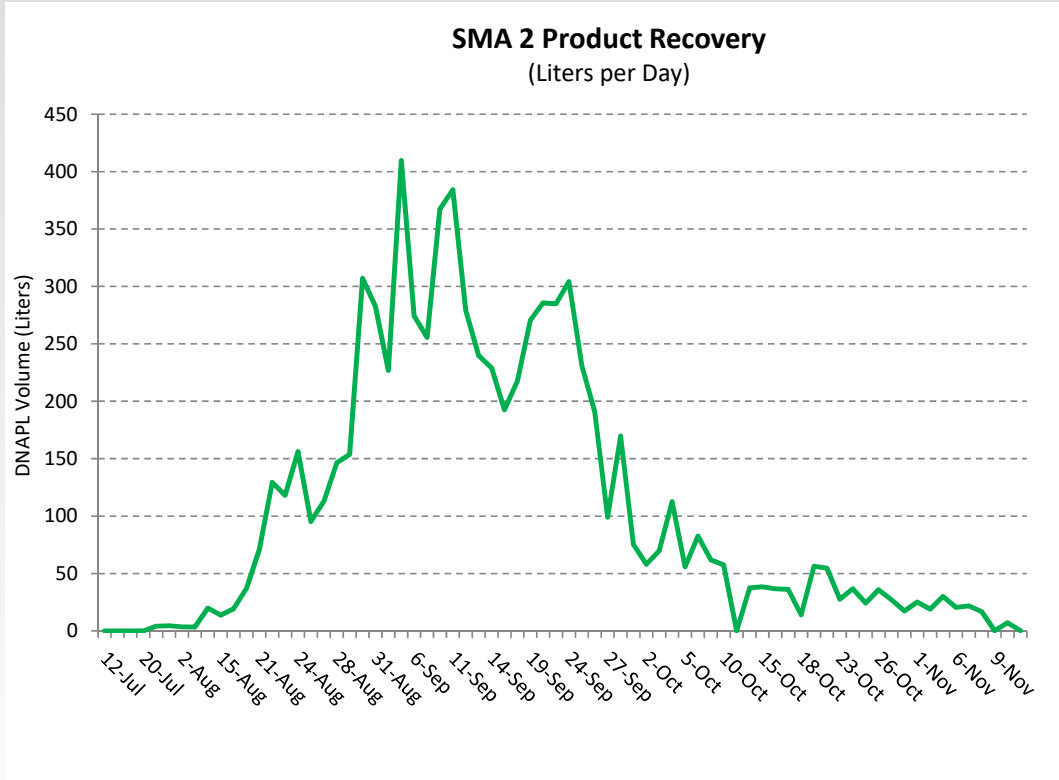
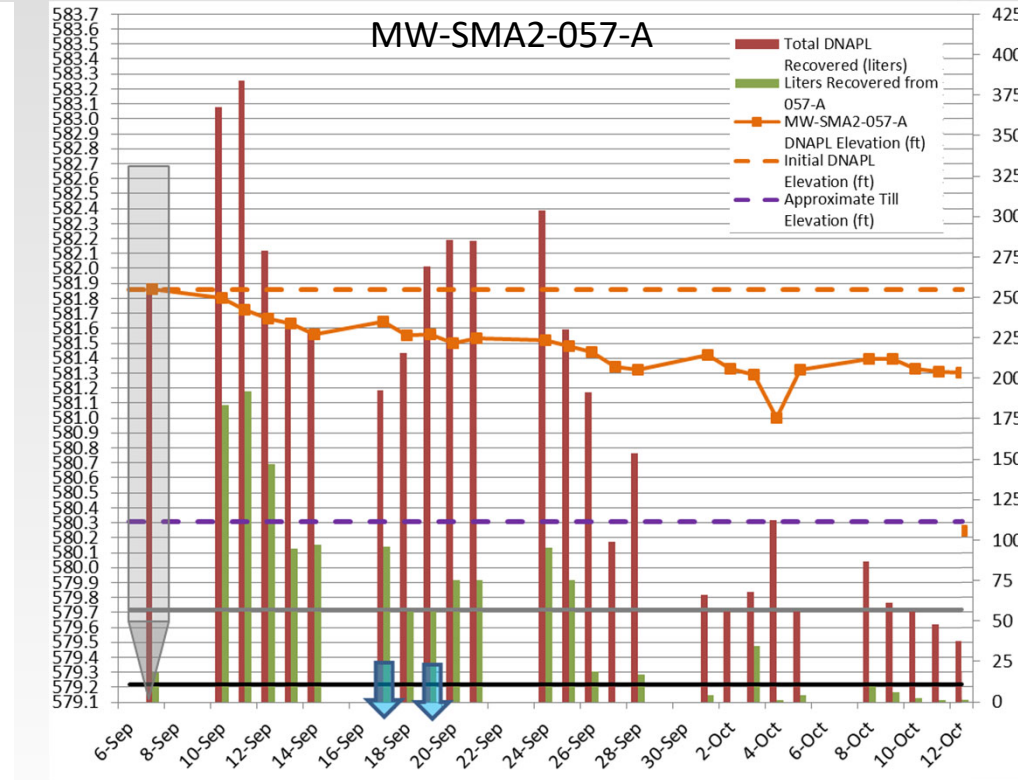
DNAPL Recovery Monitoring

- Removal frequency and volume was tracked for each well, and the information was used in real time to optimize recovery.

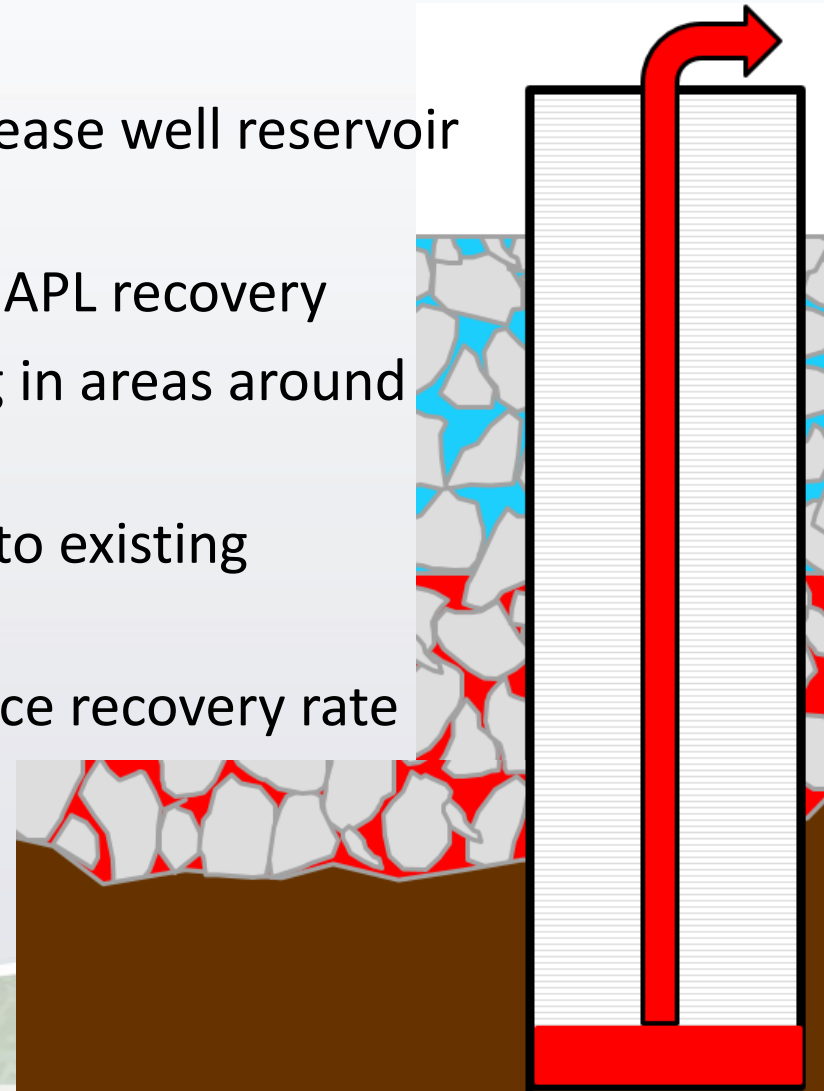
DNAPL Recovery Optimization

- Pushed wells deeper into the till unit to increase well reservoir capacity
- Adapted pumping frequency to optimize DNAPL recovery
- Installed additional wells in a tighter spacing in areas around productive wells
- Installed additional recovery wells adjacent to existing productive wells
- Installed larger diameter wells (4") to enhance recovery rate

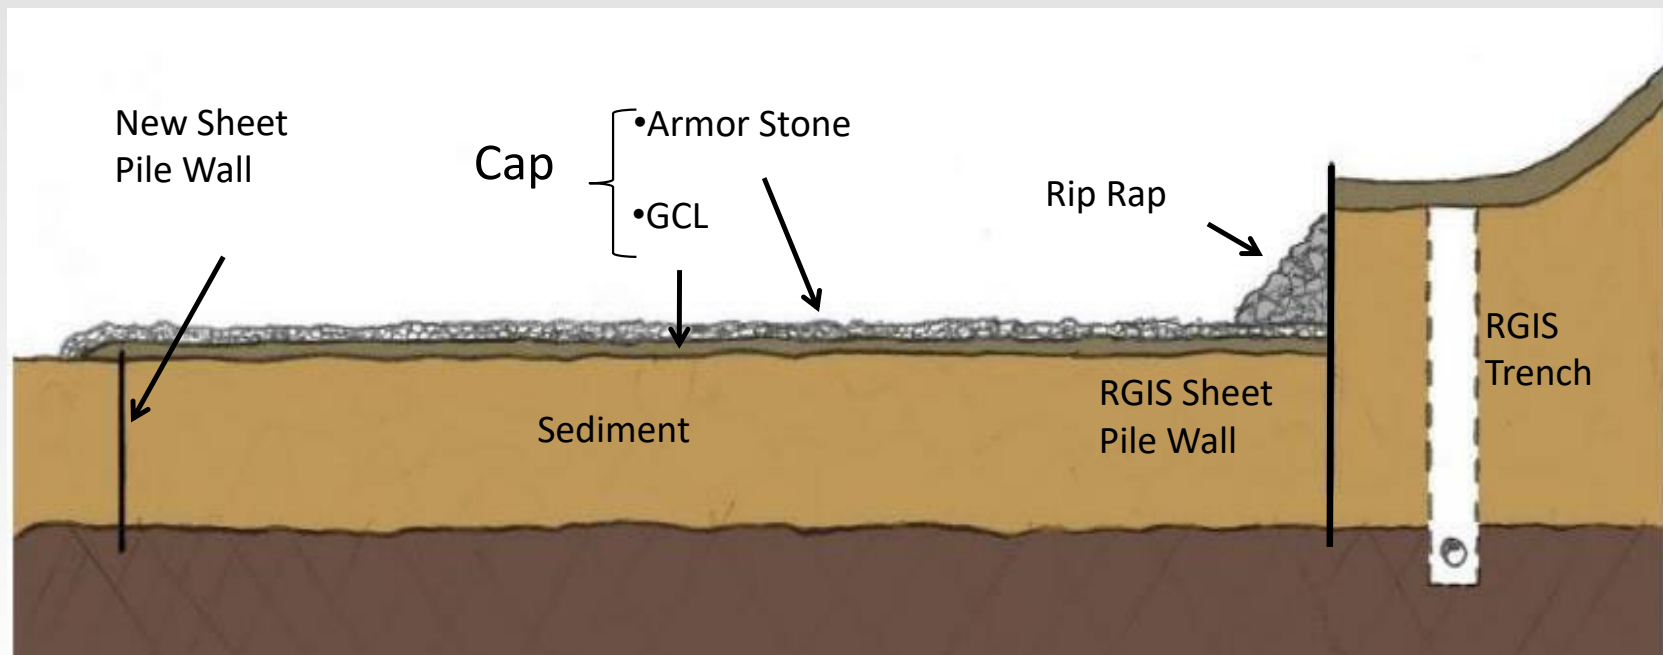
Residual In Situ Containment

- Following the removal of free phase DNAPL, the residual DNAPL deposit areas were contained using sheet pile walls and an impermeable cap.
