Implementation of a Strategic Approach for Vapor Intrusion Assessment and Mitigation along a 1,200-foot long Trichloroethene Groundwater Plume

Richard H. Christensen, PhD; Mike Grzegorek, CHMM
Acuity Environmental Solutions, Fishers, IN

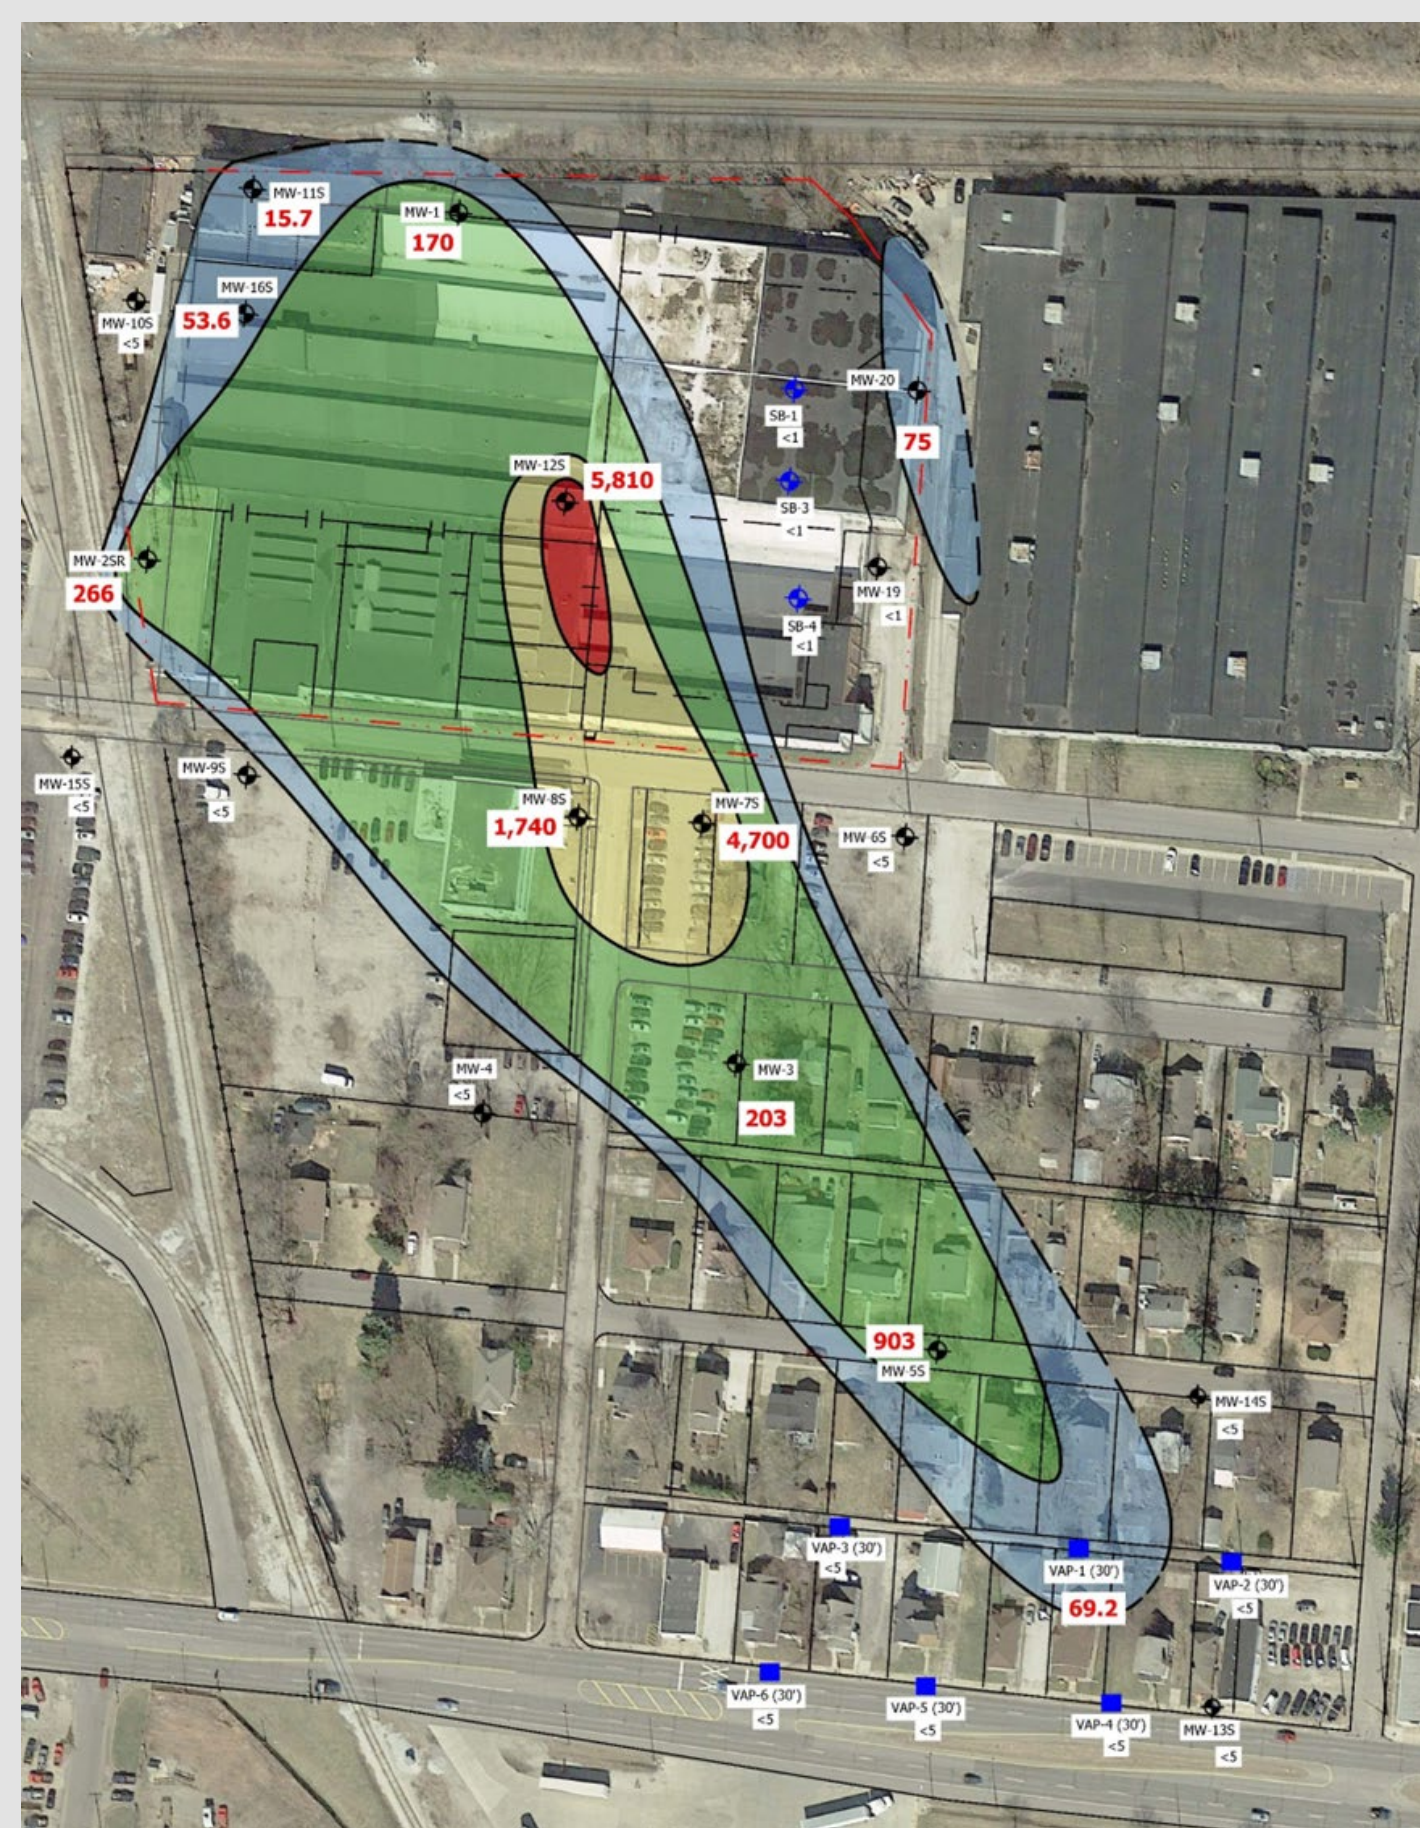
- Release resulted in a 1,200-foot long TCE plume
- TCE concentrations in groundwater of 1 µg/L can create sub slab vapor concentrations of >150 µg/m³

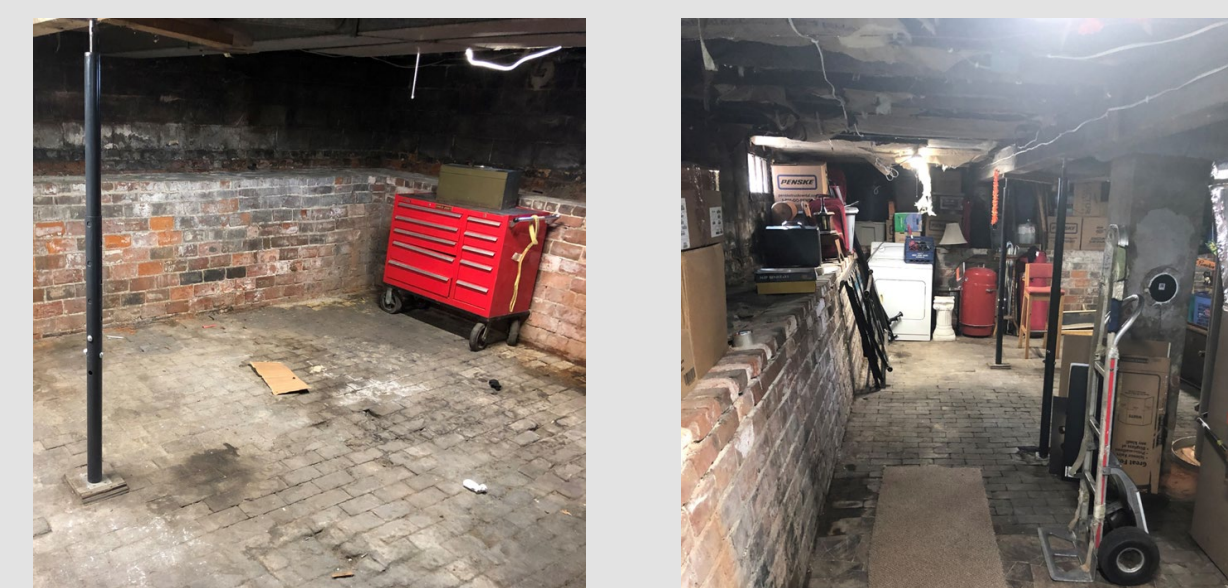
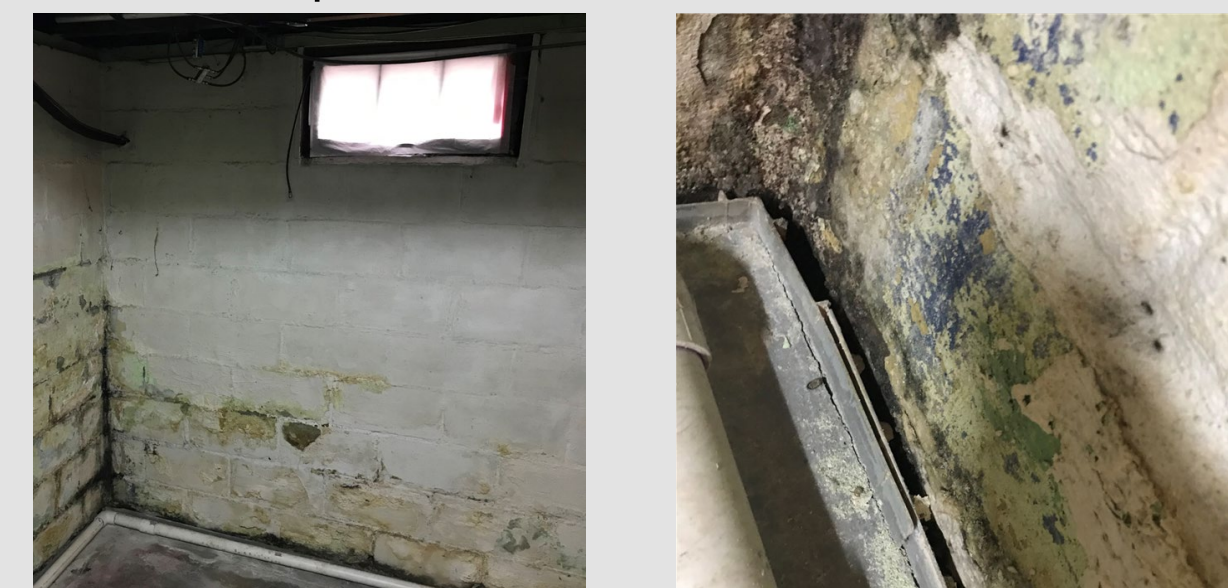
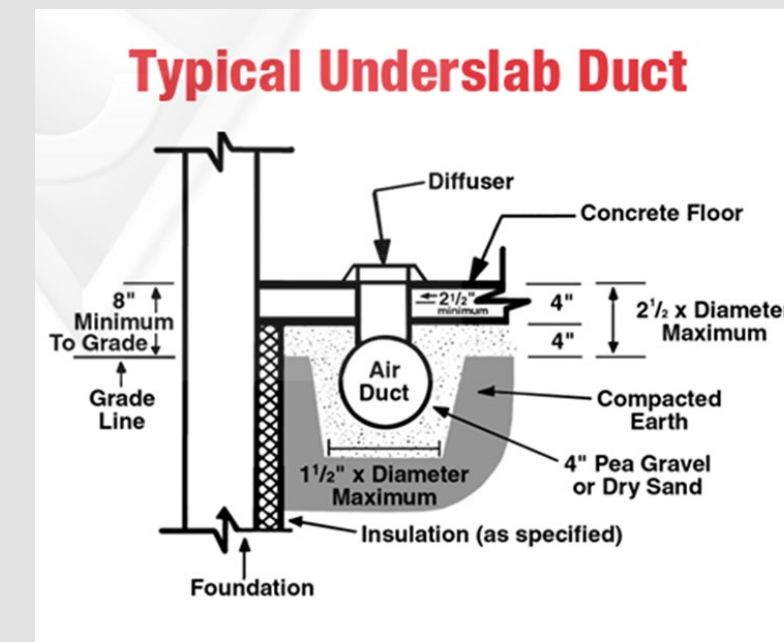
Vapor Mitigation Challenges

- “Michigan style” basements
 - Crawl space converted to basement, often hand dug
 - Dirt or brick lined basement floors, open conduit to vapors
- Weeping” basements
 - Sumps and moisture collection systems which collect moisture/water infiltration
 - Preferential pathway
 - Short circuit vapor extraction
- Sub slab HVAC piping
 - Preferential pathway
 - Short circuit vapor extraction

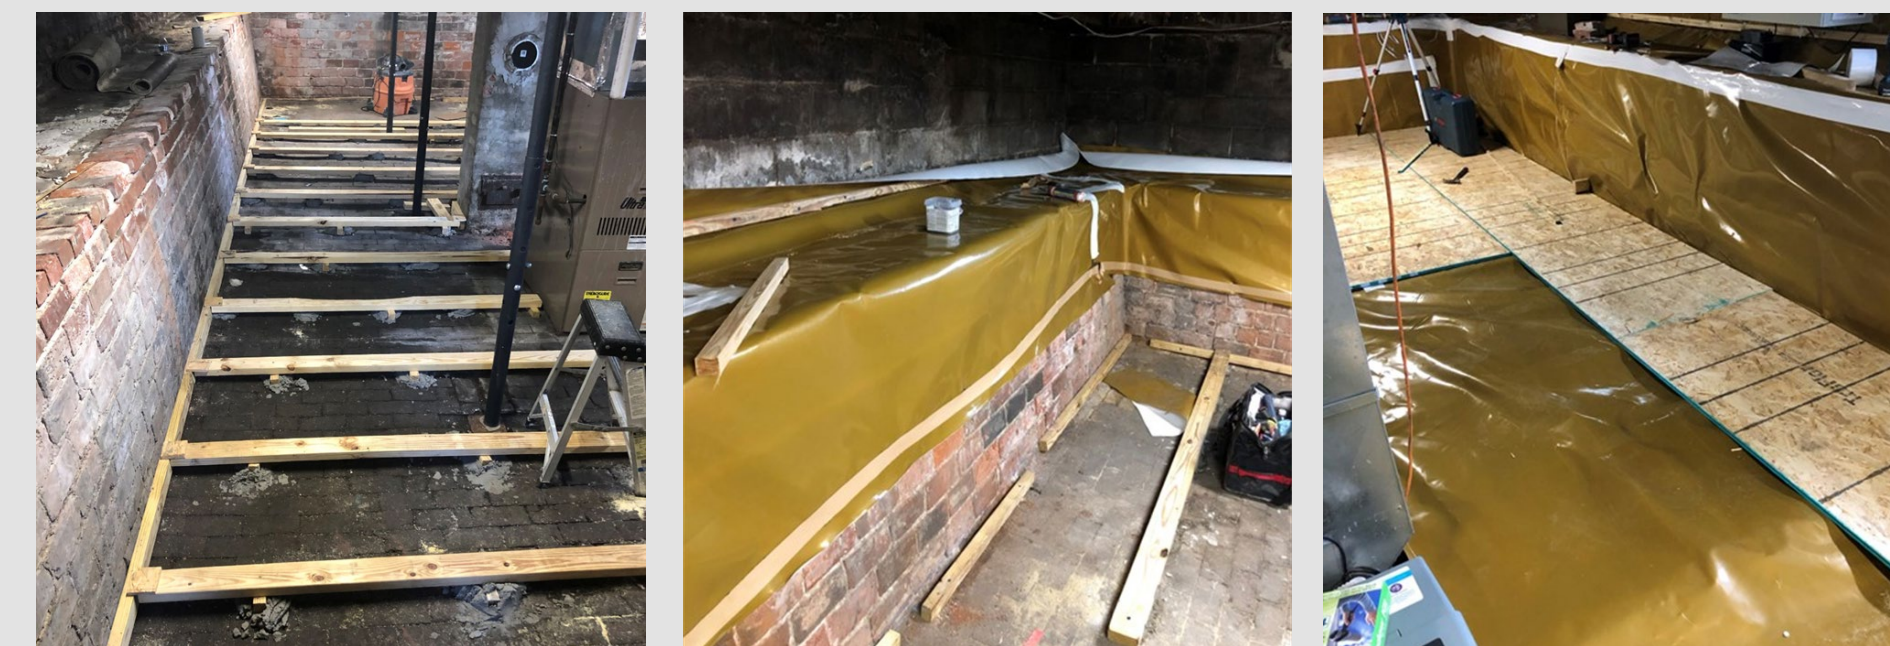
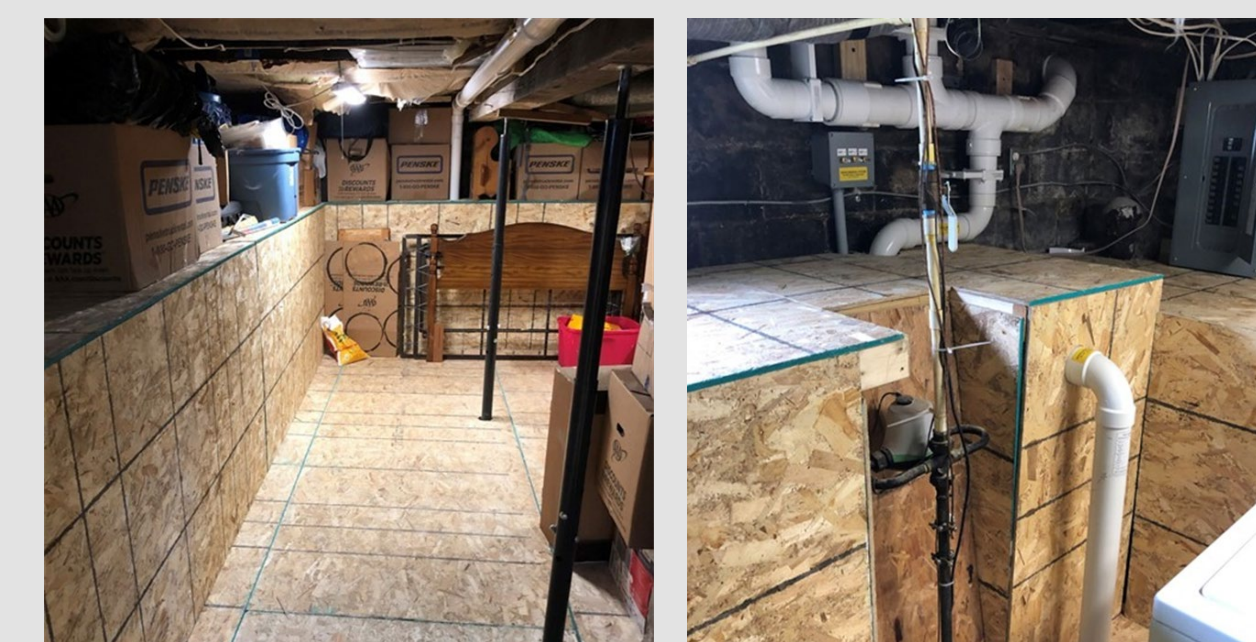
“Michigan Style” Basement

- The magnitude of preferential pathways made simple SSDS problematic
- Initial 160 ft² heat recovery/ventilation (HRV) system installed
 - Confirmation sampling results above screening levels
- Replaced with larger HRV and Fantech Eco-Touch Controller for greater air exchange
 - Confirmation sampling results failed over two separate events, equal distribution during heating season
- Abandoned HRV and installed a sub-membrane depressurization system (SMDS)
 - Installation of 20-mil vapor barrier placed over treated wood frame built upon brick floor and walls
 - OSB wood panels used to cover floor and wall to protect vapor barrier
 - Fan connected to two extraction points sealed to and below the membrane
 - Confirmation sampling confirmed efficacy

Initial Investigation	Post HRV Install	Post HRV Modification	Post 2 nd HRV Modification	Post SMDS Install	Additional Confirmation
Basement	36.9	21.8	33.3	48.3	ND	ND
1 st Floor	24.7	2.9	13.6	40.3	Not sampled	ND

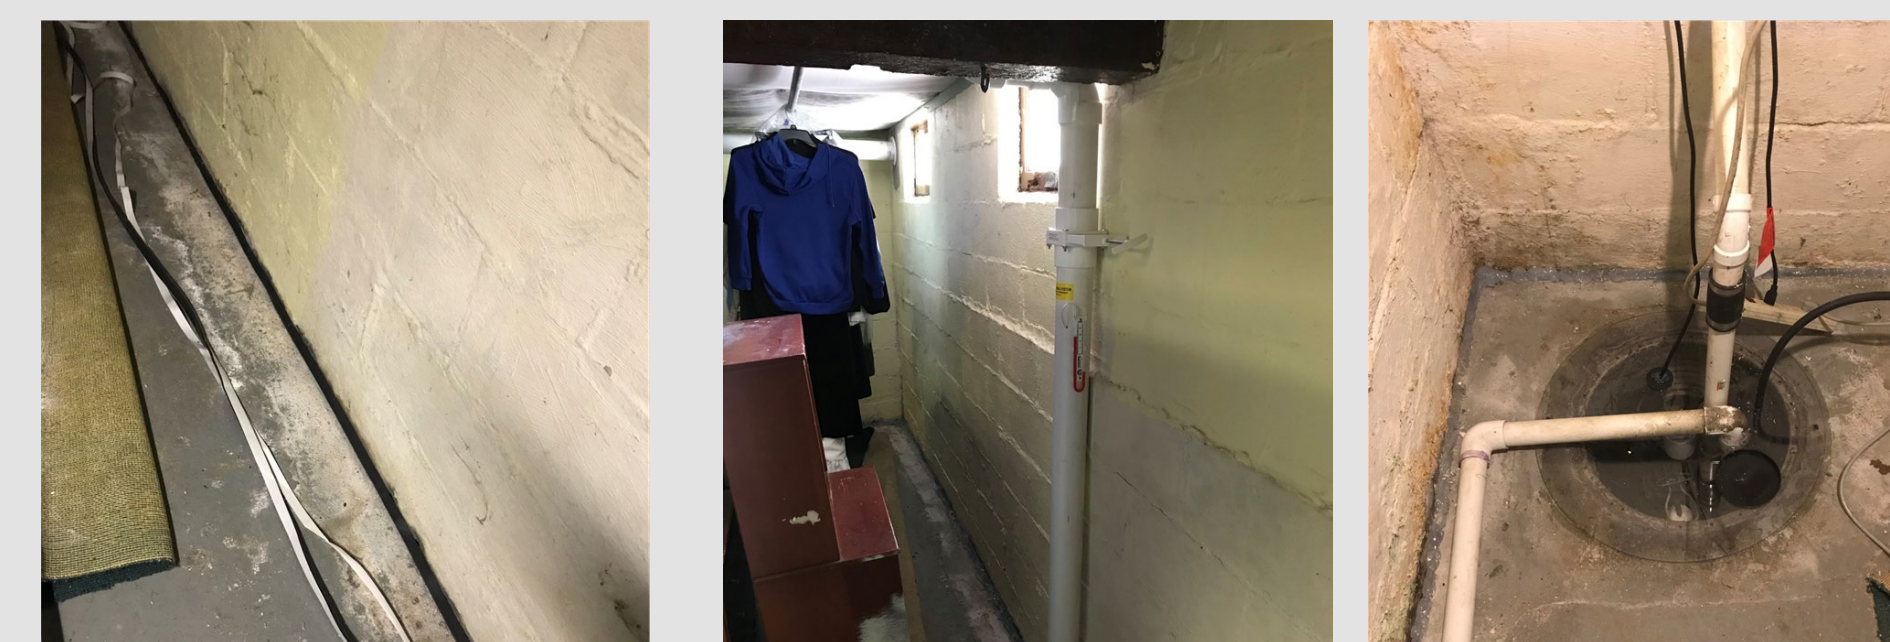
“Weeping” Basement

- Initial HRV system installed
 - Confirmation sampling results above screening levels
- Abandoned HRV and installed sub-slab depressurization system
 - Sealed the open channels of the moisture capture system
 - Fortunately, new HVAC system reduced moisture in basement and channels not needed
 - Replaced sump cover lid with an airtight model
 - Installed two extraction points into the basement slab
 - Confirmation sampling confirmed efficacy

Initial Investigation	Post HRV Install	Post HRV Additional	Post SSDS Install	Additional Confirmation
Basement	9.0	4.5	4.9	ND	ND
1 st Floor	1.6	1.4	4.0	ND	ND

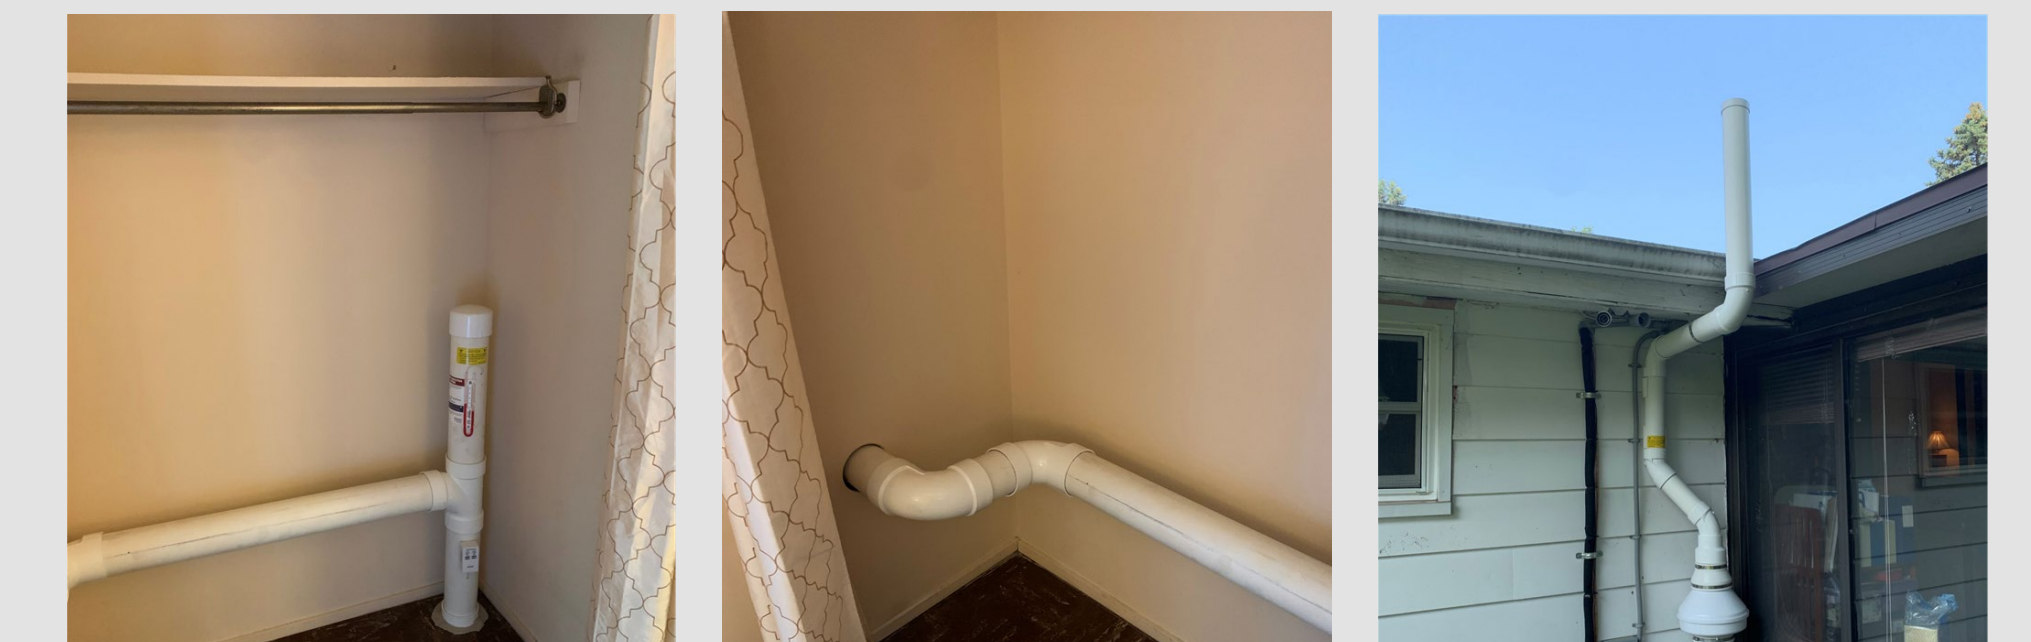
Sub Slab HVAC Piping

- In floor duct work
 - Depth of duct work below slab ruled out a horizontal extraction point into the foundation wall
 - Luckily, the duct work did not have major cracks/separations which could act as preferential pathways, or short circuit the SSDS
- SSDS installed in interior closet
 - Extraction point “inside” of the HVAC ductwork “loop”
 - Confirmation sampling confirmed efficacy

Initial Investigation	Post SSDS Install
1 st Floor	2.54	ND
