The In Situ Treatment of TCE and PFAS- Impacted Groundwater Using Anaerobic Bioremediation, Polylactate Ester and Colloidal Activated Carbon

R. McGregor

InSitu Remediation Services

Battelle 2023

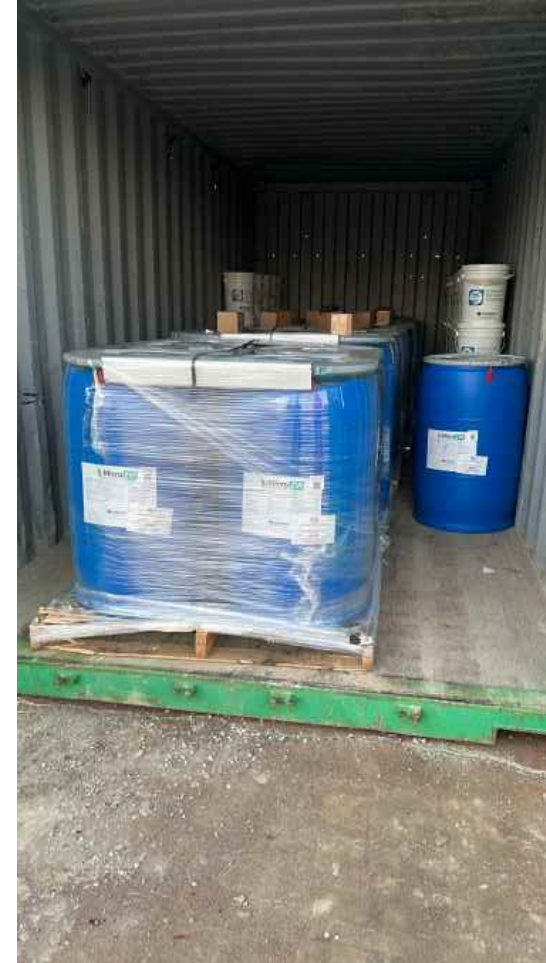
Study Site Injection Plan

- Test Area:
 - 100 m² area
 - Targeting shallow plume
- Reagents
 - Colloidal activated carbon (PlumeStop™)
 - Micro SZVI™
 - Hydrogen Releasing Compound™
- Injection
 - Grid - 10 ft spacing
 - 10 injection wells (2" PVC)
 - 30 slot opening
 - 10 ft screens

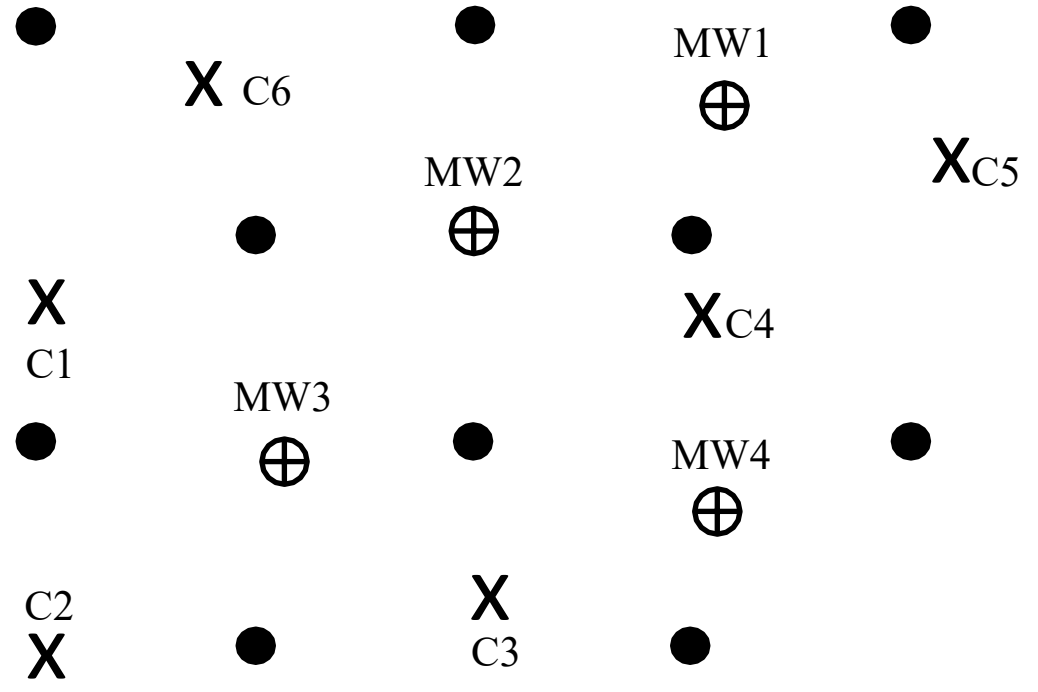
Study Site Layout

- Injection Well
- ⊕ Monitoring Well
- X Core

Groundwater Flow
↓
