Source Area Bioremediation in Fractured Bedrock with Karst Features Revisited as Sustainable and Resilient Remediation

11 May 2023

Sixth International Symposium on Bioremediation and Sustainable Environmental Technologies

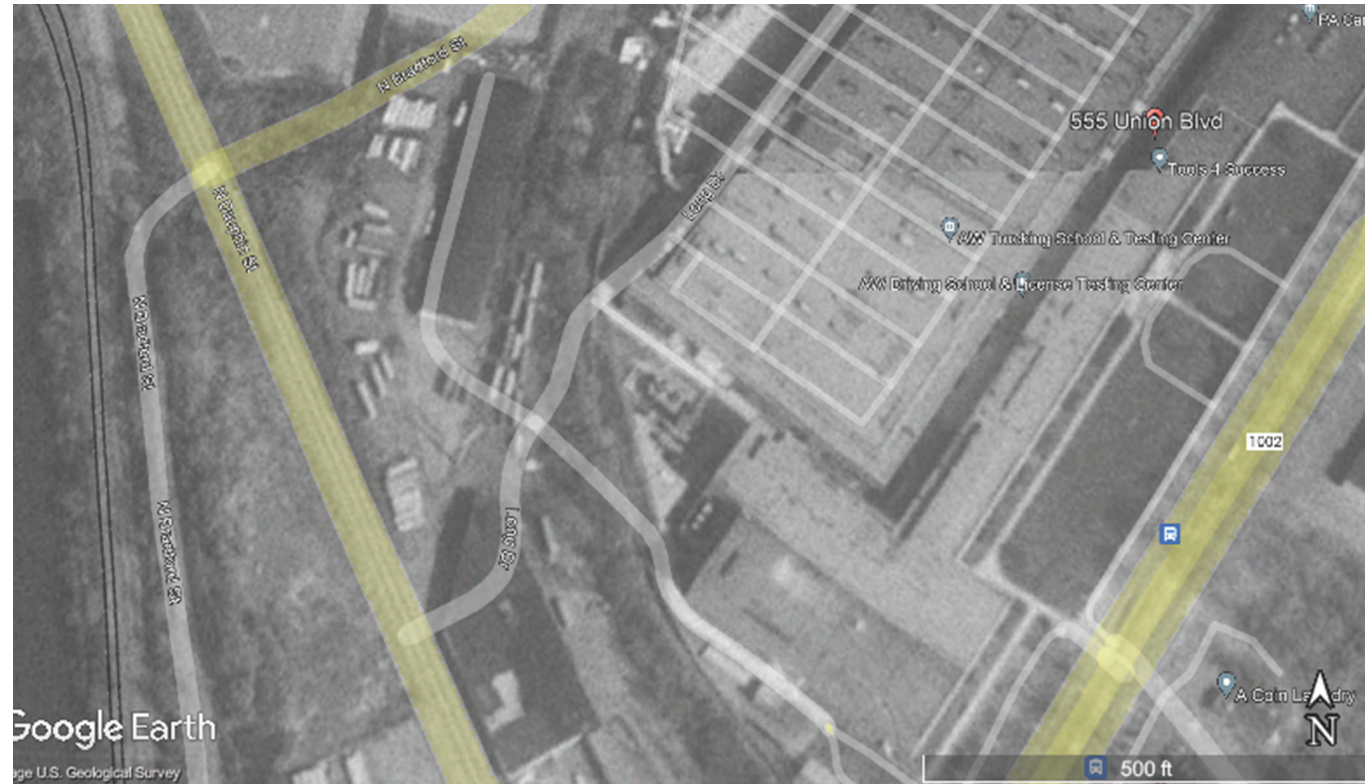
- Approximately 12 wells initially installed in 2005 to identify potential COC impacts to groundwater
- Wells were installed from 90' to almost 250' bgs screened in highest producing fractures in the bedrock
- Well clusters were installed in 2010 with shorter screen intervals to better define the vertical extent of the plume and identify higher flow fractures
- GW fate and transport model developed to help define risk based remedial goals to protect the adjacent river

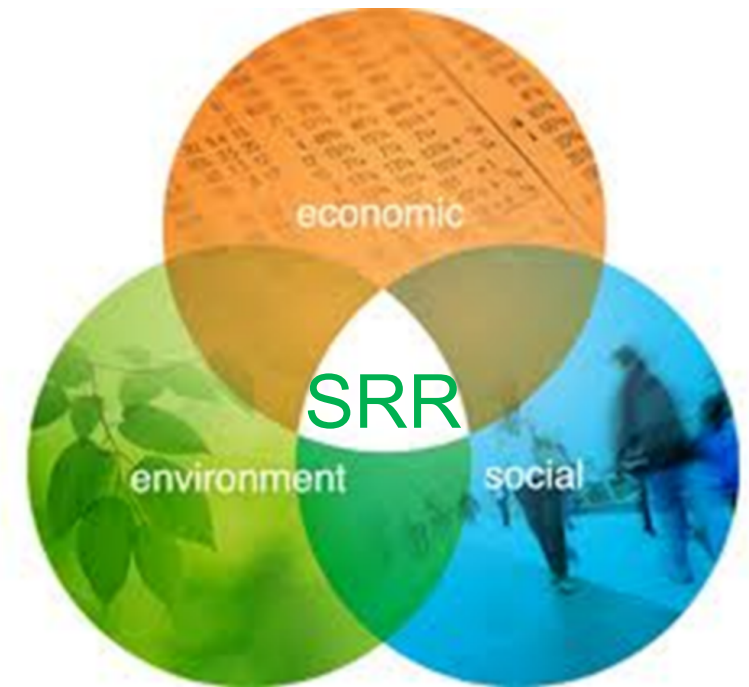
Semi-Quantitative Assessments

- Semi-quantitative sustainability assessment was conducted comparing pump and treat, thermal, in situ chemical oxidation and in situ bioremediation.
- Phased in situ bioremediation (biostimulation and bioaugmentation) was selected as the most sustainable and resilient remedy to achieve risk-based remedial goals.

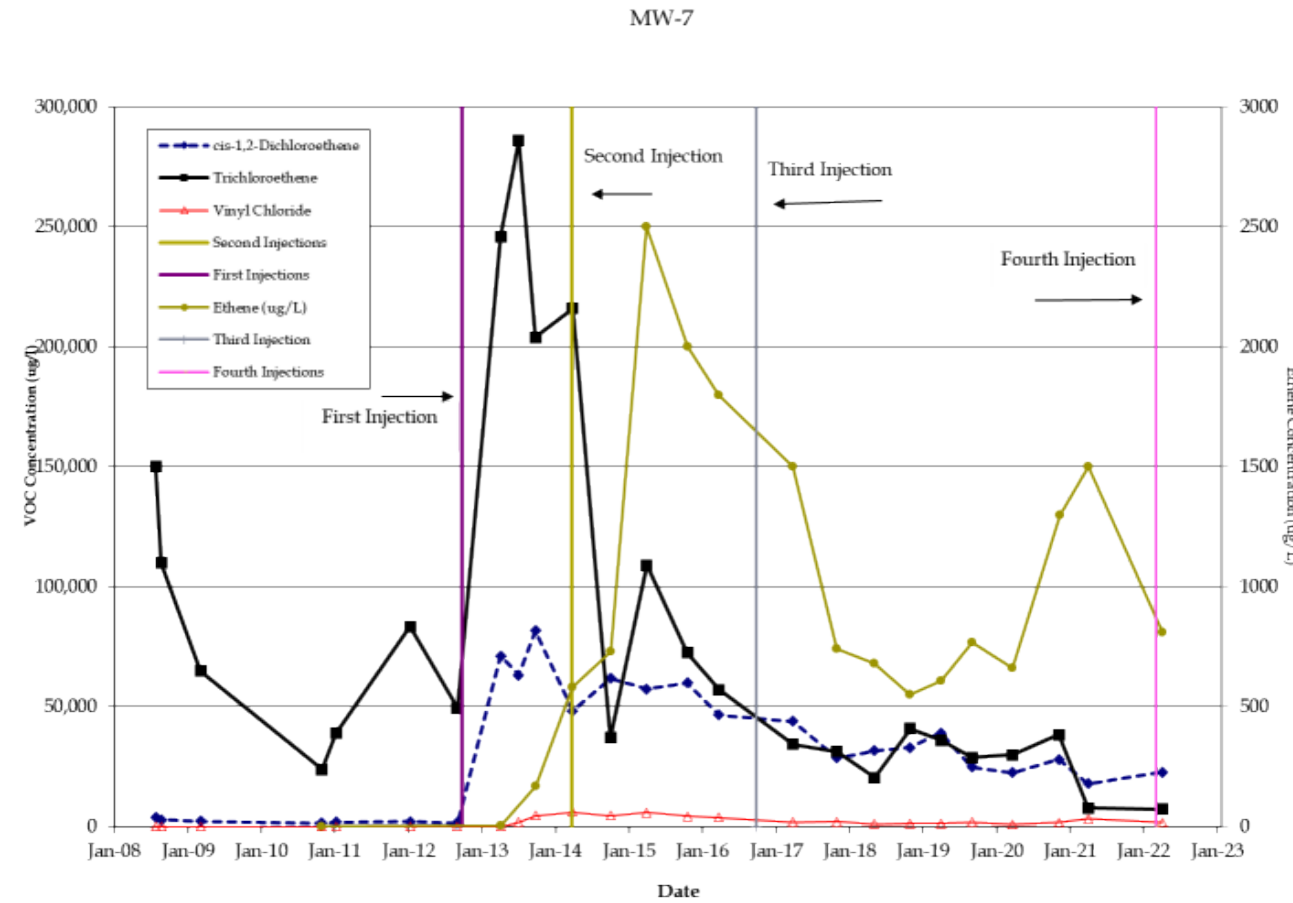
- Observed DO < 1 mg/L and ORP < -100 within 6 months of first injection event in several monitoring wells
- TOC increased to > 40 mg/L
- Initially observed significant increase in TCE in source area likely due to mobilization during injections
- The elevated TCE and significant increase indicated DNAPL that had not been previously identified

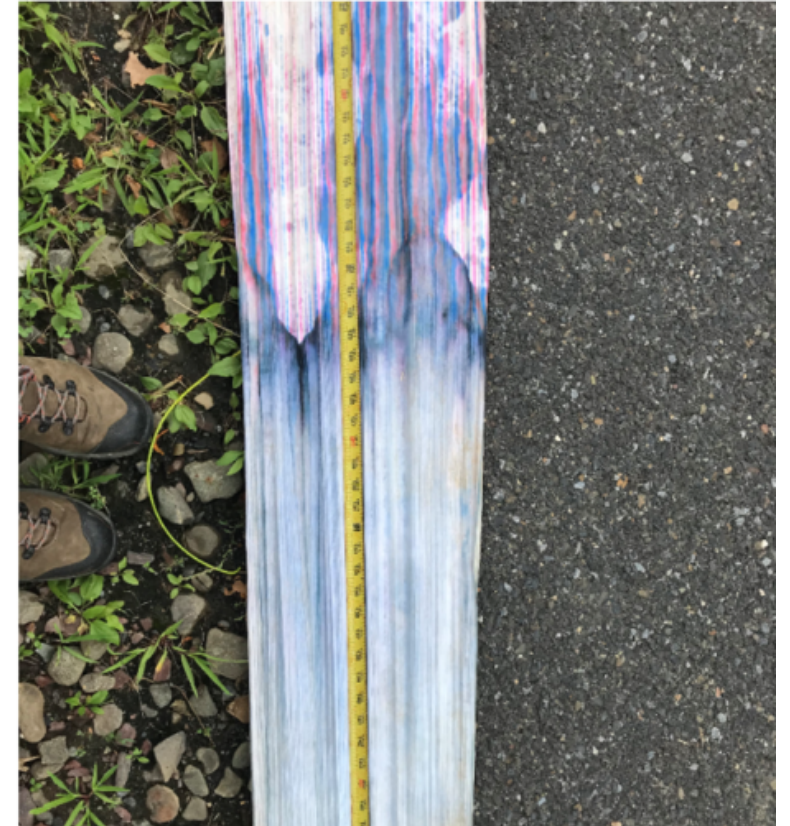
- Additional remediation points were installed, however to better evaluate presence of DNAPL sorbers were placed in the boring and oil red O was used on cuttings
- Sorber confirmed presence of DNAPL at approximately 110' bgs
- Placed additional sorbers in 3 more borings and additional sorber in initial boring
- To limit potential for mobilizing additional NAPL, remediation point was converted from injection to bioboring

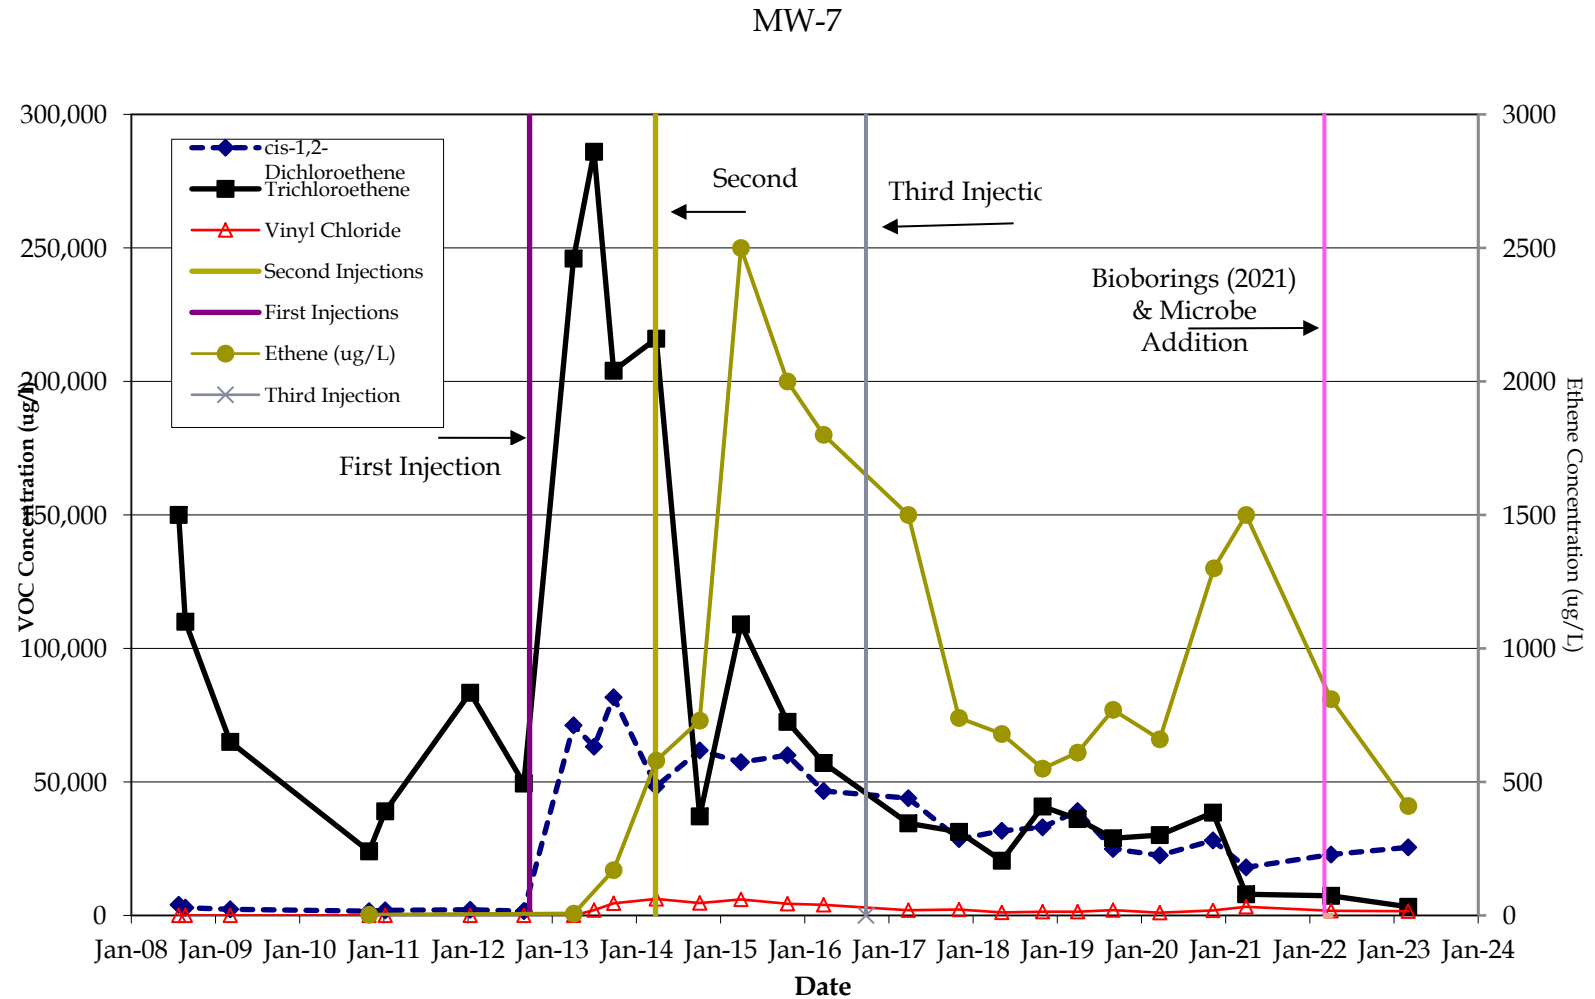
COC Laboratory Data in Source Area MW

- 86% reduction of TCE in source area well previously showing almost 300 mg/L of TCE
- Degradation products observed but not increasing
- Ethene observed at 410 µg/L

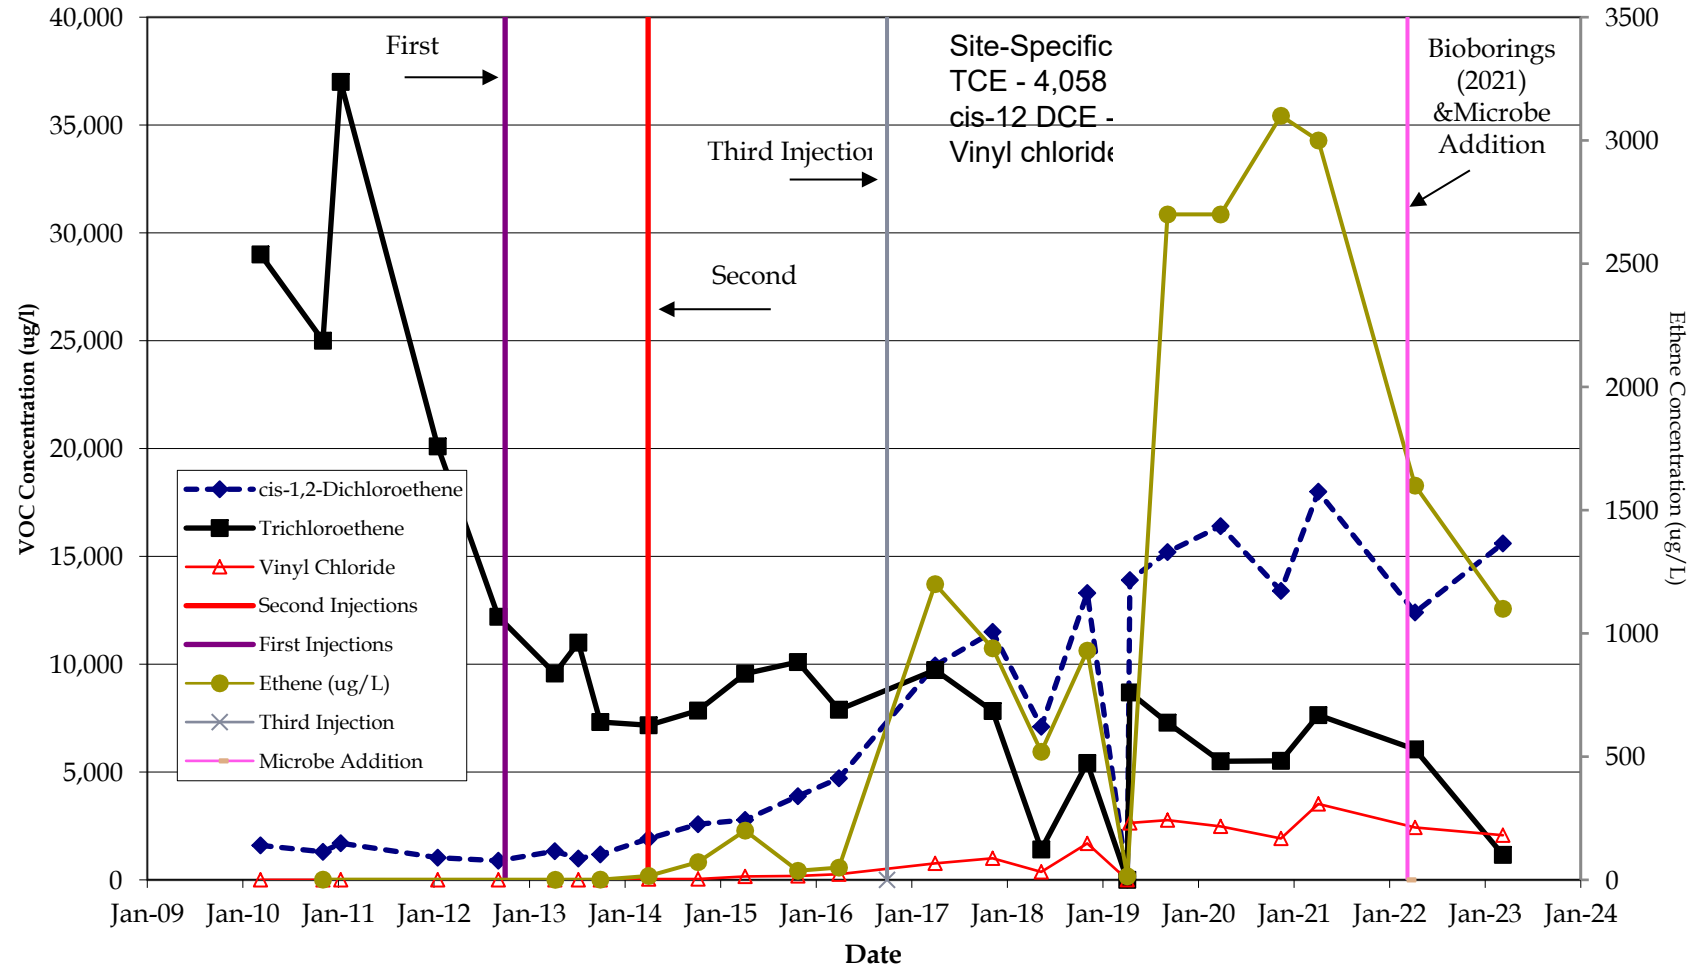
MW-9D

- 99.8% reduction of TCE
- VC reducing in last two years
- Over 1,000 µg/L

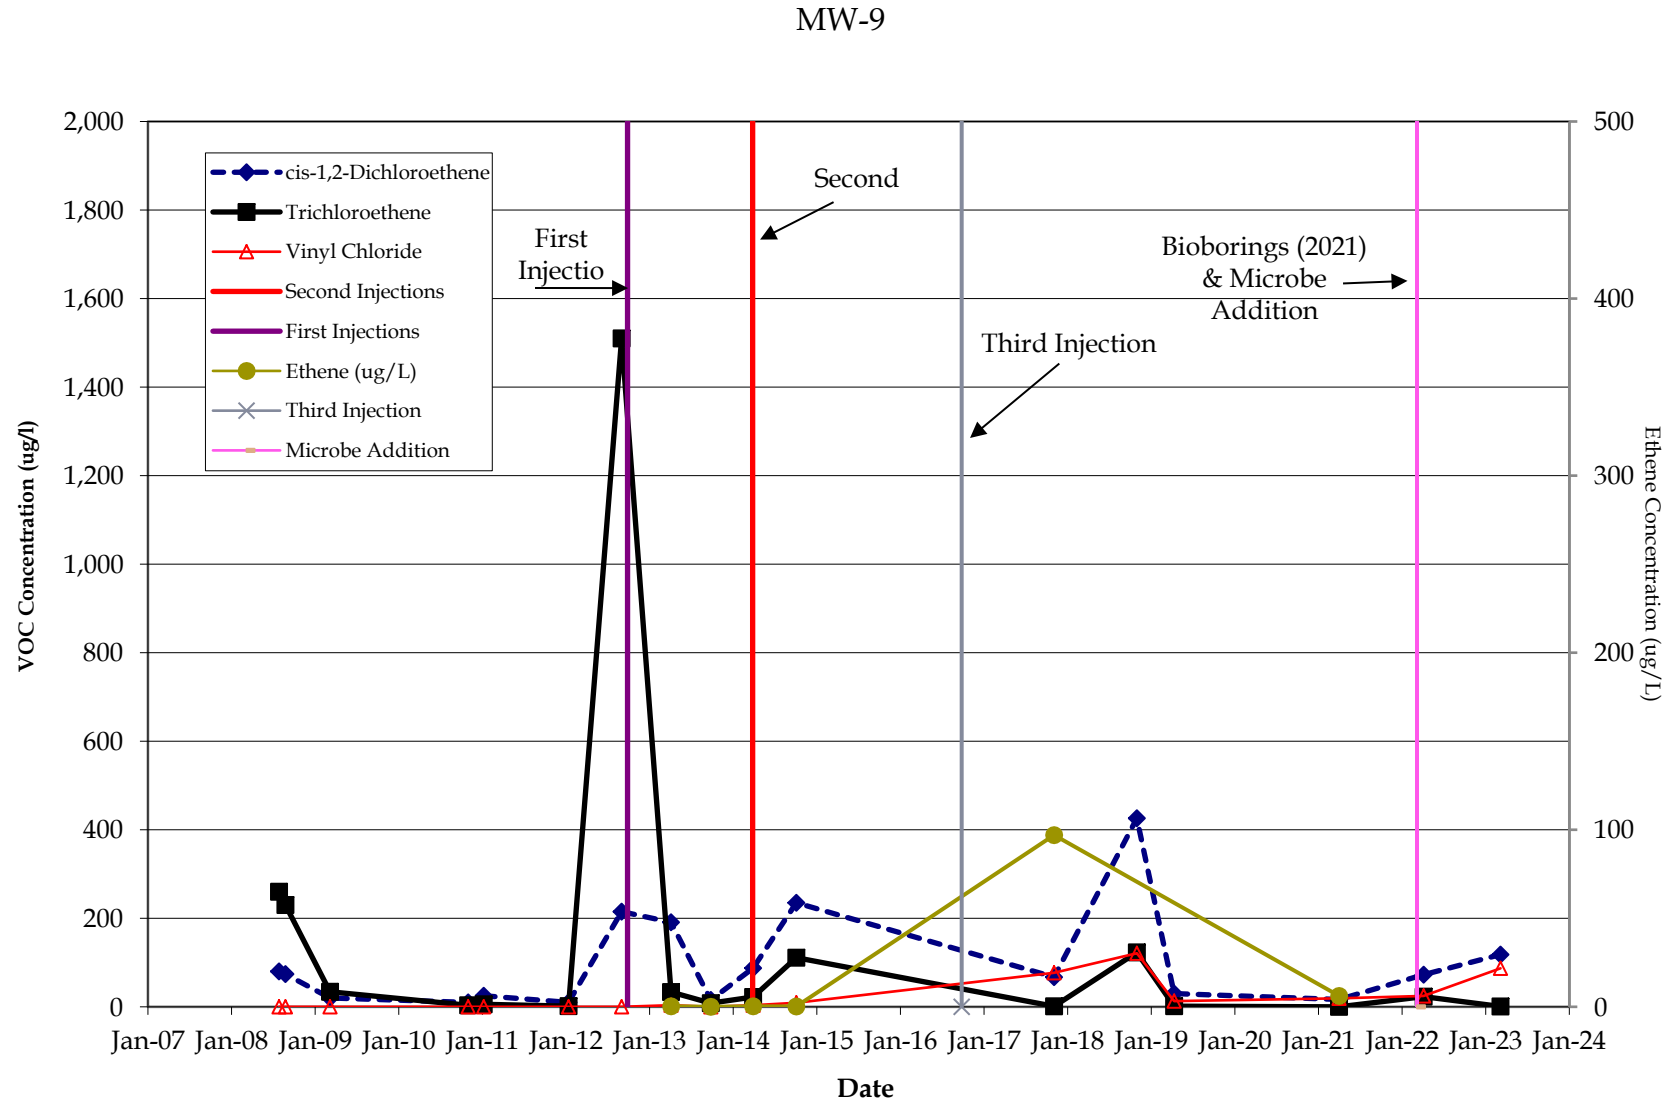
- Very low detections of TCE, well below RBCs
- Low detections of degradation products
