***Passive and Active Soil Gas Sampling Along Sanitary Sewer Line
used for Source Area Delineation and Vapor Intrusion Assessment***

Battelle Conference, May 2023

Richard H. Christensen, Jr., RG, PhD, Principal Geologist

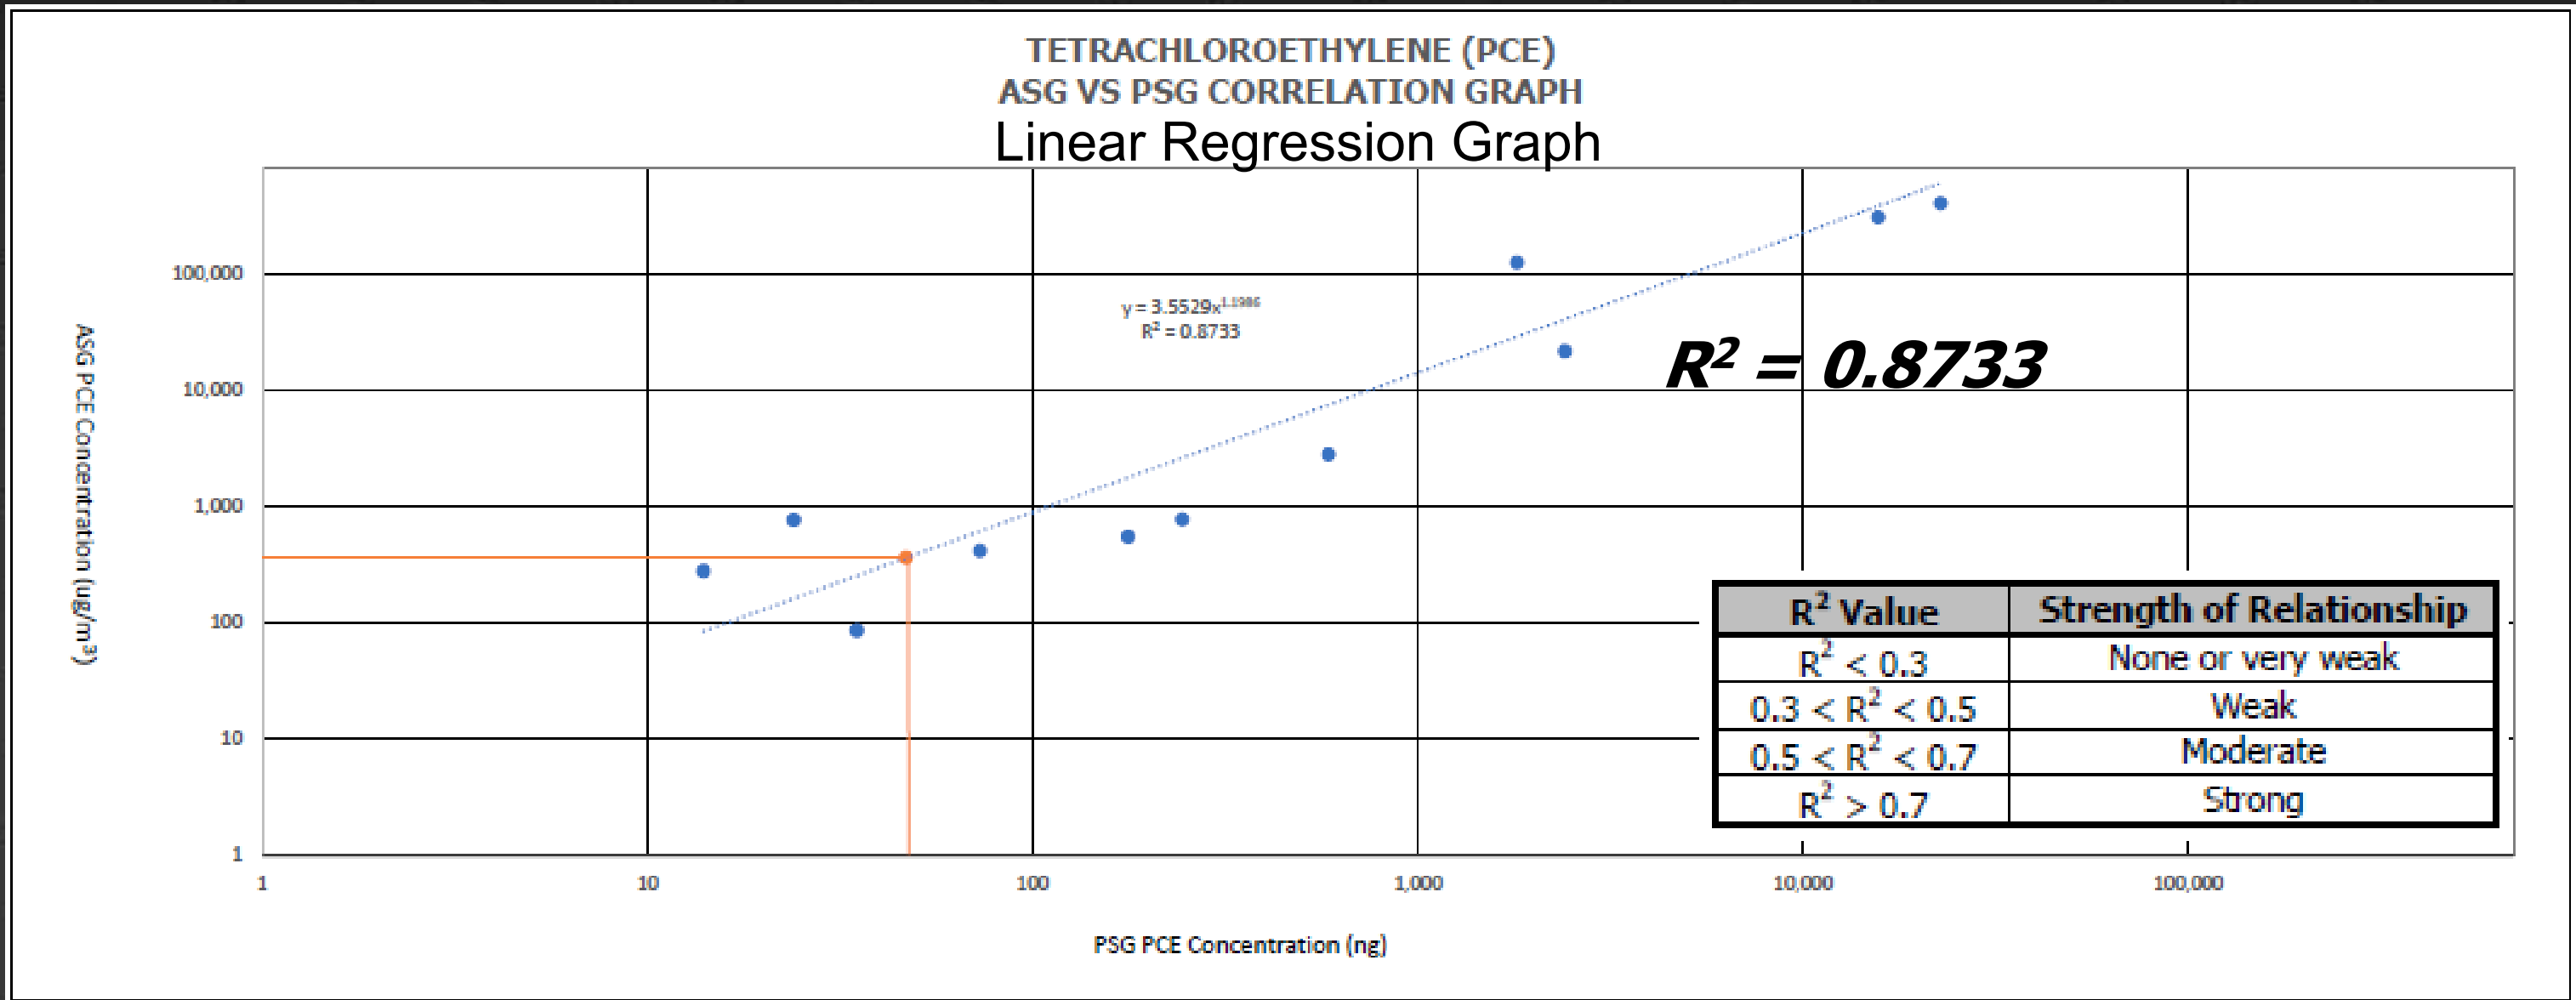
PCE Results - Statistical Correlation

Sample ID	ASG ($\mu\text{g}/\text{m}^3$)	Sample ID	PSG (ng)	Correlation Prediction ($\mu\text{g}/\text{m}^3$)
ASG-09	402,000	PSG-15	22,800	705,531
ASG-12	305,000	PSG-49	15,700	437,846
ASG-07	905,000	PSG-50	7,080	158,148
ASG-11	21,500	PSG-07	2,410	39,867
ASG-06	124,000	PSG-46	1,810	27,645
ASG-08	2,800	PSG-53	586	6,536
ASG-10	771	PSG-08	245	2,143
ASG-05	548	PSG-22	177	1,414
ASG-04	277	PSG-58	14	55
ASG-03	416	PSG-33	73	456
ASG-02	85.7	PSG-39	35	178
ASG-01	763	PSG-61	24	110

- PSG sampling confirmed initial CSM that the sanitary sewer was the release point of cVOCs AND the sewer back up was limited in its extent into the apartment complex.
- Statistical Correlation of PSG and ASG analytical results convinced EPA of the suitability of using PSG for source area delineation purposes.
- No additional source area delineation was required by the USEPA

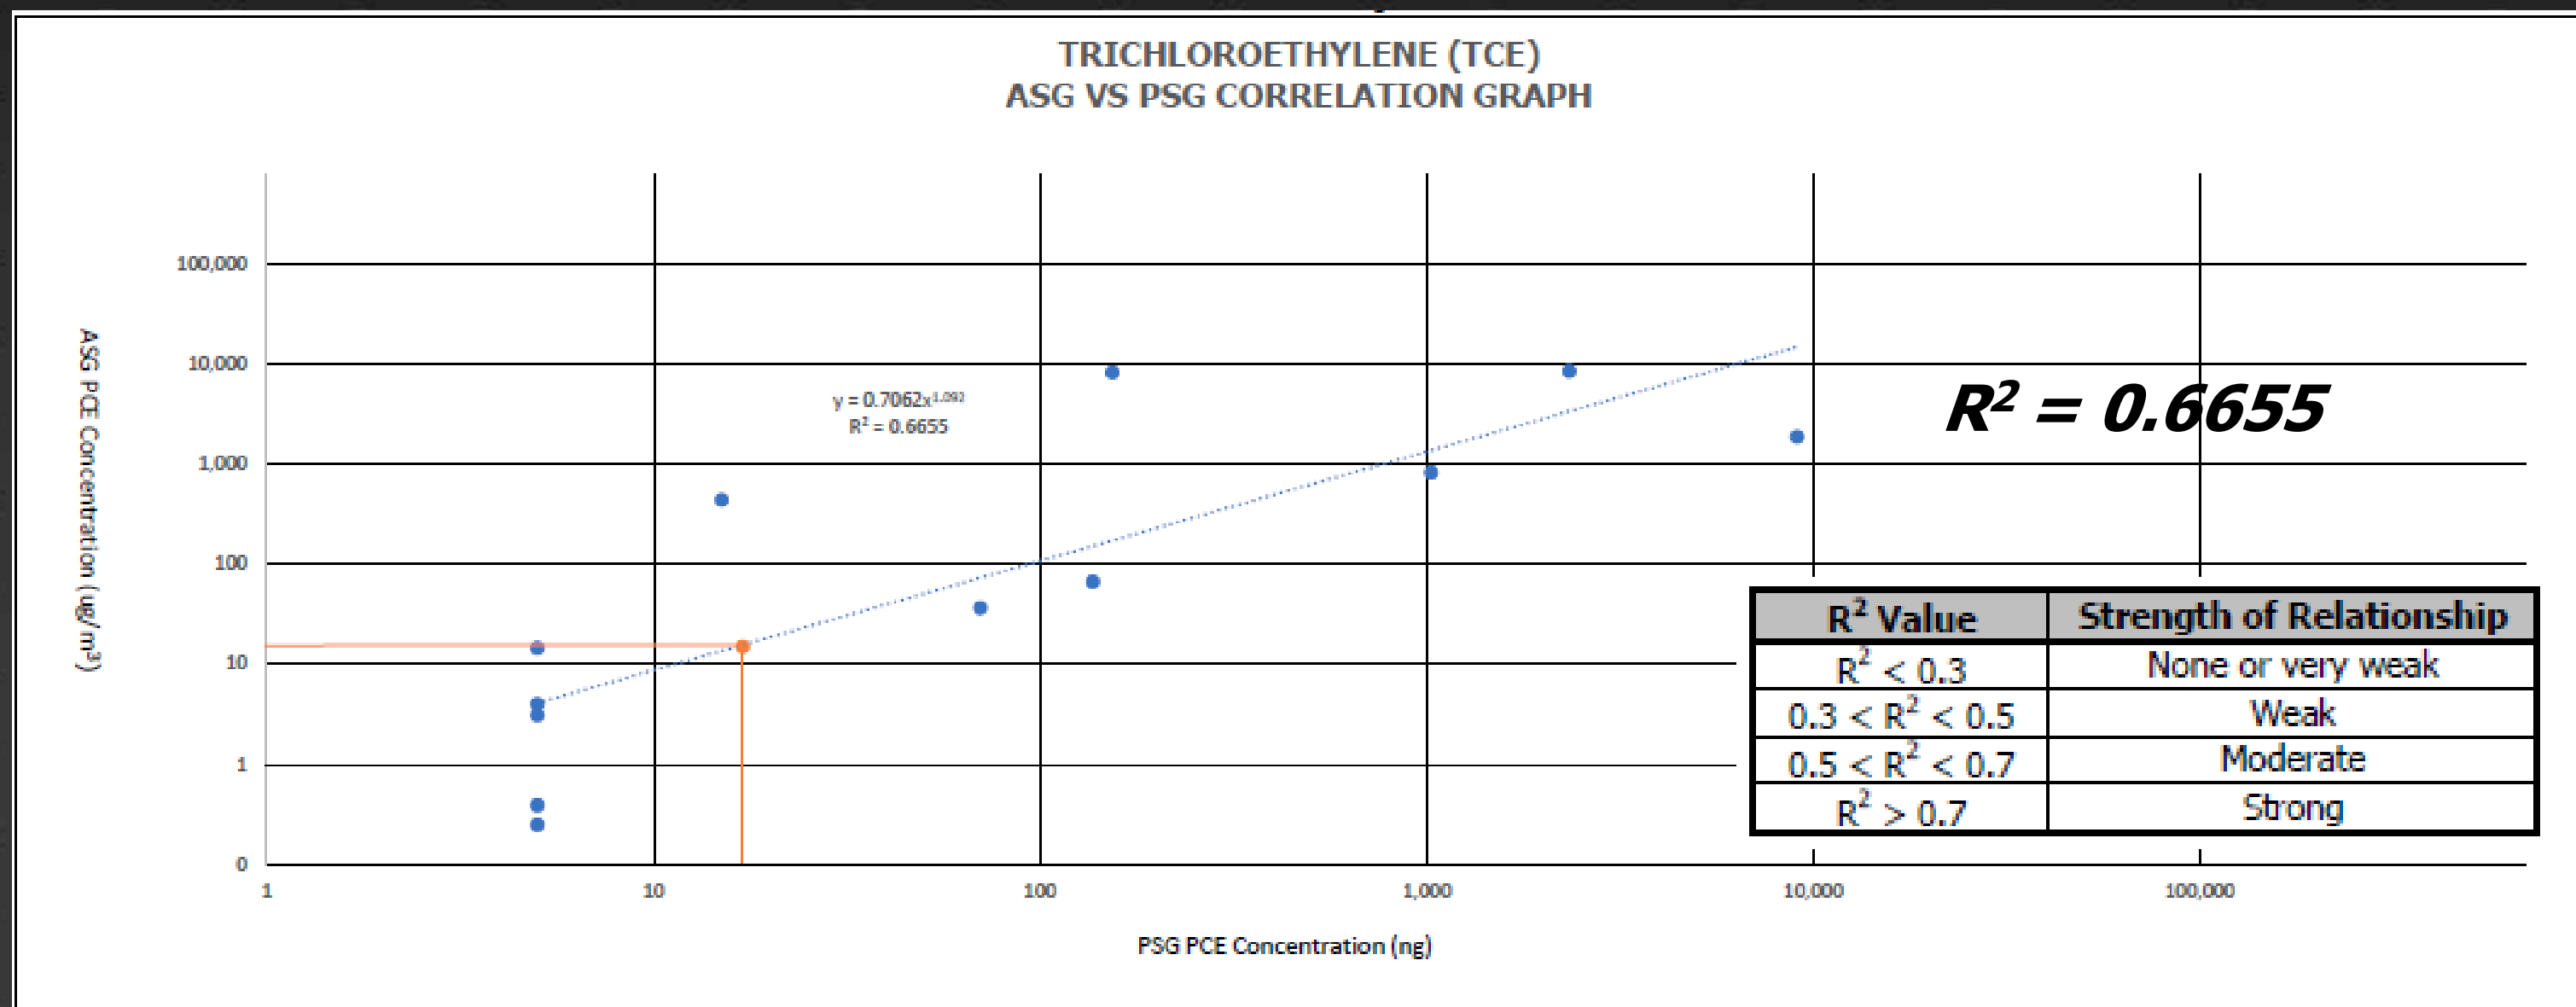
TCE Results - Statistical Correlation

Sample ID	ASG ($\mu\text{g}/\text{m}^3$)	Sample ID	PSG (ng)	Correlation Prediction ($\mu\text{g}/\text{m}^3$)
ASG-09	1,880	PSG-15	9,090	14,848
ASG-12	8,480	PSG-49	2,340	3,374
ASG-07	8,270	PSG-50	154	173
ASG-11	829	PSG-07	1,030	1,377
ASG-06	440	PSG-46	15	14
ASG-08	37	PSG-53	70	73
ASG-10	67	PSG-08	137	152
ASG-05	0.25	PSG-22	5	4
ASG-04	4	PSG-58	5	4
ASG-03	3.1	PSG-33	5	4
ASG-02	0.39	PSG-39	5	4
ASG-01	15	PSG-61	5	4
