# Advancing urban site remediation using in-situ bioaugmentation for chlorinated aliphatic hydrocarbons in groundwater

Jarrood Yoder, PG, LSP

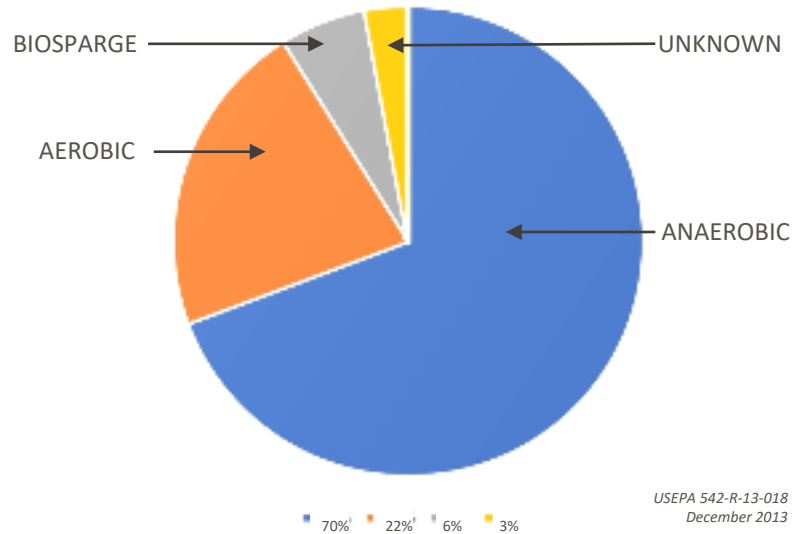
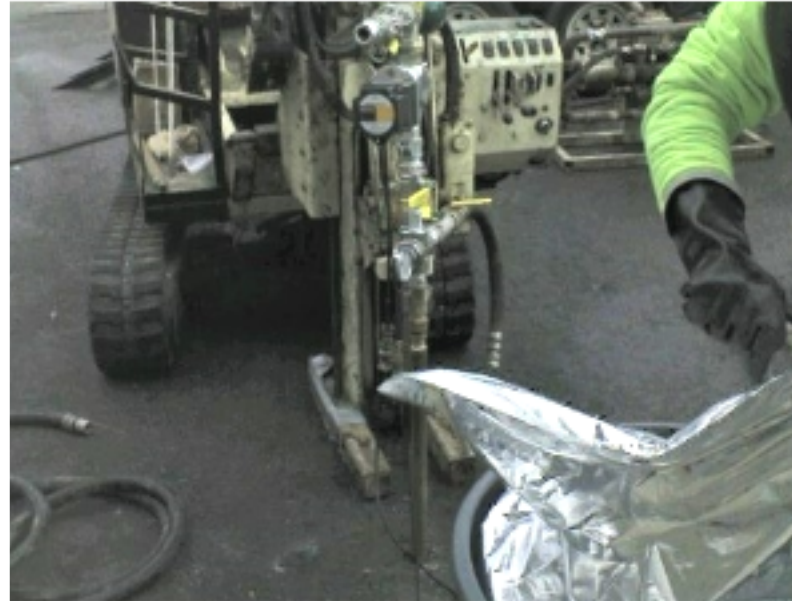
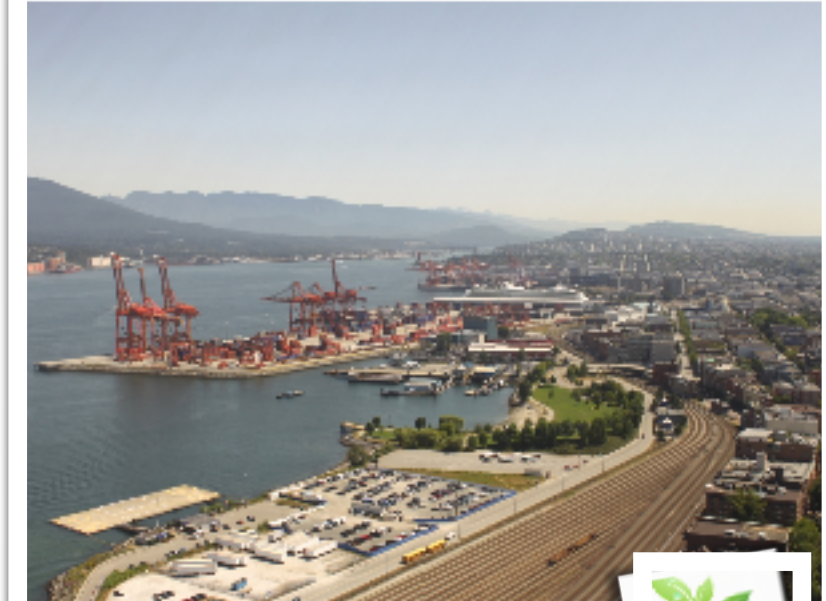
BIOREMEDIATION REMEDIES AT NPL SITES 1989 TO 2008

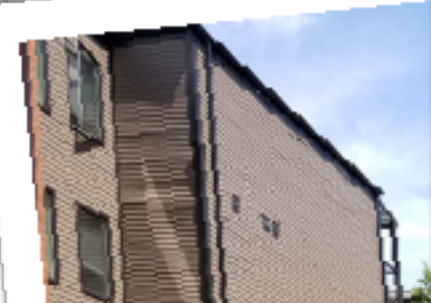
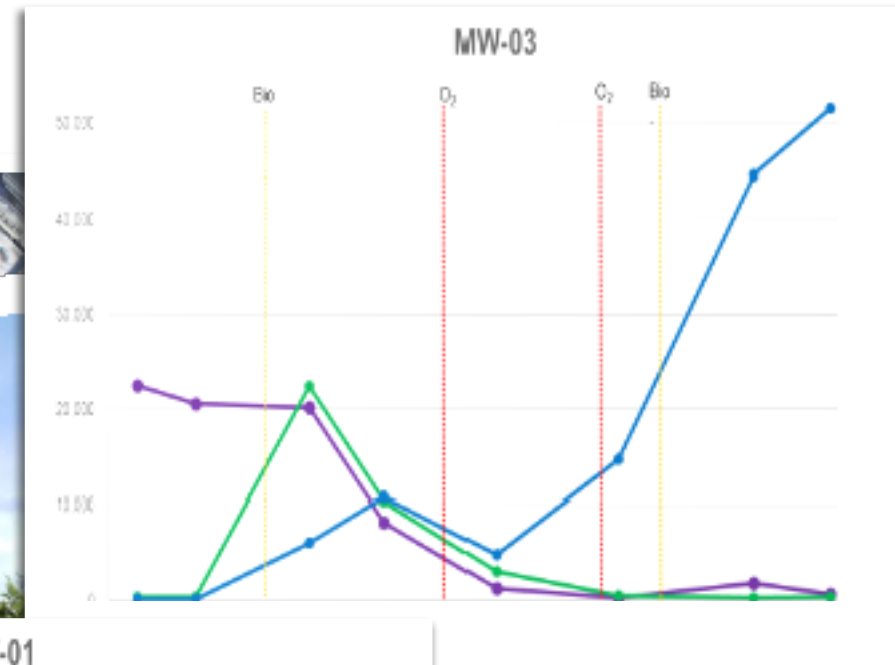
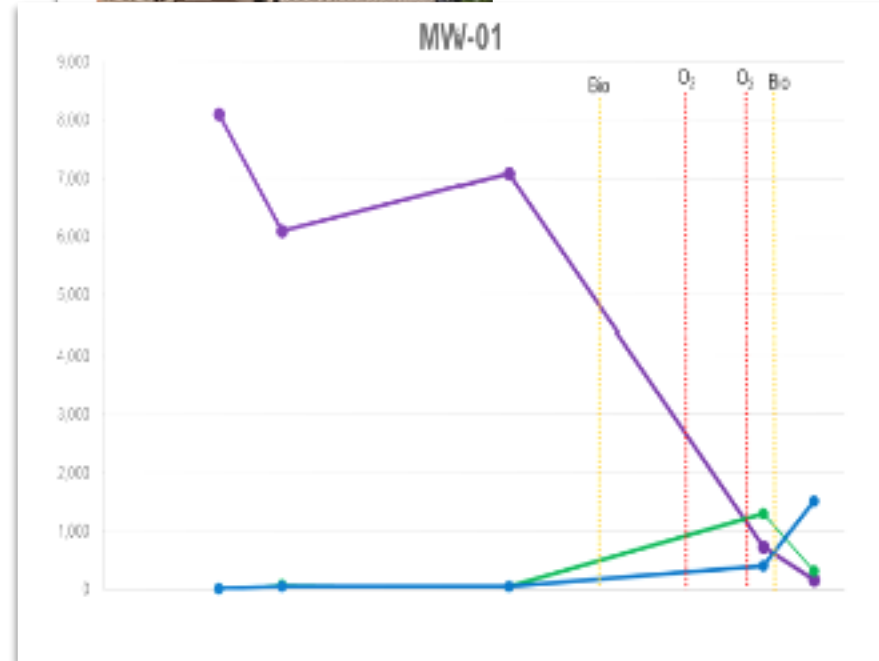
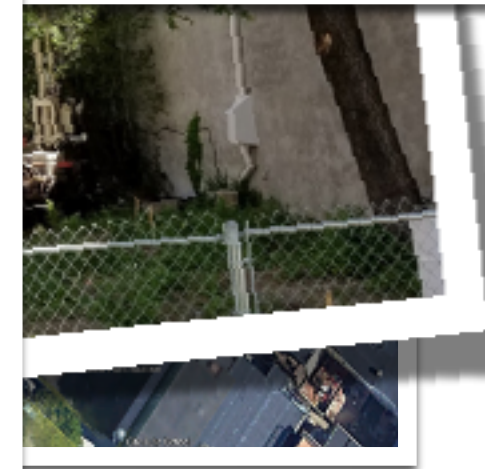
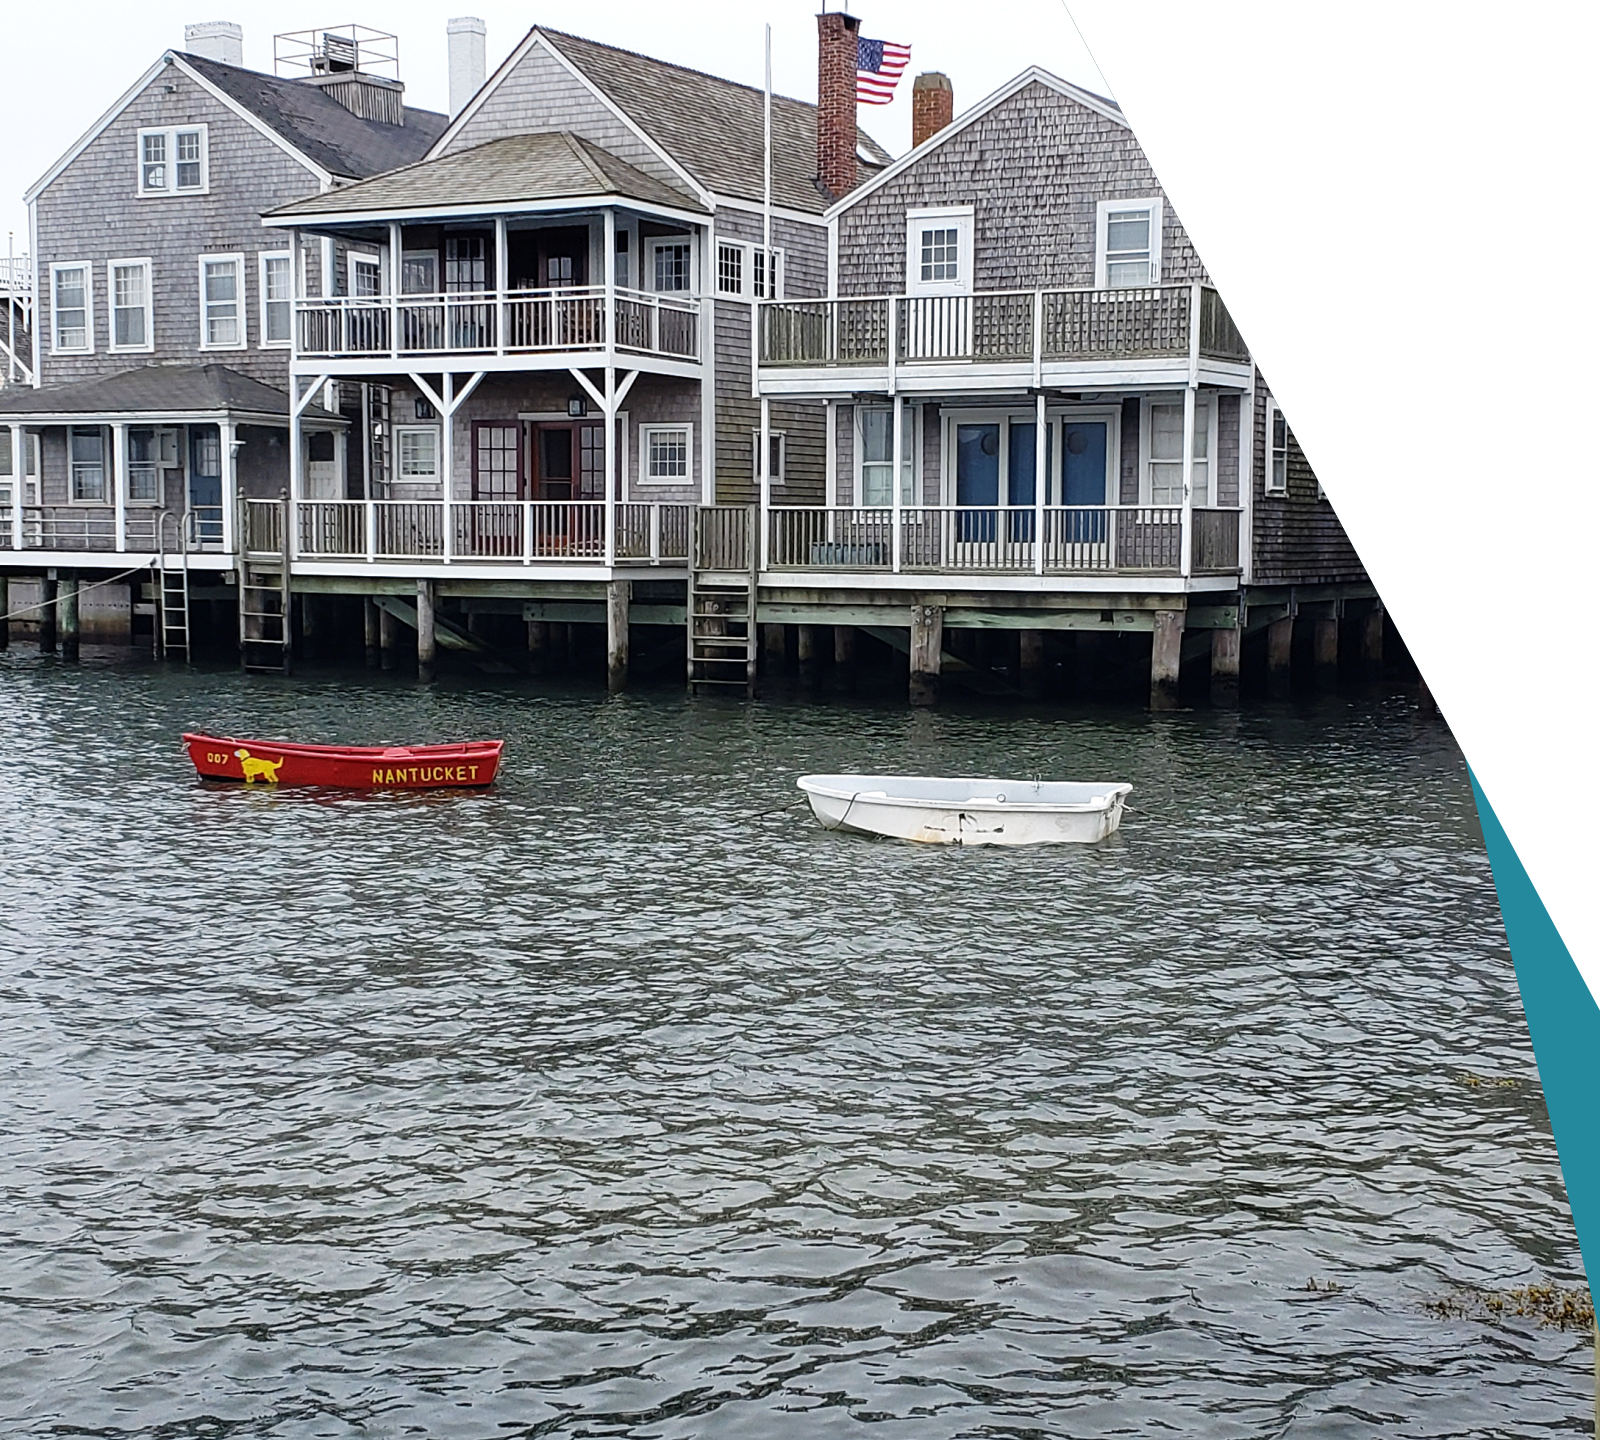
# Case Study No.2

Similar to Case Study No.1 except:

- Soil consisted of fill materials underlain by fine sands and silt
- Shallower groundwater (~8-9')
- Groundwater concentrations of PCE ~ 5 mg/L to 50 mg/L.
- No daughter products in groundwater
- Sumps in basements
- Vapor intrusion = Imminent Hazard
