Use of Thoron to Identify Preferential Pathways for Vapor Intrusion

Jay Peters Katherine Dilawari, P.E., LSP

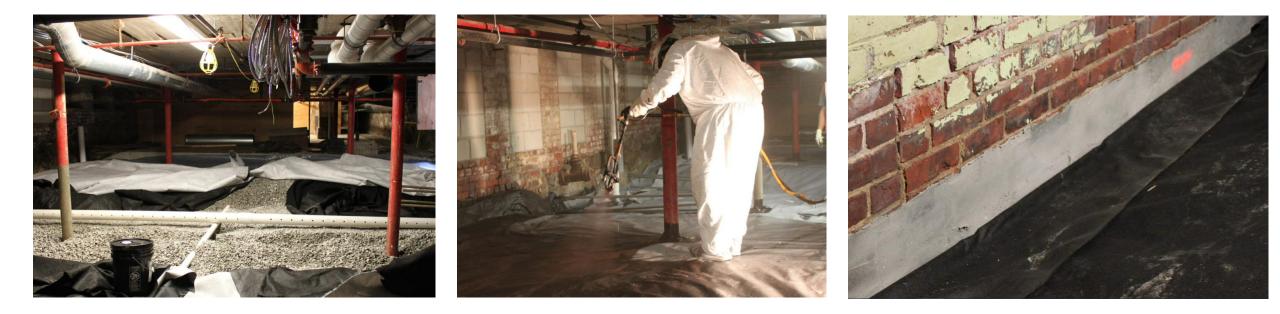
Radon mitigation system

• Owner elects to install radon mitigation systems prior to testing indoor air

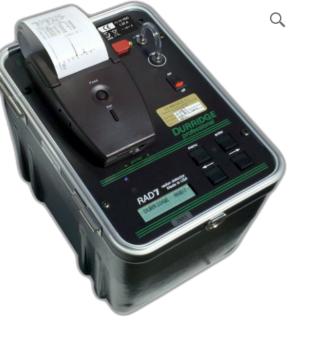
- Used RAD-7 thoron detector with sampling wand directed toward suspect vapor entry points
 - Utility perforations
 - Stairwells
 - Floor / wall perimeter

- Identified high levels of thoron at wallperimeter seam
- Further inspection revealed that vapor barrier was not properly sealed to wall
- Repair initiated
- Subsequent indoor air testing for radon yielded non-detect results
