→ **Tom Kinney, CPG, PG**
Contaminant Assessment &
Remediation Team Leader, Senior
Geologist, GHD

Battelle 2023

Site 1 Setting

Site 2 Setting

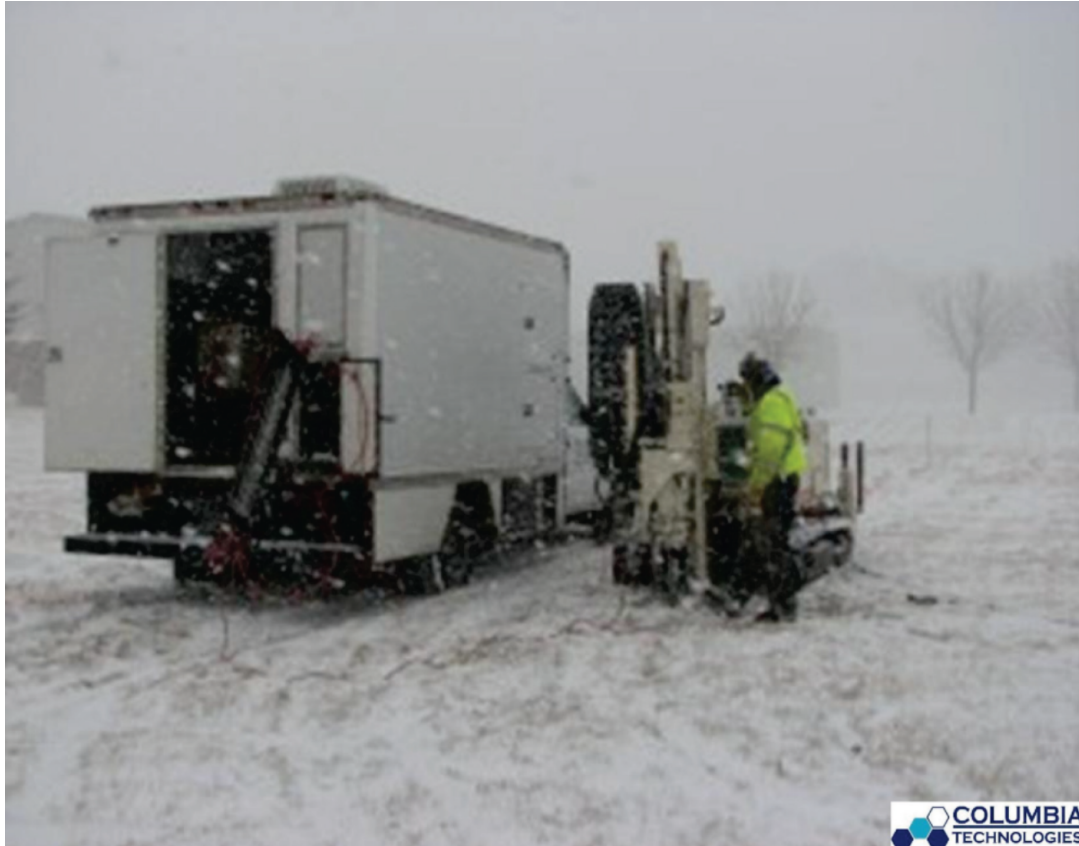
Remedial Investigation

RI included:

- Membrane Interface Probe (MIP)
- Hydraulic Profiling Tool (HPT)
- Traditional drilling and sampling
- Aquifer testing
- 3-D models
- TCE Isotope analysis
- Treatability studies

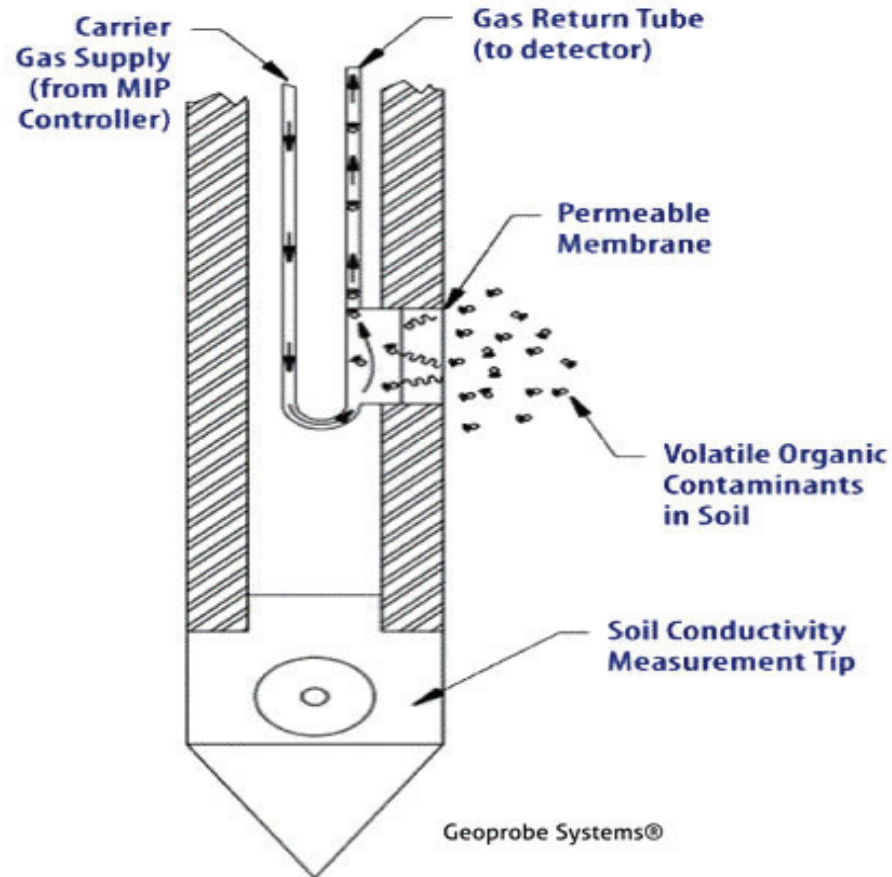
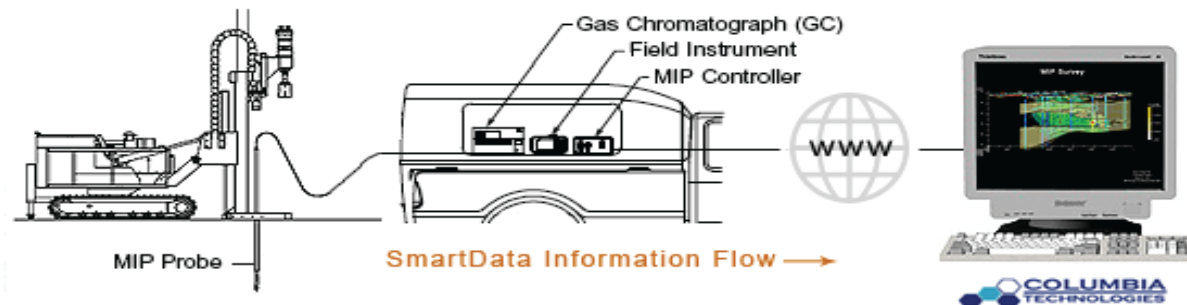
Remedial Investigation

The extensive size of the site and the thin plumes of TCE present, MIP technologies were utilized to rapidly identify and delineate the vertical and horizontal extent of TCE

Site 1 - MIPs completed in transects perpendicular to GW flow

Identified three separate TCE plumes; 2 were long thin dilute plumes

TCE present in 0.5 to 5.0 ft thick interval in middle of aquifer

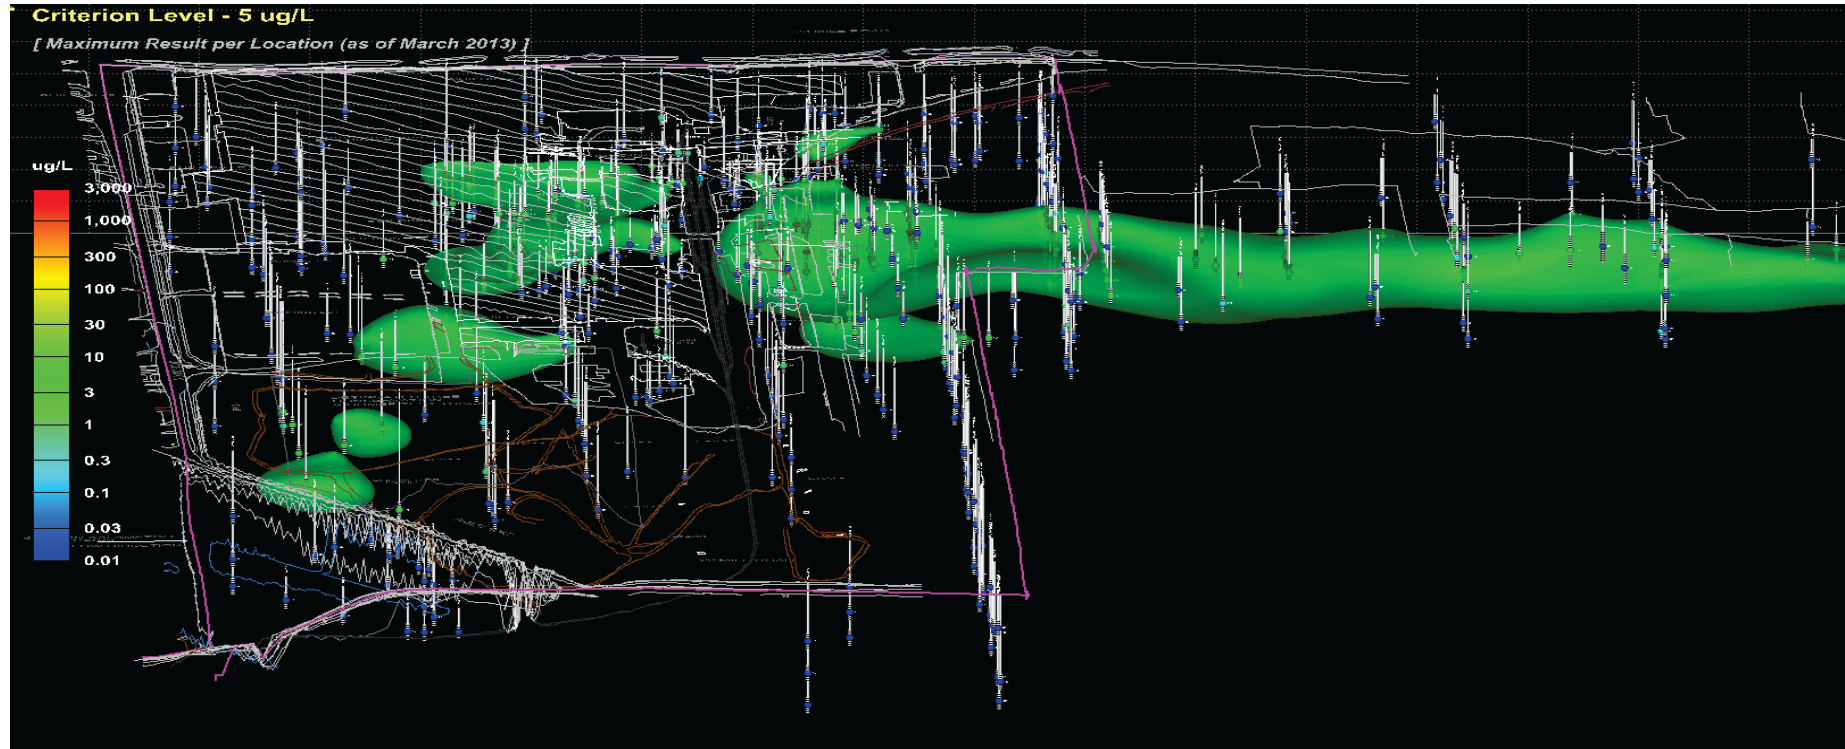
Conceptual Site Model

Based on CSM – FS completed selecting PRBs at downgradient edge of plumes

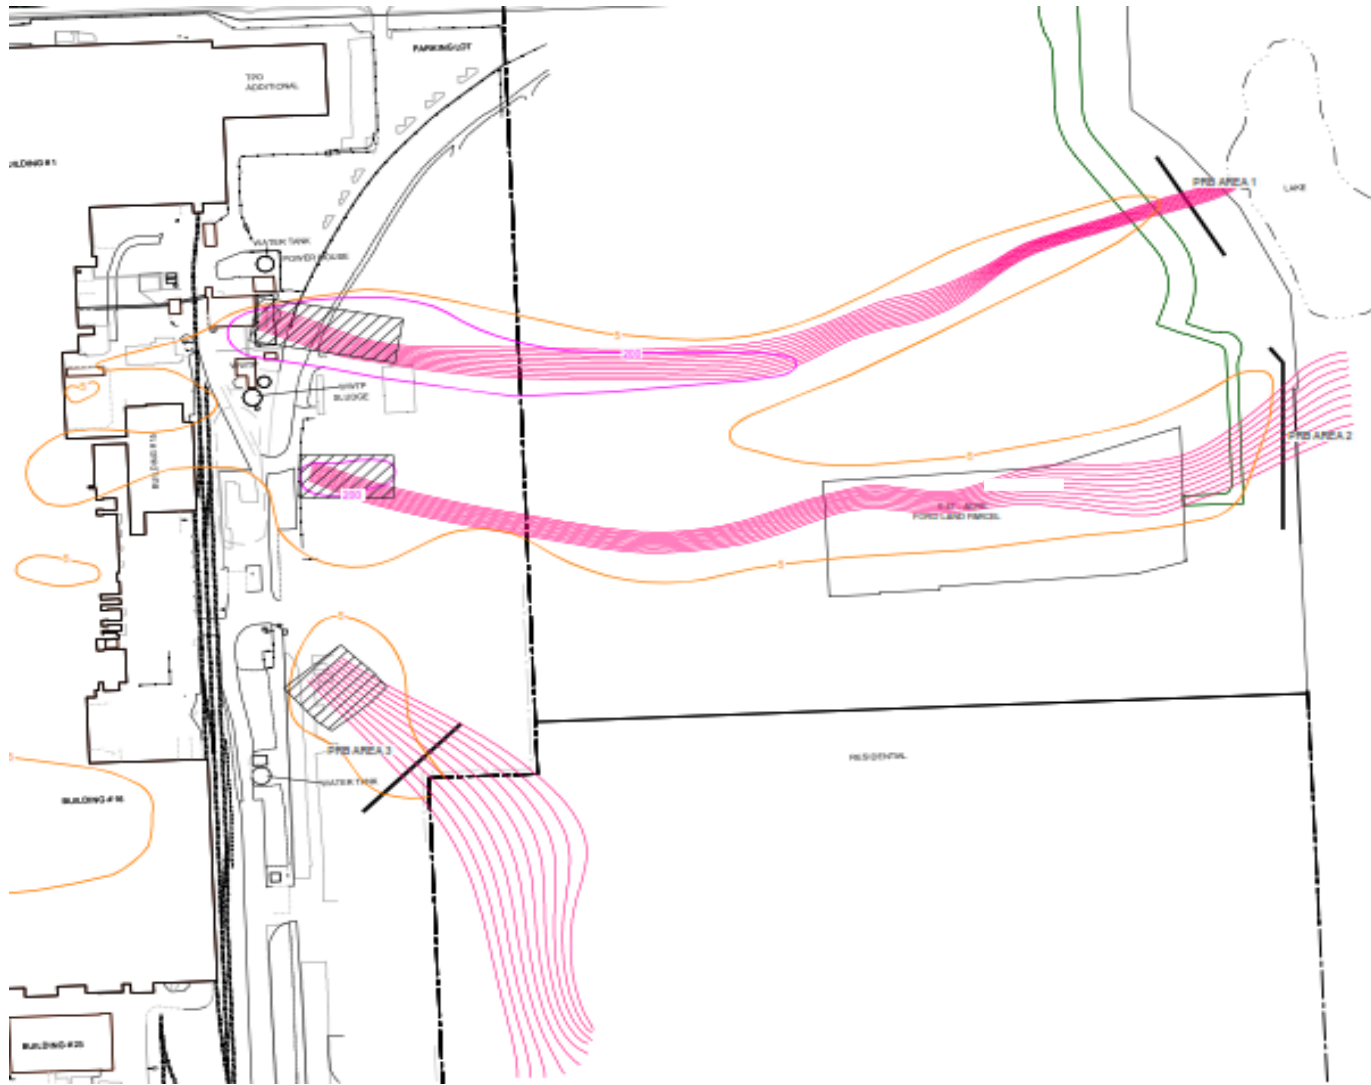
Pre-Design Investigation

- 3D fate & transport model
- Temporary and permanent monitoring wells to verify exact location of plume for PRB locating
- Soil borings along path of proposed PRB to better define stratigraphy
- Slug tests and collection of soil for grain size and permeability tests
- **HPT data was consistent w traditional testing method results**

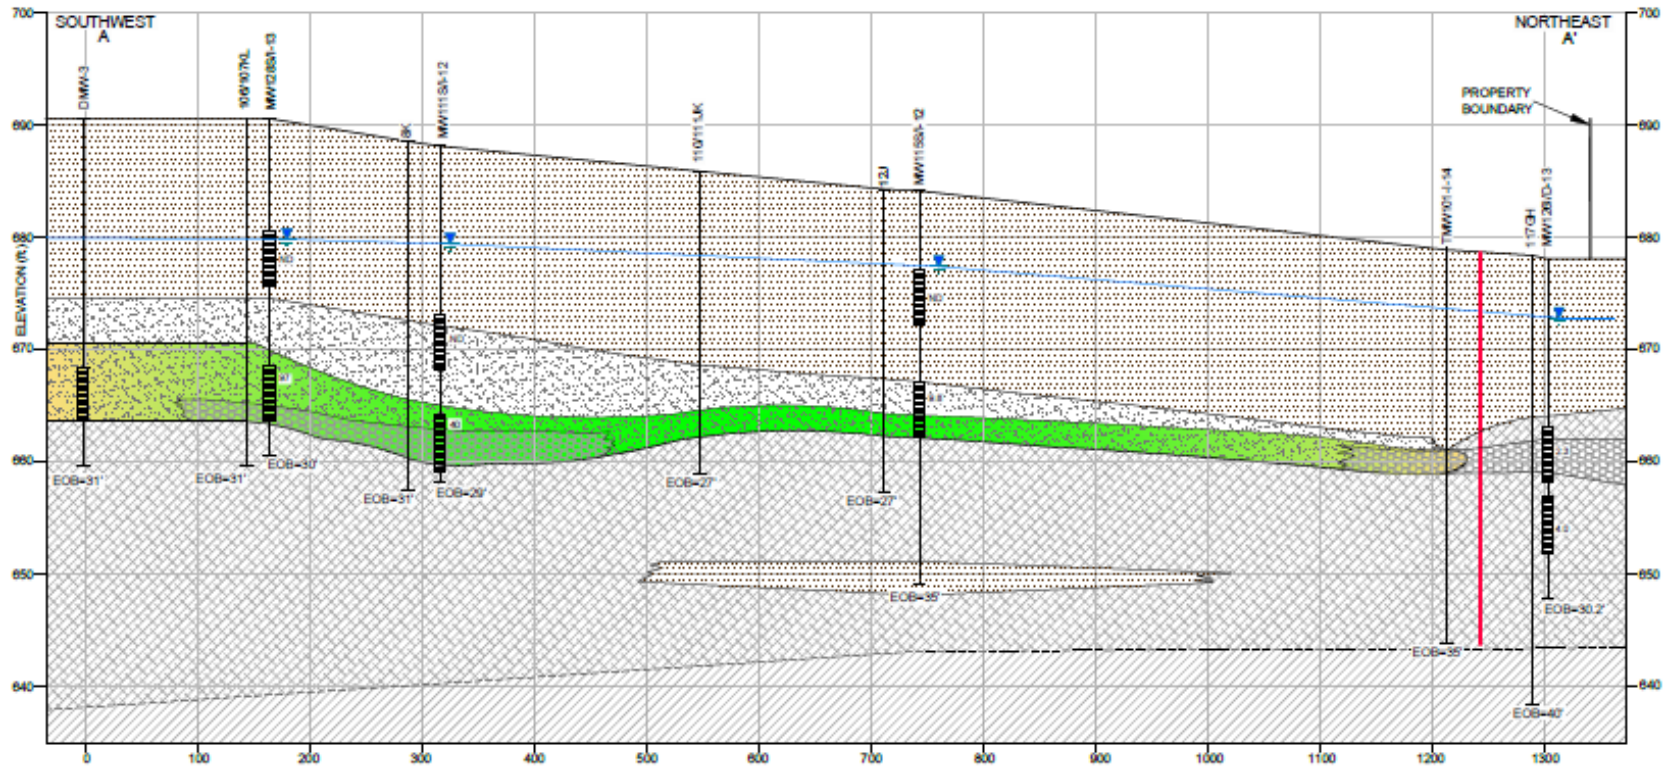
PRB Design

PRB identified in red, tying into the lower clay unit

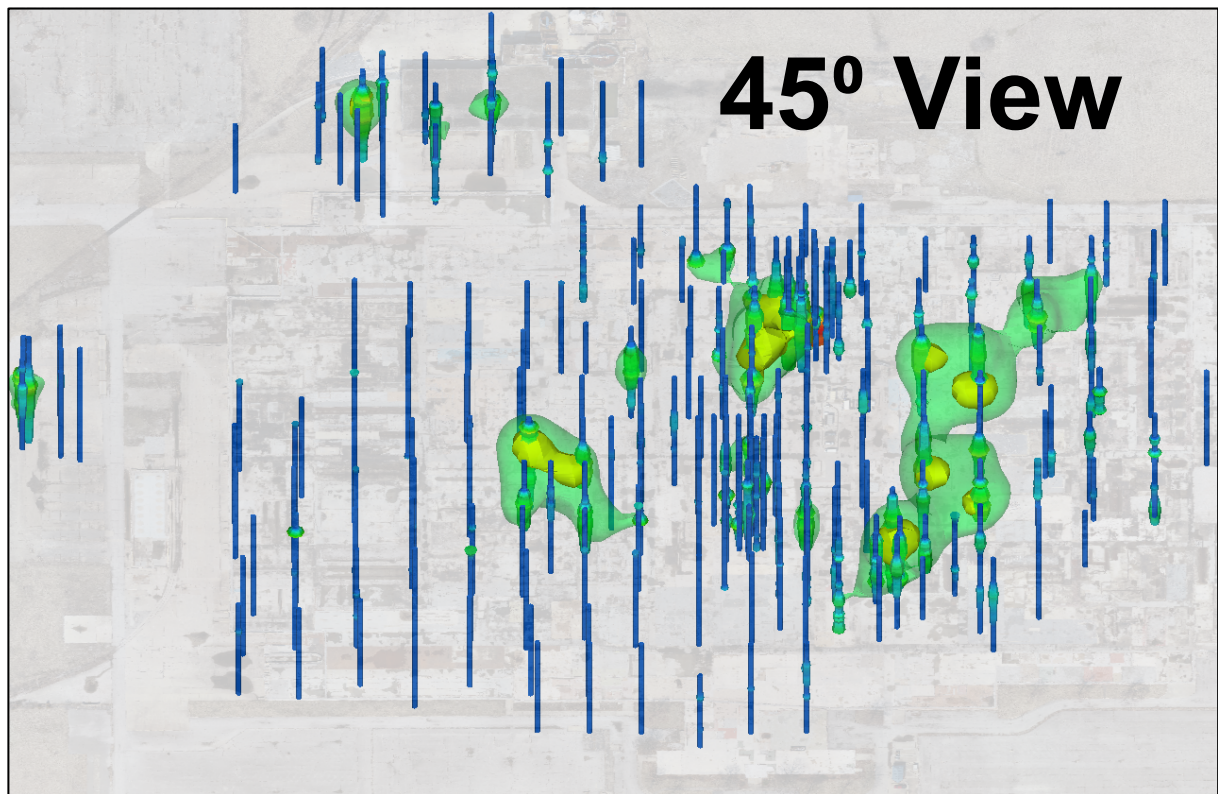
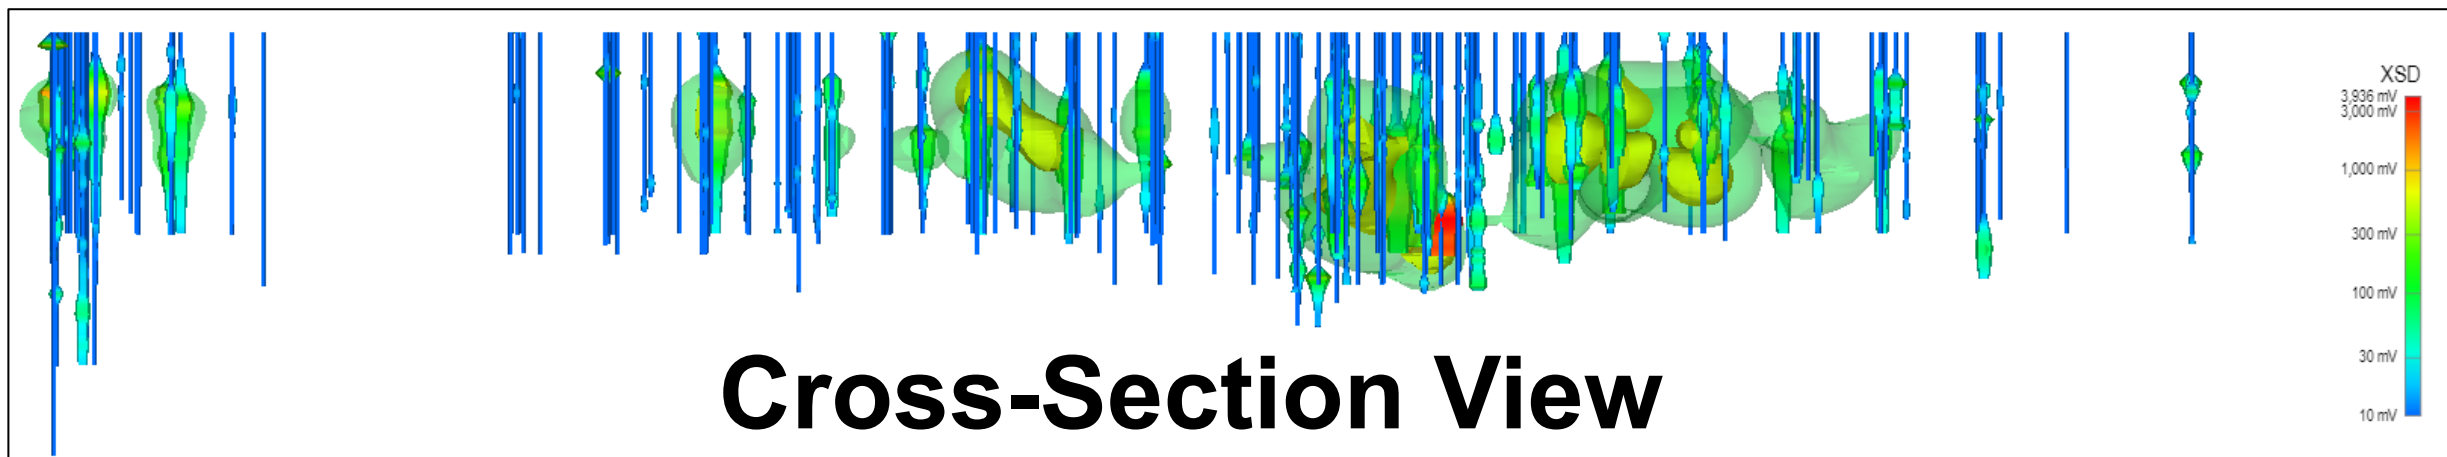
MIP Results and Interpolation

- MIP
 - 280 MIP borings
 - Identified cVOCs
- LIF
 - 158 LIF borings
 - Identified LNAPL

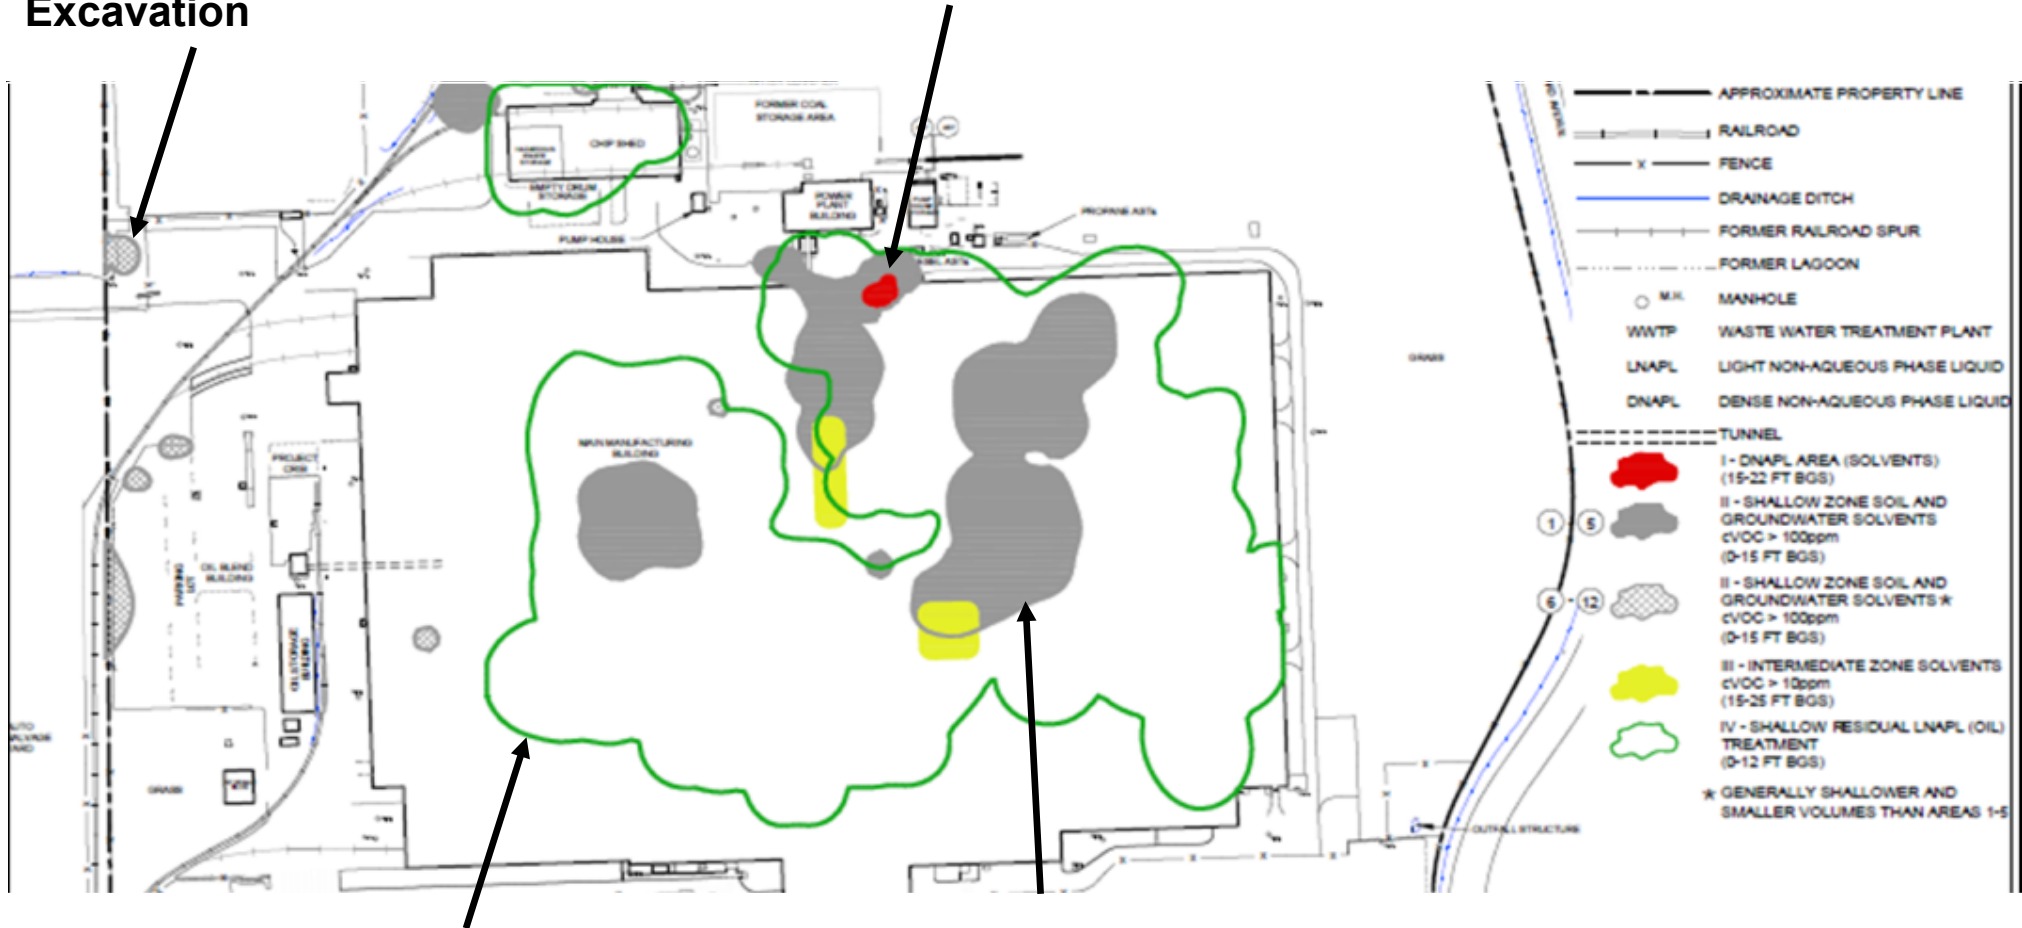
Liquid Solvents– intermediate zone GW (15 – 25 ft)
In-Situ Thermal Remediation (**DNAPL Area**)
