Design Stage Conceptual Site Model Wyckoff Eagle Harbor Superfund Site

Battelle Sediments Conference

Jeff Gentry, Jacobs Helen Bottcher, U.S. Environmental Protection Agency Ken Scheffler, Jacobs Scott McKinley, Jacobs Dave Finney, Jacobs February 2019

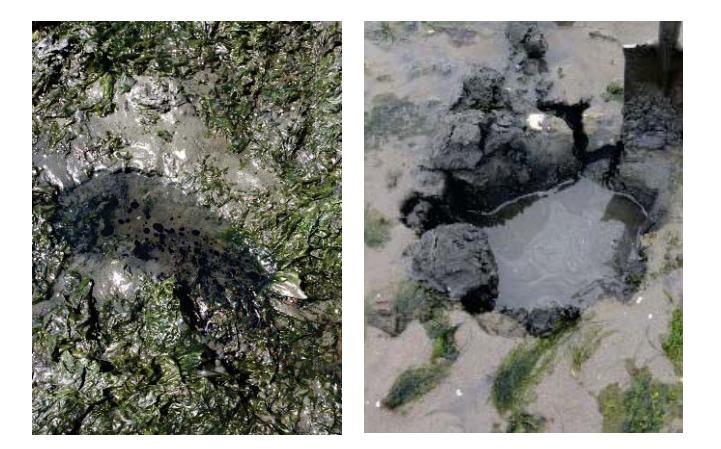
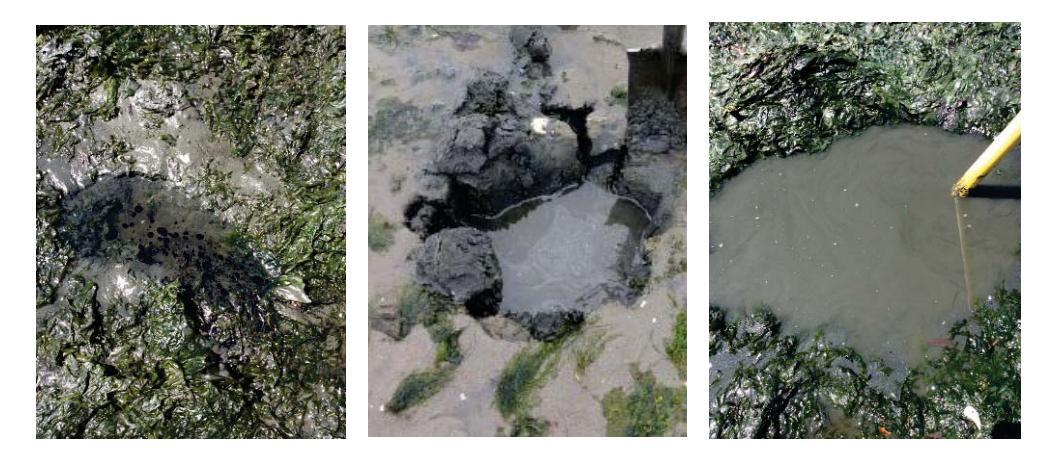
183 "clam holes" excavated and elutriate NAPL observations recorded

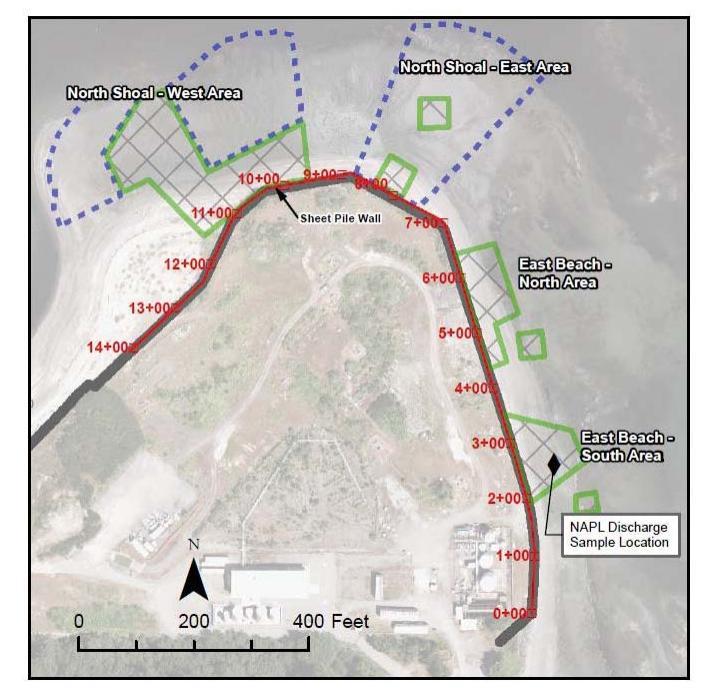
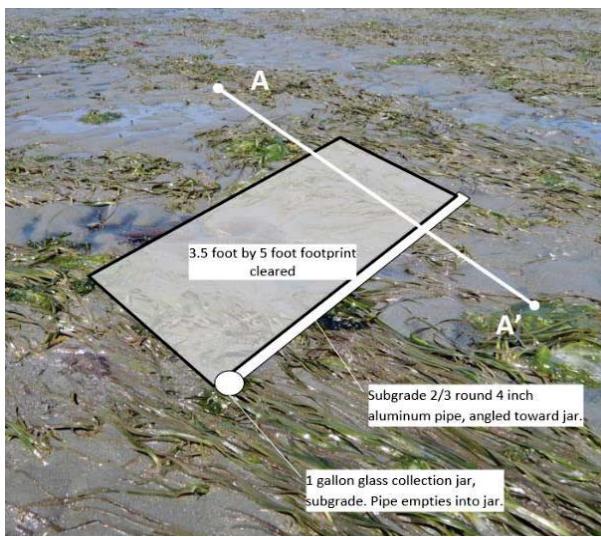
NAPL Discharge Rate Tests

- NAPL discharge locations identified prior to field event
- NAPL collected from seep area during low tide

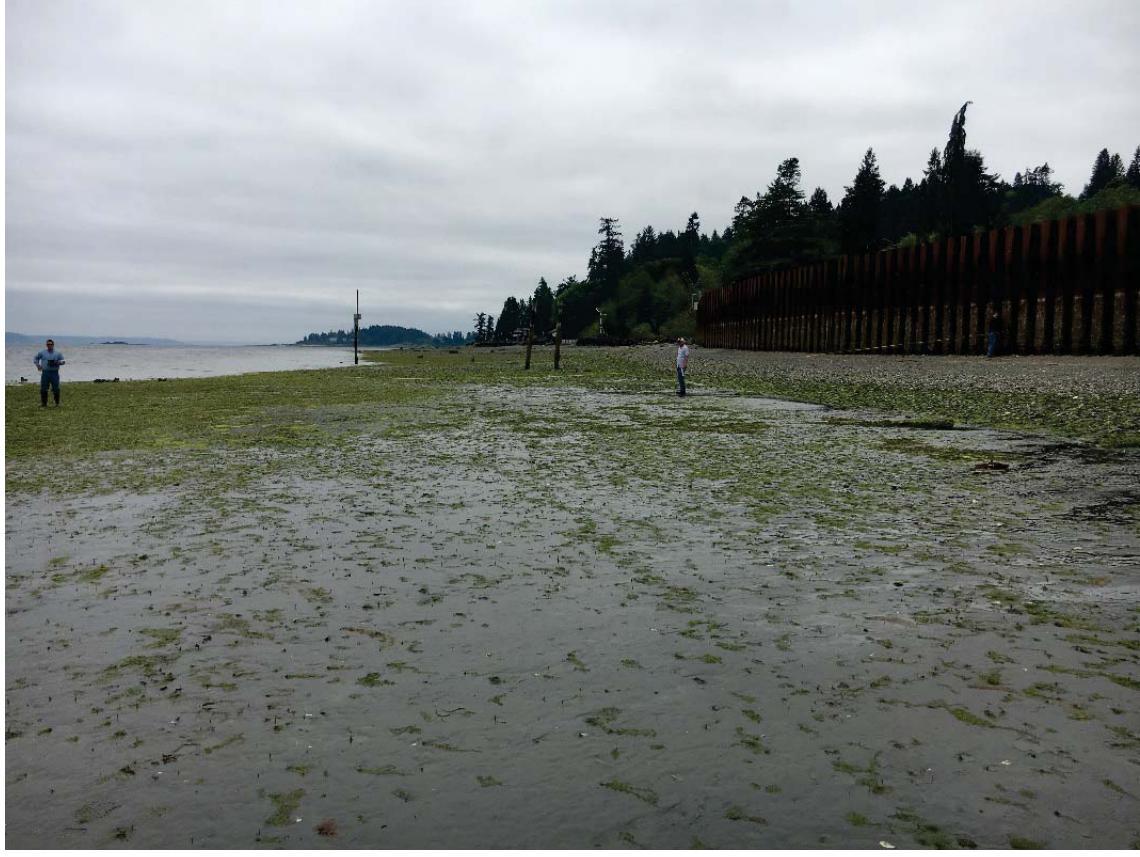
Source Control and MNA has Vastly Improved the Intertidal Area NAPL condition

- 1986 Video shows low vegetation and high NAPL discharge
- Currently, eel grass and clams present

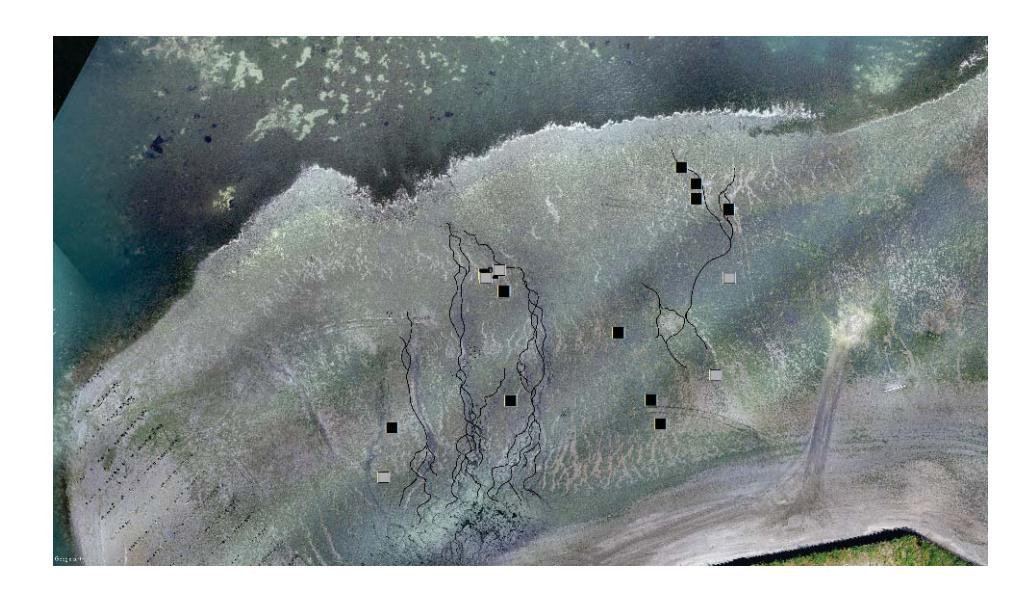
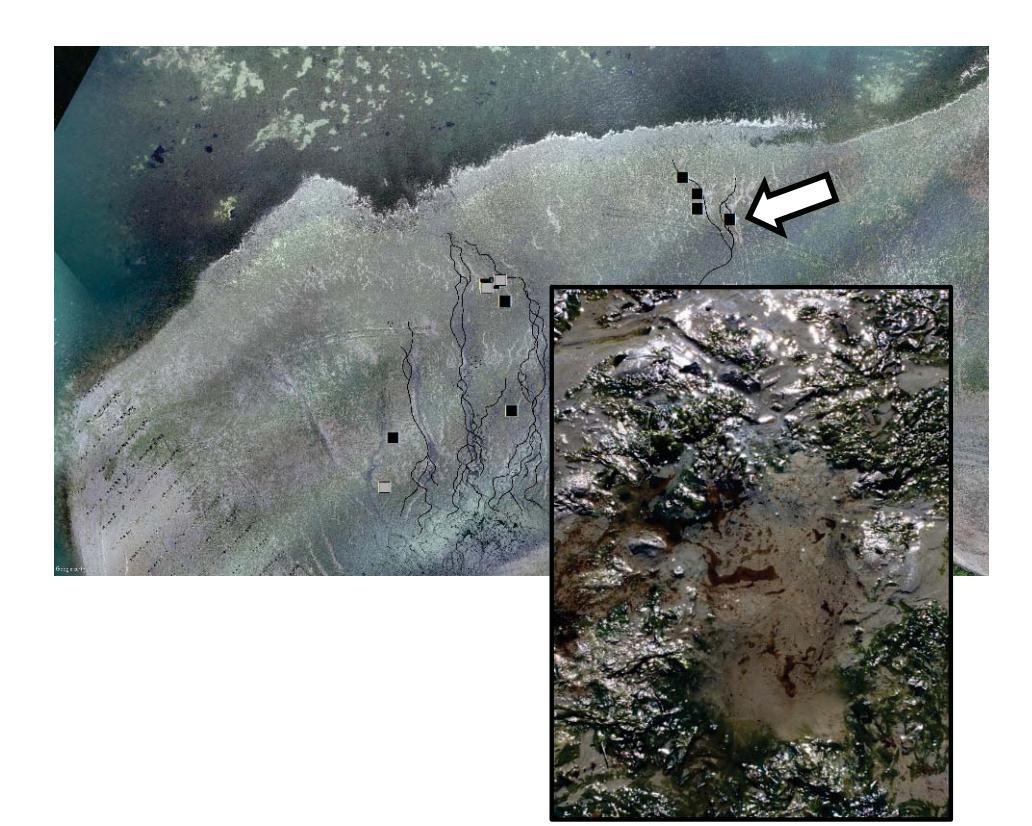
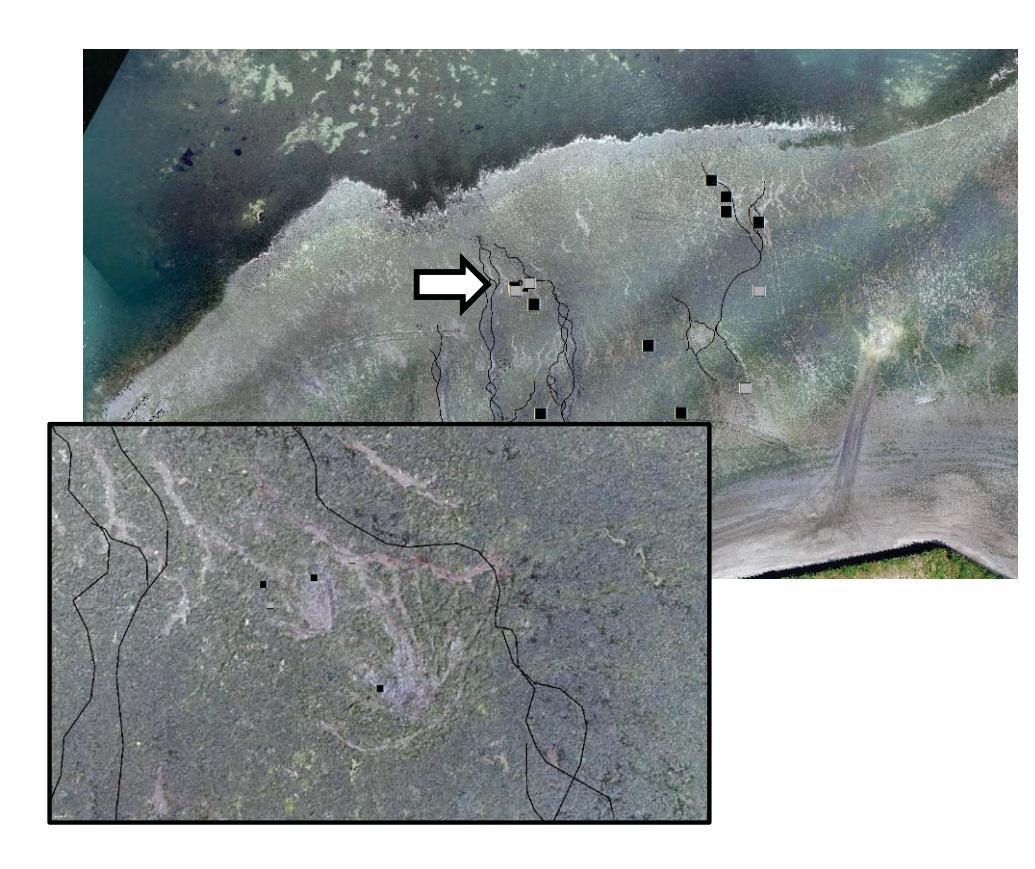
- NAPL blebs and sheen in shallow sediment followed tidal drainage
- Surface blebs observed 235 feet from sheet pile wall

- NAPL blebs and sheen in shallow sediment followed tidal drainage
- Surface blebs observed 235 feet from sheet pile wall
- Detailed imagery allowed surface NAPL impacts to be identified

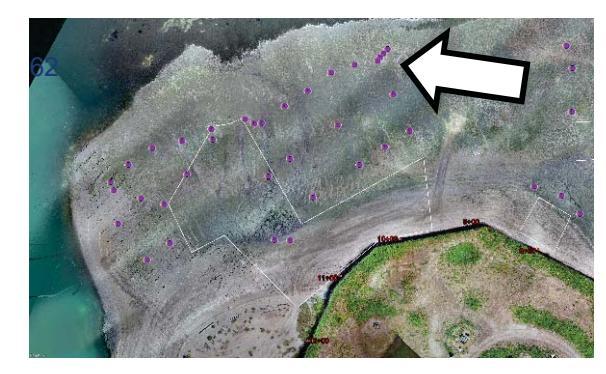
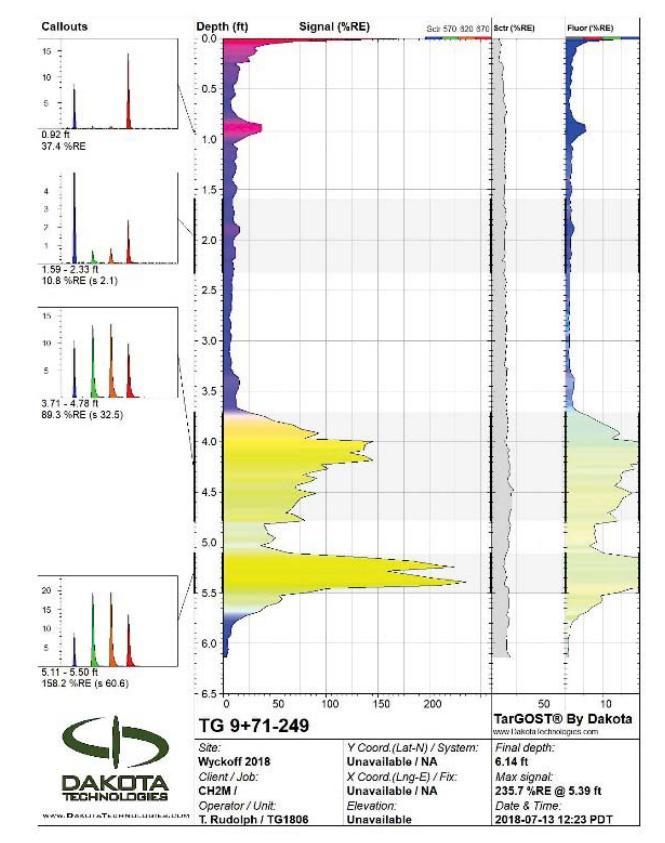
Deep NAPL Impacts Occur at Tidal Drainage Ends

- High TarGOST response up to 6 feet deep
 - 250 feet from wall
- Two step-out borings, same general response

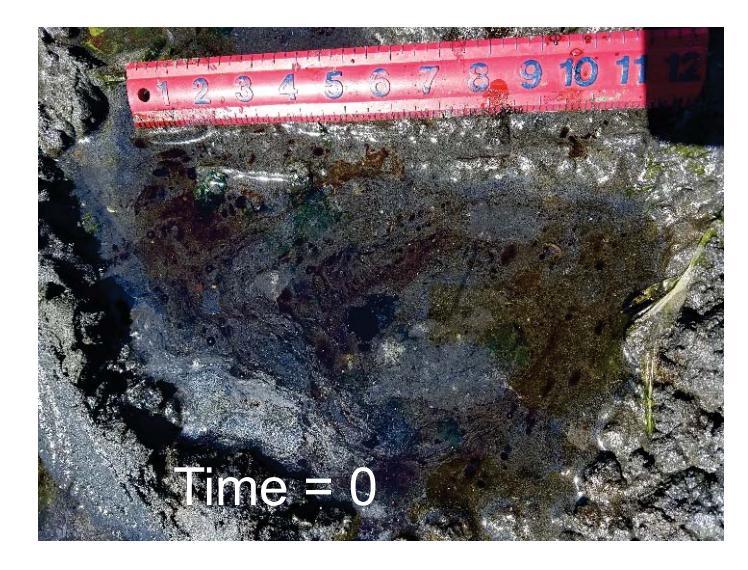
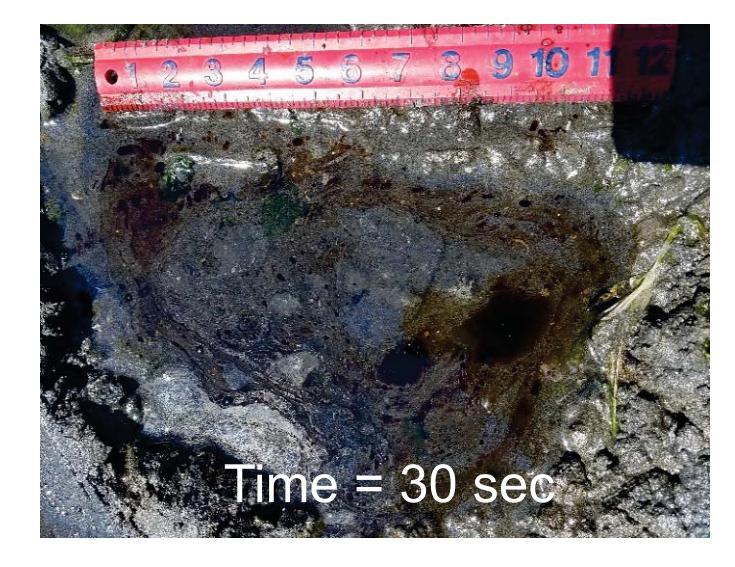
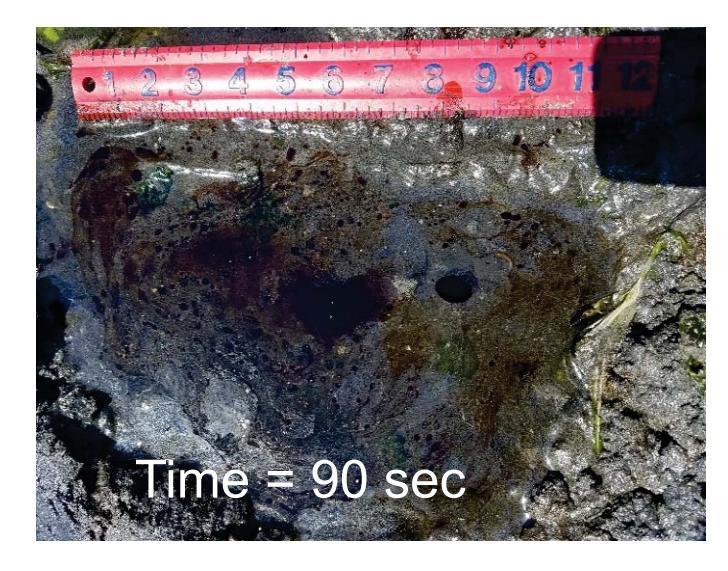
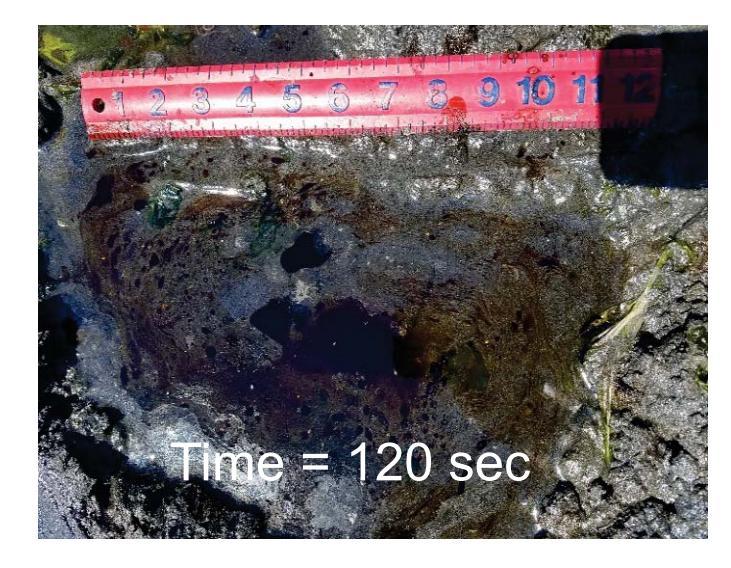
- High TarGOST response up to 6 feet deep
 - 250 feet from wall
- Two step-out borings, same general response
- NAPL observed in borehole

- High TarGOST response up to 6 feet deep
 - 250 feet from wall
- Two step-out borings, same general response
- NAPL observed in borehole
- TarGOST interpolation also follows tidal drainage

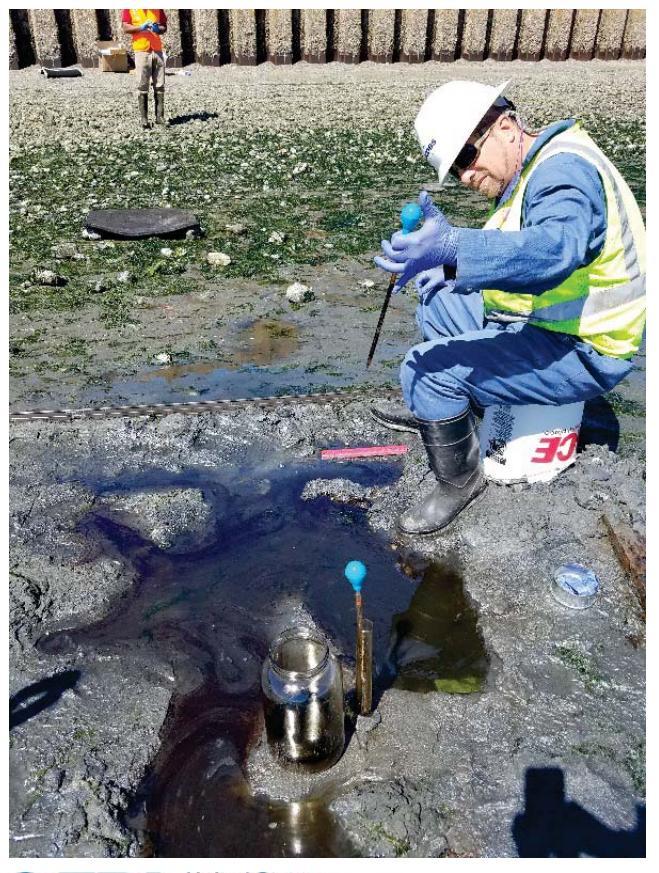
- 200 mL of NAPL (or 196 grams) was collected over one tide cycle
 - 0.97 specific gravity LNAPL!
 - Total collection area ~100 ft² (9.2 m²)
 - majority of the discharge occurring from an area of 1 ft² (0.092 m²)
