IMMEDIATE AND EFFECTIVE PFAS TREATMENT IN BEDROCK AQUIFER AT A HAZARDOUS SITES CLEAN UP ACT SITE

Barry Poling (REGENESIS, Louisville, KY, USA) Glenn Nicholas Iosue, P.E., BCEE (REGENESIS, Philadelphia, PA, USA) Jonathan Dziekan (Tetra Tech, Langhorne, PA, USA) Lisa Strobridge, PG (Pennsylvania Department of Environmental Protection, Norristown, PA, USA) Colin R. Wade (Pennsylvania Department of Environmental Protection, Norristown, PA, USA)

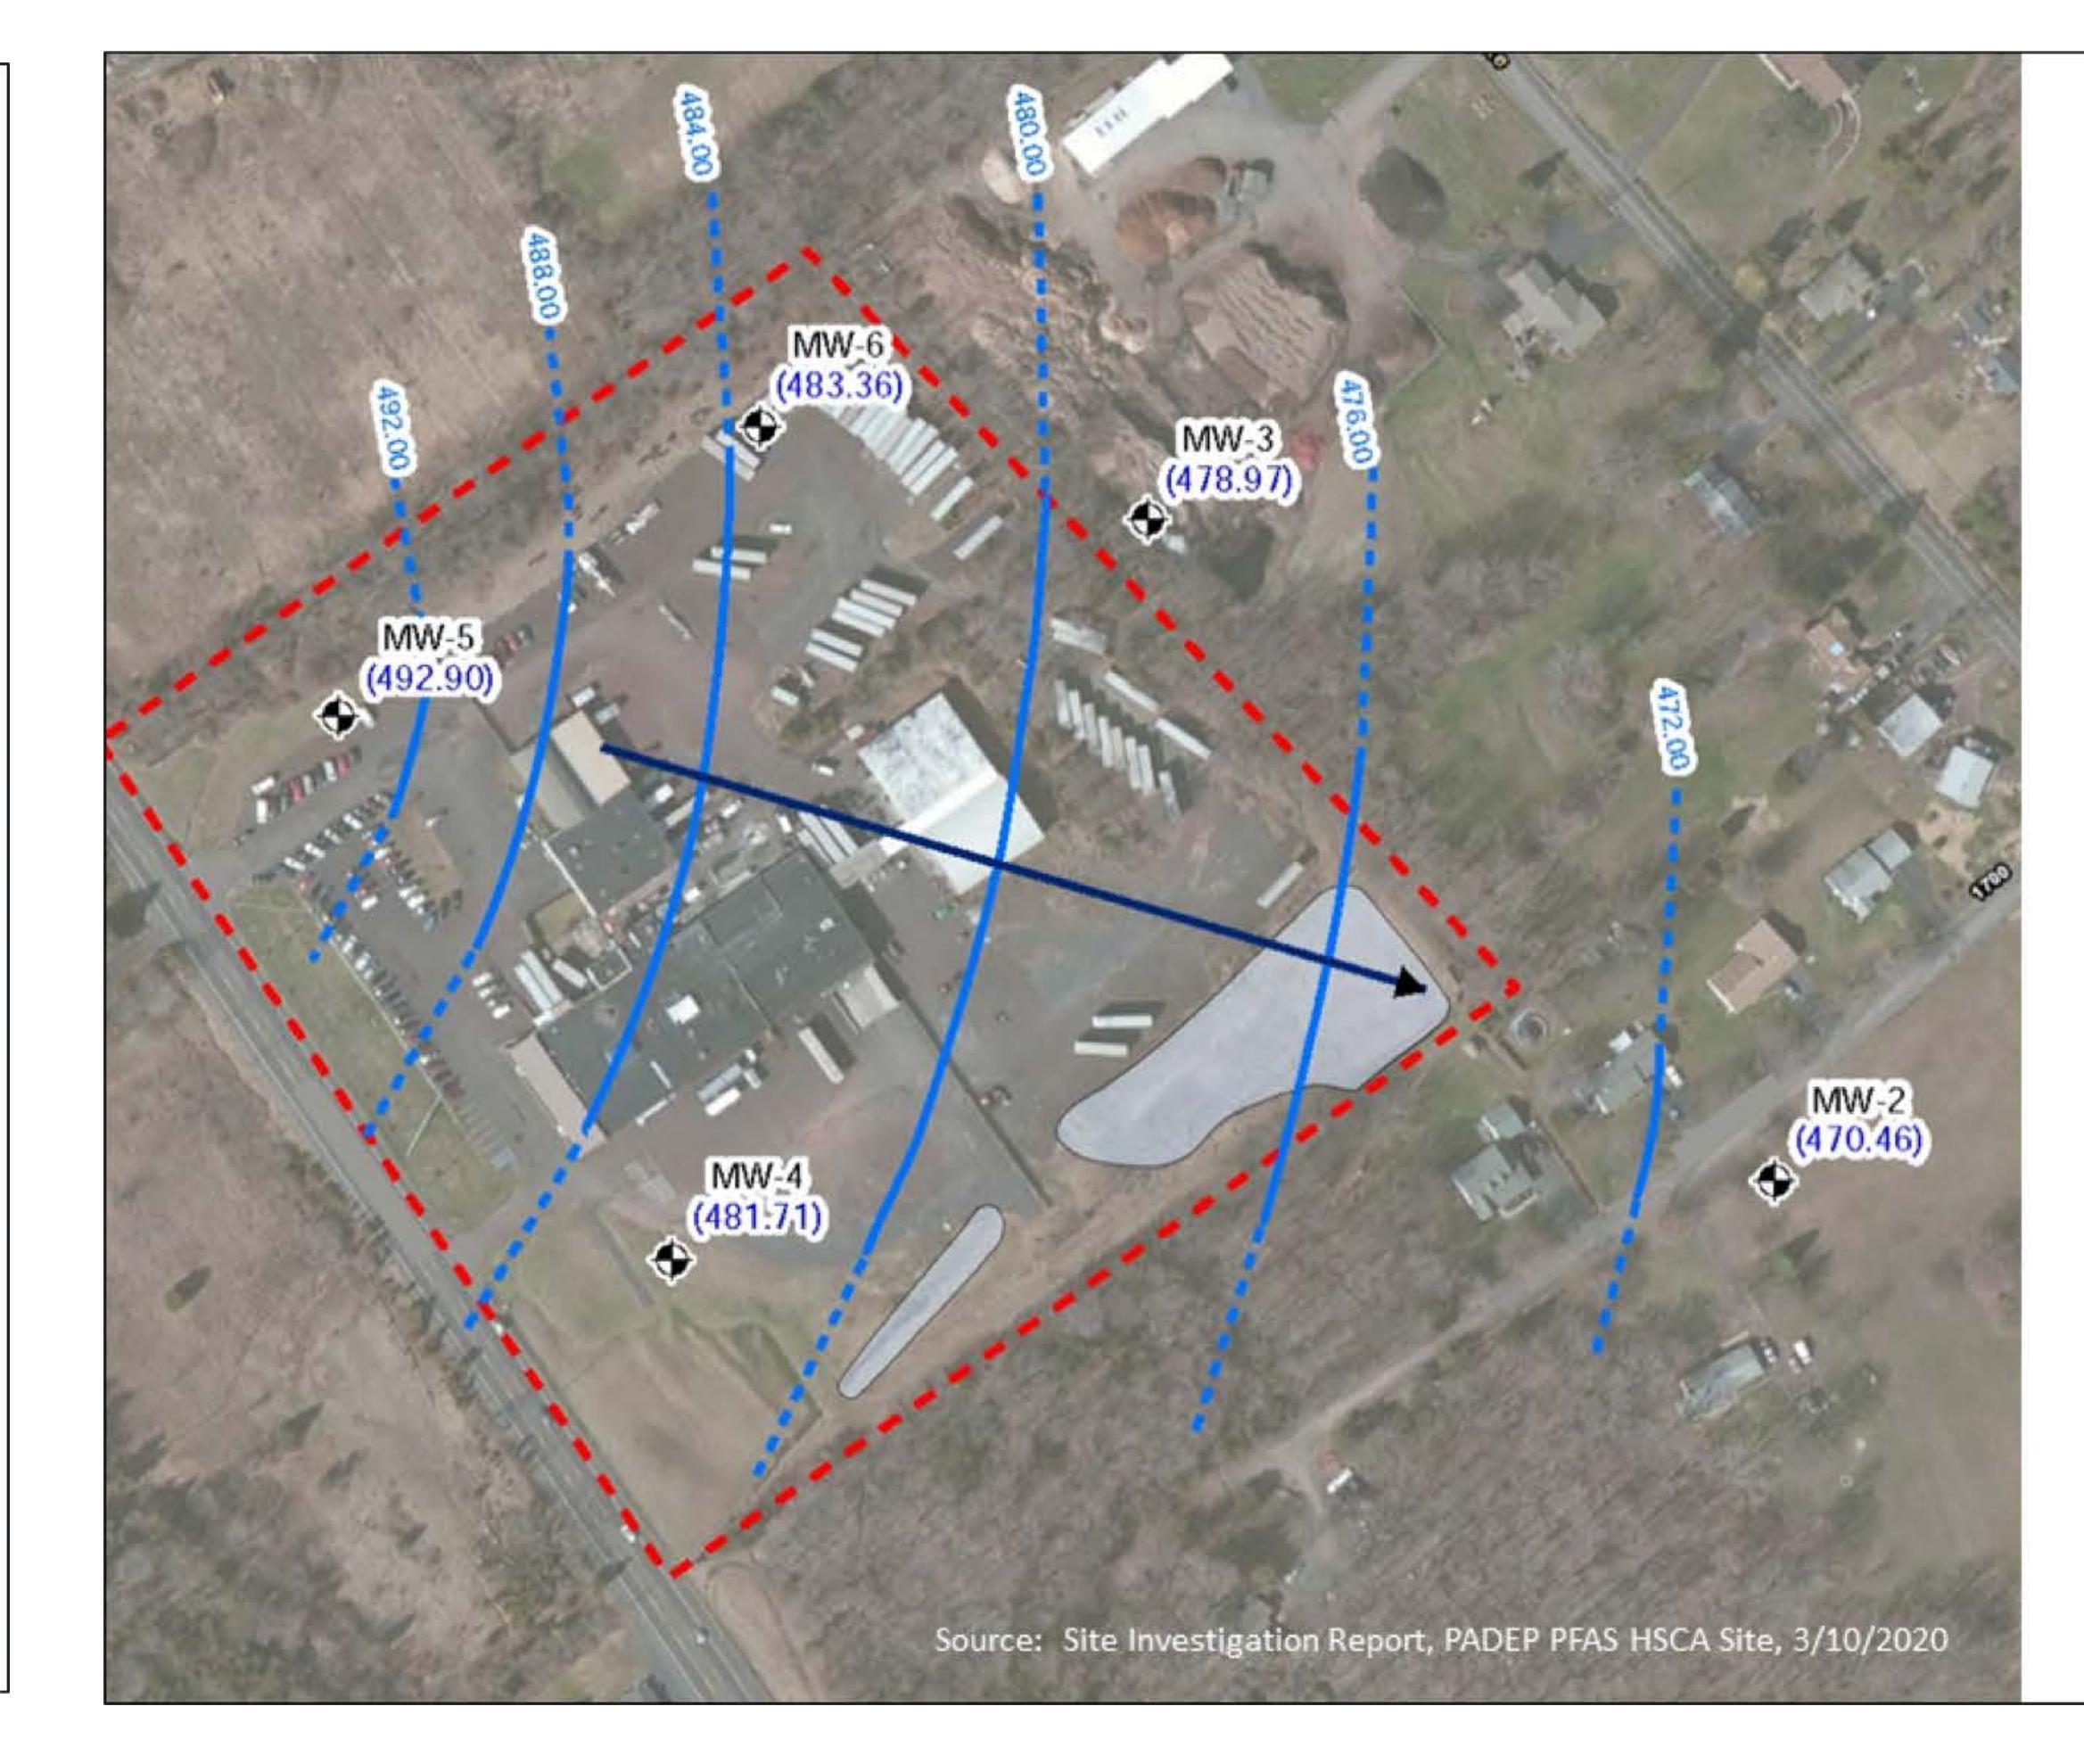
Shallow **Groundwater Flow**

Brunswick Formation to 100 ft

Groundwater primarily to SE via fracture flow

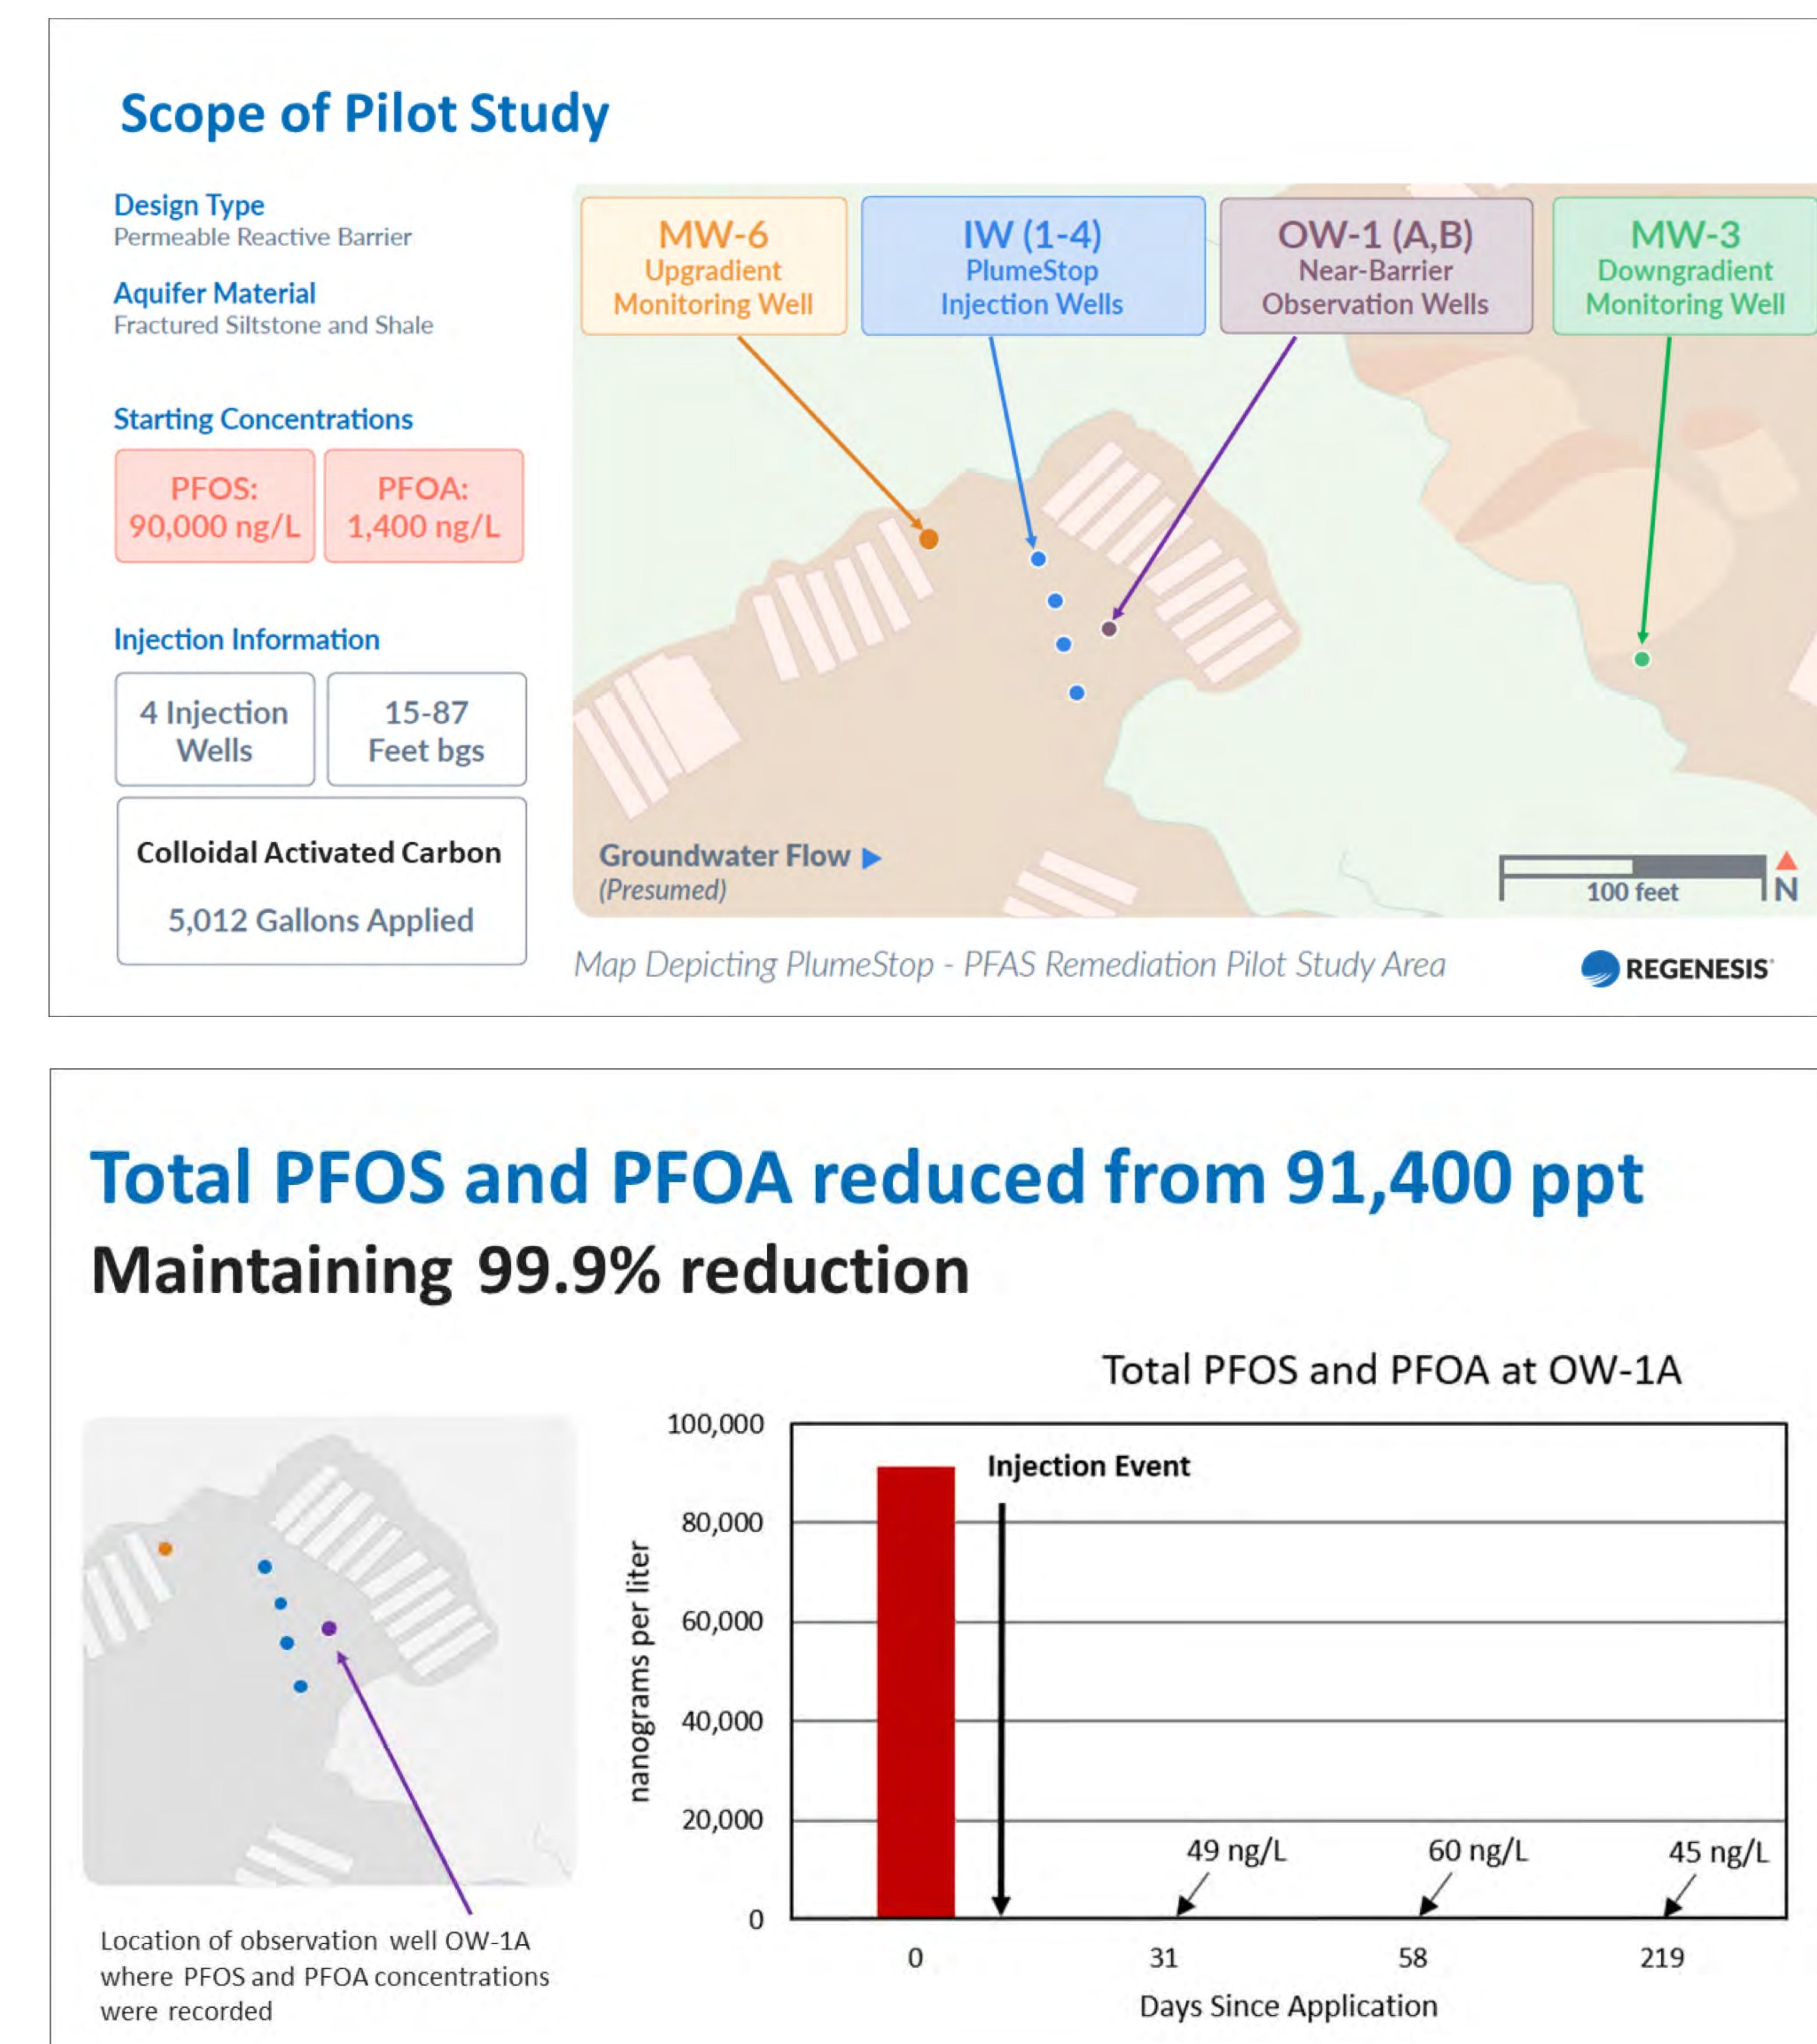
The combination of a fractured bedrock hydraulic environment combined 91,400 ng/L PFOS and PFOA were reduced to and an extensive target vertical treatment interval can present approximately 70 ng/L (99.9% reduction), after only one month following the injection event. These results demonstrate the challenges to an *in situ* remediation approach due to the wide-ranging secondary porosity controlling groundwater remedy's effectiveness to quickly, sustainably, and safely contain movement over the interval. The highly variable porosity high concentrations of PFAS in fractured bedrock, reducing the observed at this site was quantified during the injection test, risk to downgradient receptors. Expansion of the treatment leading to a sound CAC PRB injection strategy that achieved the approach at this site and other sites managed by the regulatory pilot test goal. Following the CAC PRB application, the agency is actively being considered.
