Remediation of AFFF/ PFAS Impacted Soil by Sequestration and Natural Attenuation

Battelle - 6th International Symposium on Bioremediation and Sustainable Environment Technologies

RockGen Energy Center Facility and Site Description

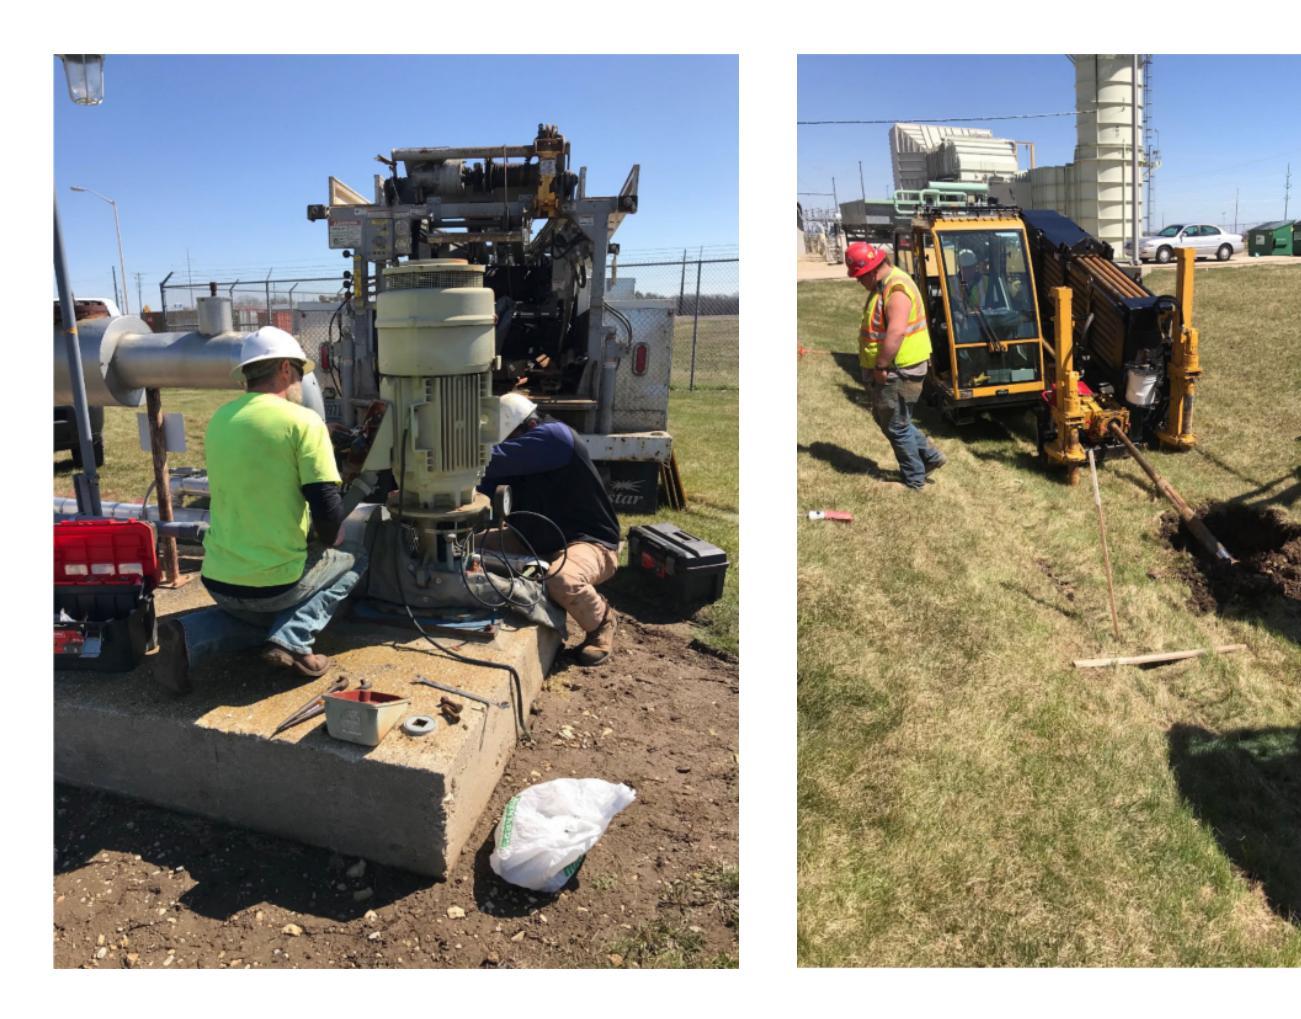
Potable Well Abandonment

- Existing well drilled to 200' bsg. impacted
- Abandonment eliminates downward groundwater gradient from pumping
- Two production wells drilled to 1,000' bgs not impacted
- HDD to minimize waste generation (~400')
- Southern industrial well selected for potable

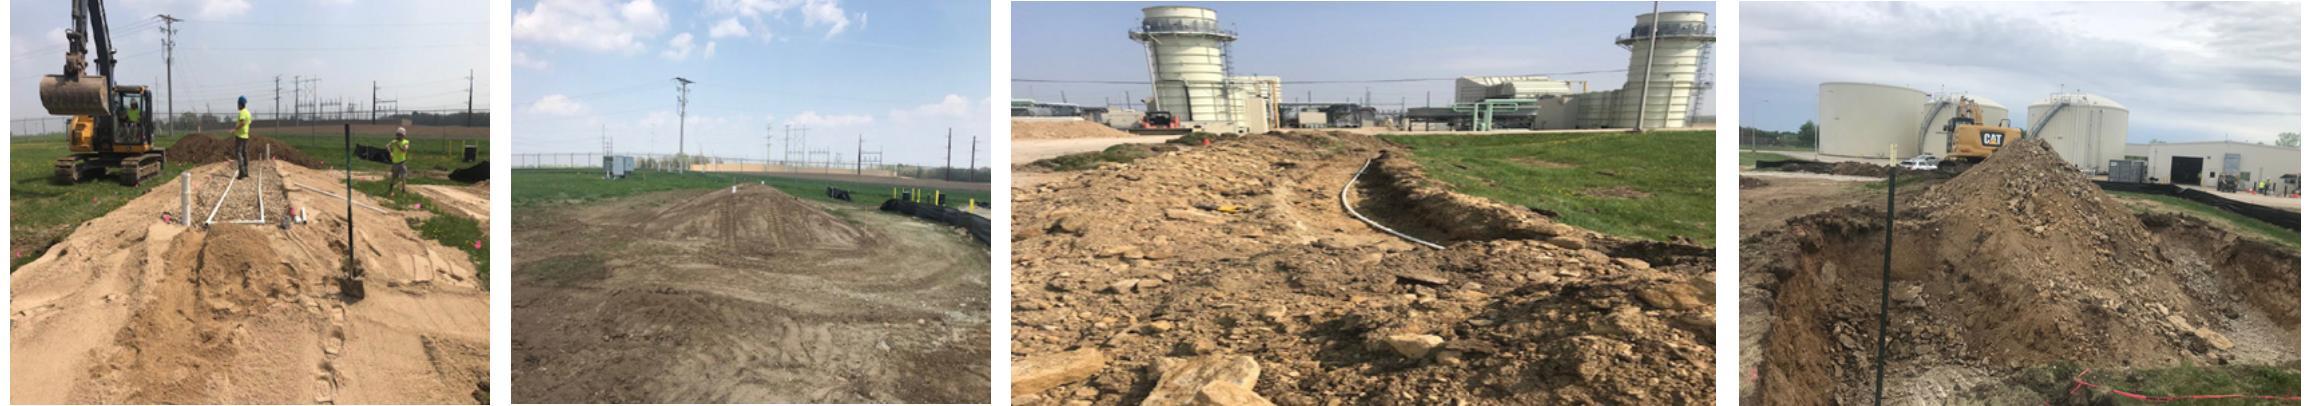
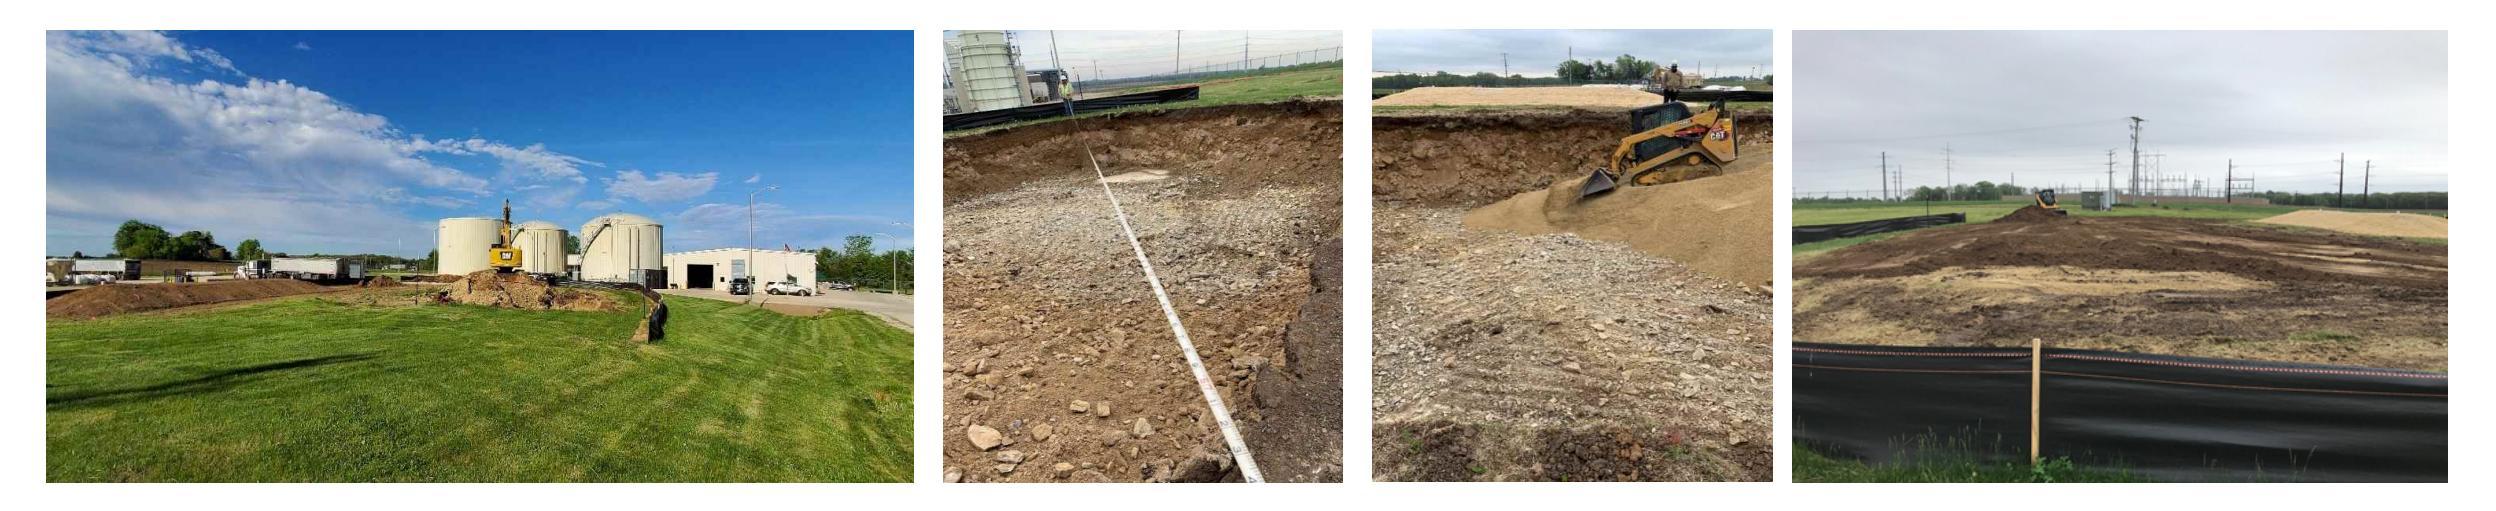
Excavation

- > TRC self-performed excavation of septic system and mound.
- > 1,000 tons disposed of in Subtitle C landfill (Wayne Disposal)

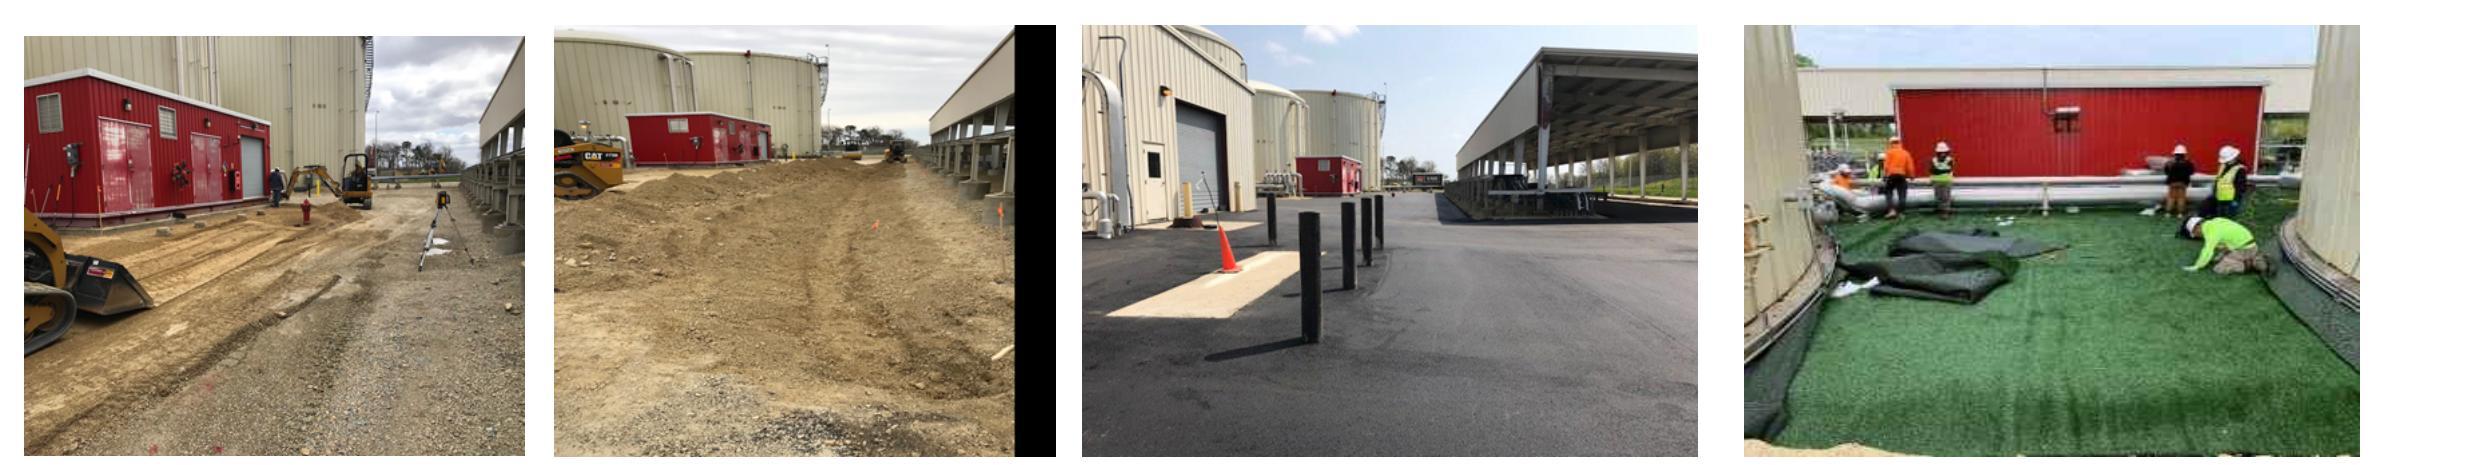
Capping - Asphalt

Site grading and prep – no removal and disposal of soil

≻5" asphalt cap

Geosynthetic cover beneath piping and facility infrastructure

Drainage enhanced

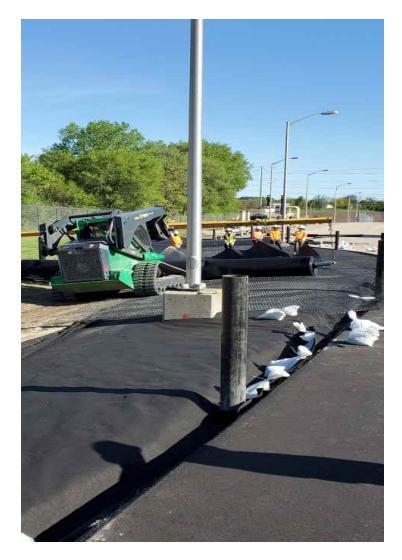
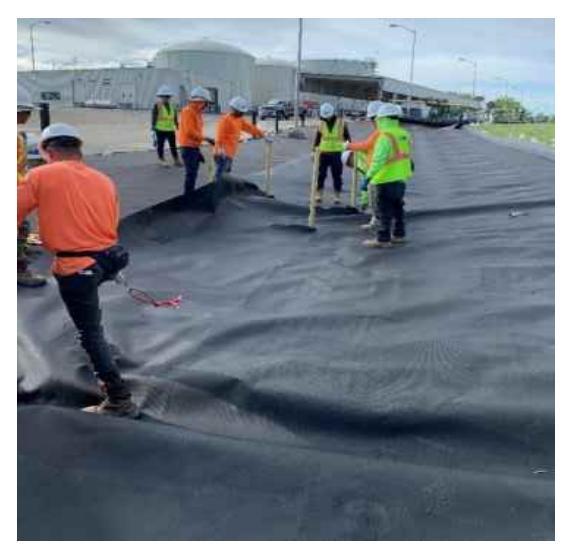
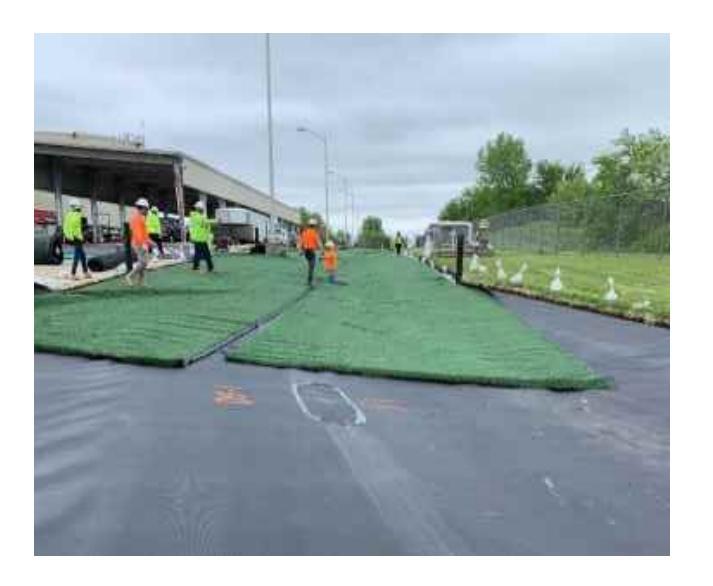
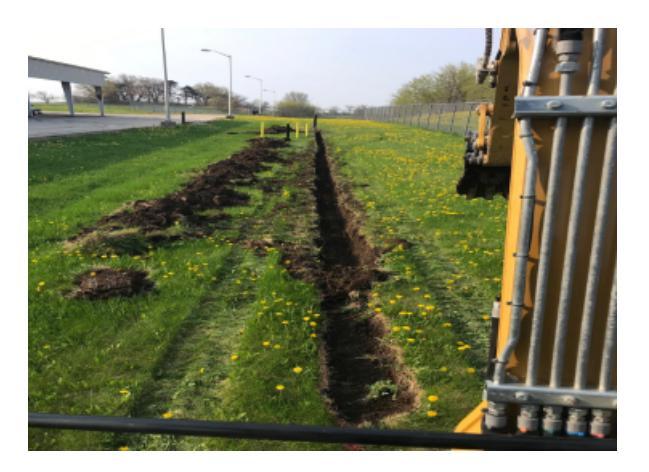
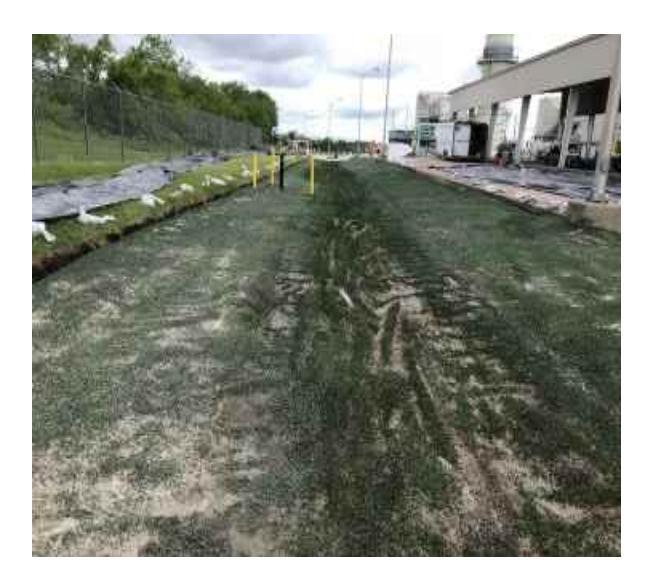
Capping – Geosynthetic Cover System

- Subgrade preparation no removal and disposal of soil
- Non-woven geotextile cushion
- ≻40-mil LLDPE
- Engineered synthetic turf
- Hydrobinder infill
